Clan Association Sites

Barkerville's Clan Association Sites

Historic Chinese Clan Association and Society Buildings

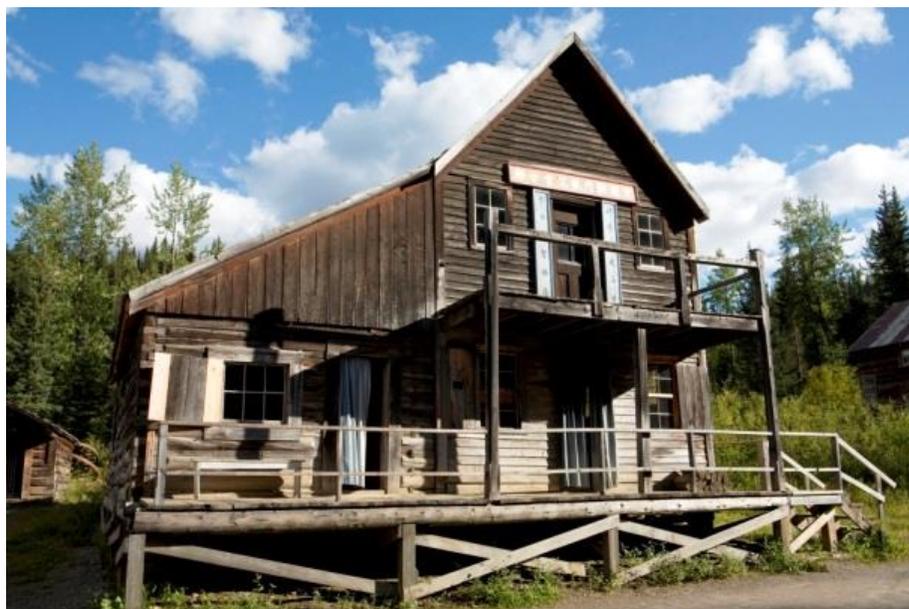
Chee Kong Tong

Barkerville, BC
Built between 1874-1877

Located in British Columbia's Barkerville Historic Town Provincial Historic Site, the Chee Kung Tong Building is a two-storey rectangular structure covered with board and batten, and flanked on the east and north by two log lean-tos. Constructed between 1874-1877, it was originally used by the members of the Chee Kung Tong organization for residential, ceremonial, and social purposes. The ground floor contained a kitchen, a hostel for recent arrivals and winterers, and a socializing space for day-to-day social activities, traditional Chinese celebrations as well as Hong-men society ceremonies. On the second floor were a society hall and an altar room. The hall served as a meeting venue where the society, which was active in the social, political, economic and recreational aspects of its members' lives, dealt with affairs of the Chinese community in the Cariboo District and exerted control over business and personal relationships among its members.

1. the first-storey hostel, kitchen facilities and space for socializing;
2. the second-storey space for a society hall and altar room;
3. its well-preserved wooden components, illustrative of boomtown construction technique;
4. the horizontal and vertical signboards above the second-storey balcony door, that distinguish this building as a Chinese construction;
5. the two log lean-tos that flank the east and north side of the main structure;
6. its setting as part of Barkerville historic town.

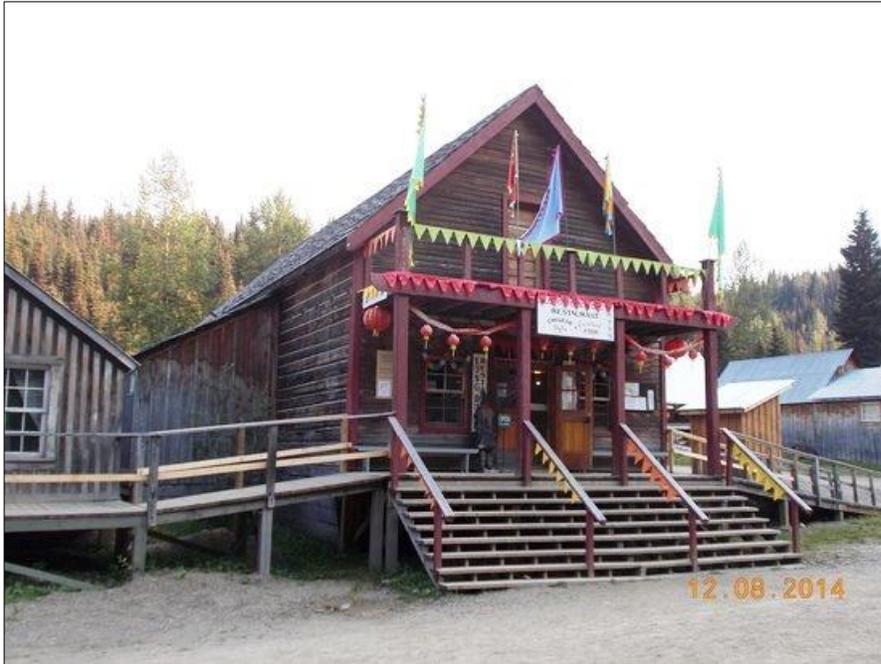
Barkerville, BC
Built in 1904

The Lung Duck Tong Restaurant is a one and one-half storey log structure with wood-framed additions built onto its north and east sides. It is located along the east side of Main Street within the Chinese District of the town. The building is said to have stood here since 1904. It was replicated in the 1970s based on the examination of historic photographs. The Lung Duck Tong building provided the local Chinese community with a place to gather, visit, play games and share meals. It was one of the early Chinese business venues in Barkerville. The building also provided weary travellers with temporary accommodation.

1. It is a larger log structure with wood framed additions built onto the east elevation and the east half of the north elevation.
2. The log structure was constructed with dovetail joints and cement chinking between the logs.

3. Logs were hewed square on both the interior and exterior faces of the log walls.
4. The west elevation is skirted with clapboard siding.
5. The west elevation and board walk are covered over by balcony extending from the wall.

6. The wood-framed pitched roof of the main building slopes downwards to the north and south.
7. Both wood framed additions were built with down sloping roofs.

8. Additions are clad with vertical boards and batten.
9. Openings into the building include a double doorway (with equally spaced windows on both sides) centrally positioned along the west elevation; a door south of center on the east elevation; a window north of center on the east elevation; a door at the west end of the east addition's north elevation; a door centrally positioned along the west gable end wall; and a window centrally positioned along the east gable end wall.

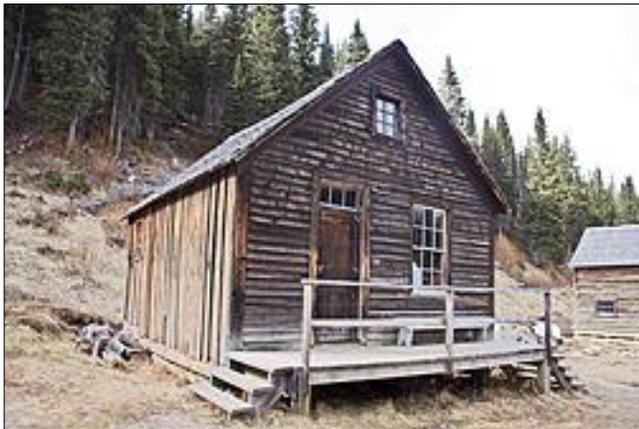
Min Yee Tong Building

Barkerville, BC
Built ca. 1869

The Min Yee Tong building is a one-storey wood framed structure located in Lot 3 along the west side of Main Street, midway within the Chinese district of Barkerville Historic Town. The structure is known to predate 1894, and may have been built as early as 1869. The building was erected on a level pad dug out of the sloping grade, with the area behind the west side of the building sloping more dramatically and is covered with grasses and shrubs that turns into a dense tree line further upslope.

1. It's a simple rectangular structure with gable/pitched roof sloping downward to the north and south.
2. Openings into the structure include: a doorway south of center on the east elevation; a window north of center on the east elevation; smaller window centrally positioned on the east gable end wall; doorway midway along the west elevation; smaller doorway north of center on the west gable end wall; and a small window or pass-through near the west end of the north elevation (now boarded over on the interior side of the wall).
3. Its wood-framed roof is covered with shakes.
4. Front elevation is clad with overlapping siding boards over vertical boards.
5. West, north and south elevations are clad with overlapping vertical planks, similar to board and batten style.

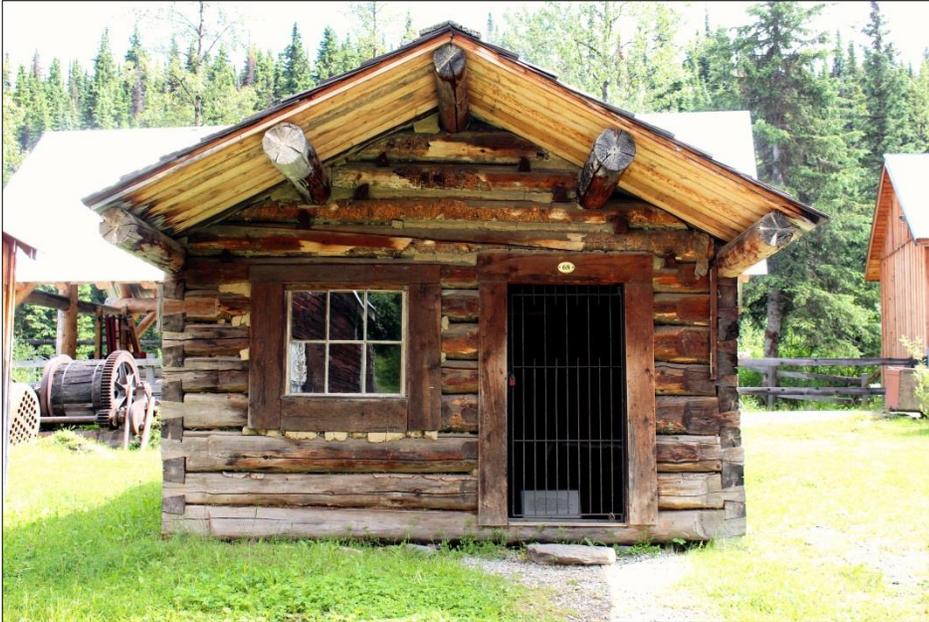
Barkerville, BC
Built ca. 1900

The Tai Ping Fong (Peace Room) is a one-storey log structure constructed in ca. 1900. The building is situated in Lot 69 along the east side of Main Street near the south end of Barkerville Historic Town (midway within the area referred to as the Chinese district of Barkerville). In more recent documents, the building is referred to as the "Chinese Masonic Hospital House" and the "Masonic sick room". The building is situated on relatively flat land with other buildings located along its north and west perimeters, and open grassed areas along its south and east sides.

1. It's a simple rectangular structure with gable/pitched roof sloping downward to the north and south.
2. Its openings to the structure include a doorway at the south end of the west elevation and a window at the north end of the west elevation.
3. The logs at the corners of the building were notched together with dovetail joints.
4. Logs were not peeled prior to being utilized and the spaces between the logs were chinked with mud.
5. Roof extends a considerable distance over the west side where the doorway is located.
6. The roof, which has been replaced, had a layer of boards with a layer of clay that was covered with a layer of shakes indicative of early fireproofing techniques and was unique to the site.
