SEISMIC RISK AND BRITISH COLUMBIA'S
HISTORIC STREETSCAPES
SUMMARY BRIEF

SEISMIC RISK AND BRITISH COLUMBIA'S HISTORIC STREETSAPES: SUMMARY BRIEF

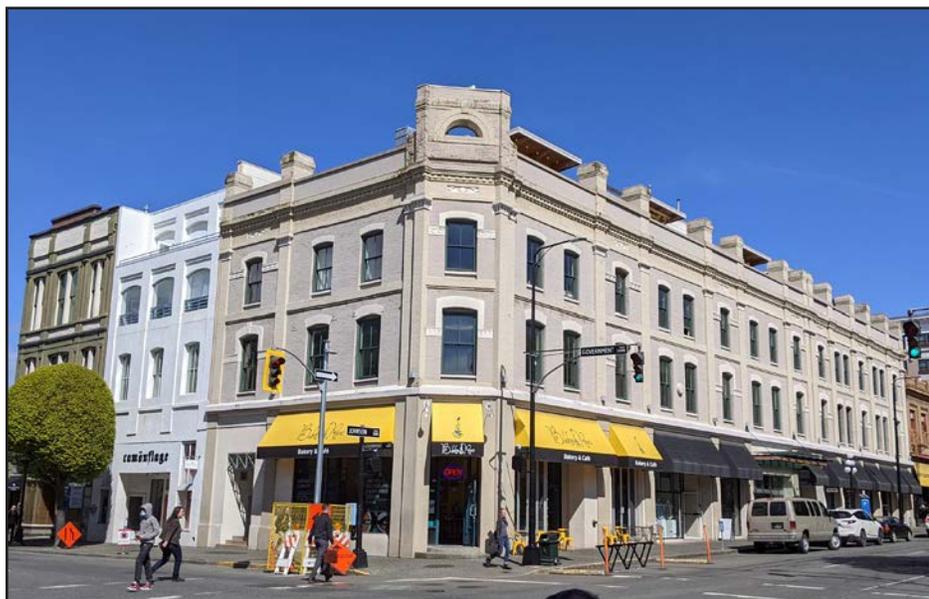
Fig. 1.2: Historic streetscapes such as this are distributed throughout BC and are at possible risk whenever the next large earthquake should strike. (Source: Ian Babbitt)

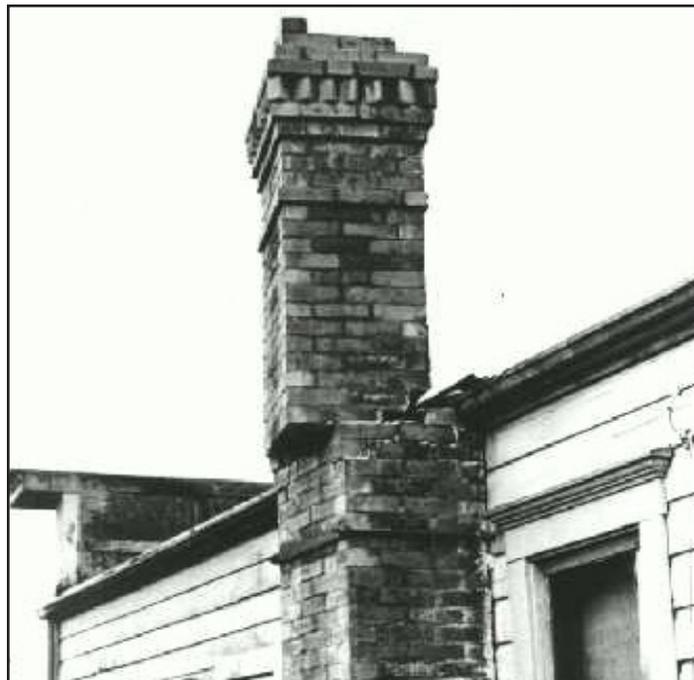
Fig. 2.2: Port Alberni Chimney Damage, 1946, over 70 km away from the earthquake's epicenter. (Source: CDM)

As is evident from the descriptions and photographs of the 1940s earthquakes, features of heritage buildings are at great risk of collapsing in a seismic event (Figs. 2.2 to 2.3). Chimneys, parapets and certain building construction types, such as unreinforced masonry (URM) Buildings, are particularly vulnerable in an earthquake (Sommer et al. 2019; Paxton et al. 2015; Paxton et al. 2013; and Ingham et al. 2012).

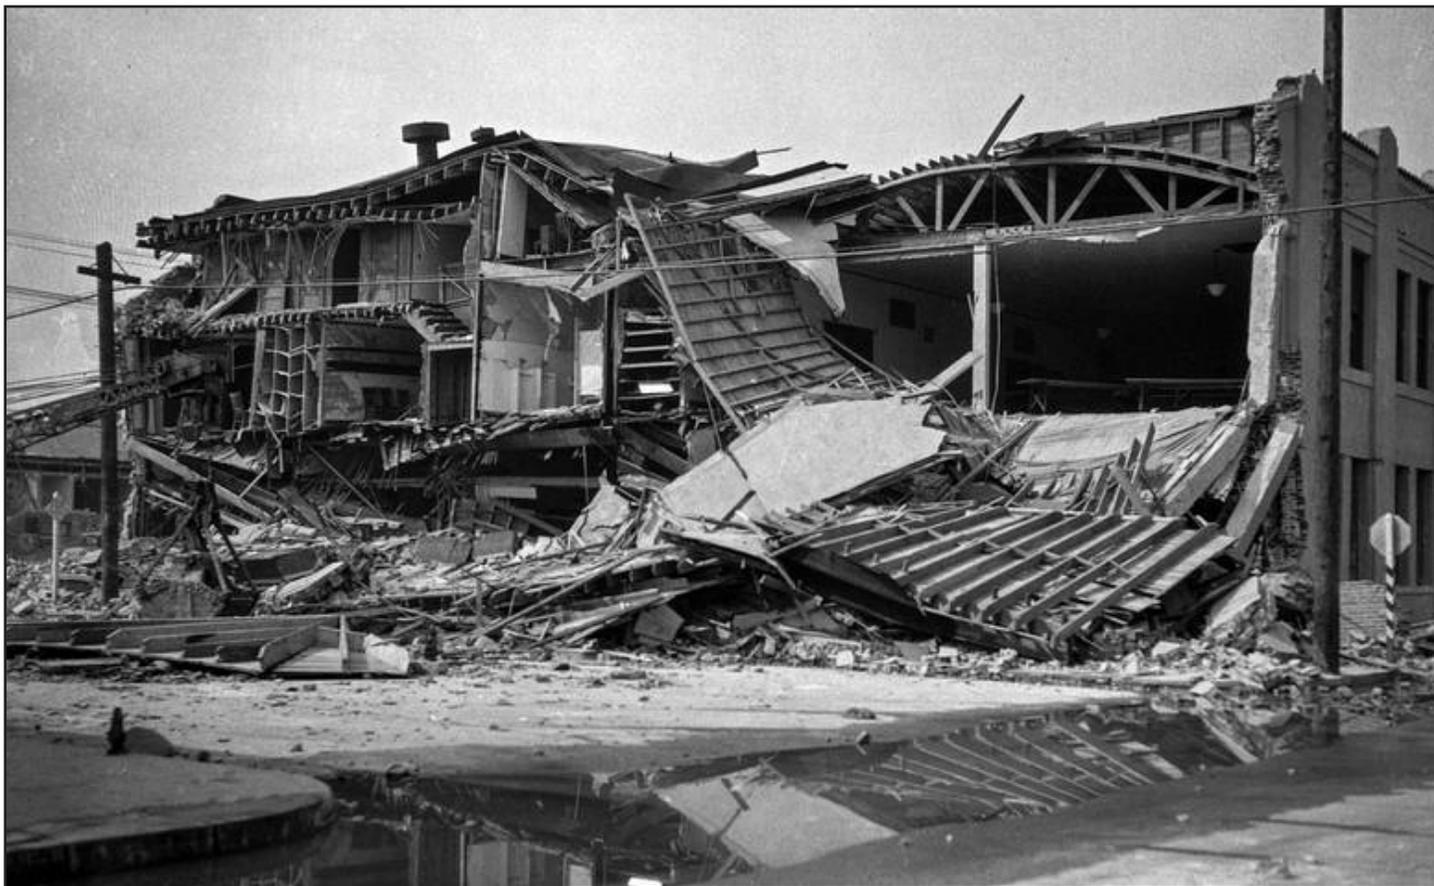
Fig. 2.7: Example earthquake damage, showing a partially collapsed Masonic Temple from the 1933 Longbeach earthquake in California. (Source: The LA Times Archive)

As is visible from the above, one of the biggest concerns with heritage buildings in an earthquake, is elements falling off the building. If not braced, as the building shakes in a seismic event, elements (often character-defining elements of a heritage building) become dislodged, particularly depending on the duration and force of the shaking. This often occurs with features at the roofline, whether parapets, gables and/or chimneys, or with other elements along the facades (such as cornices, windowsills, signage and/or awnings) and of course can include wall failures as well.

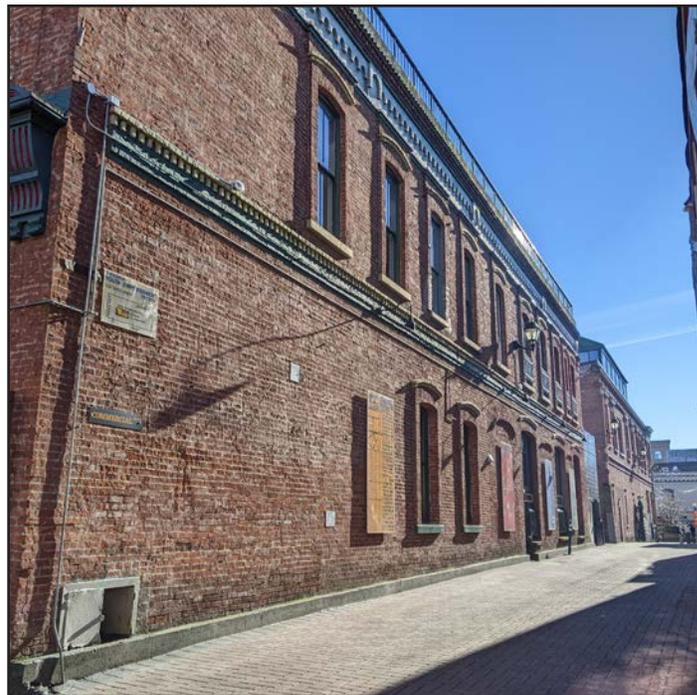
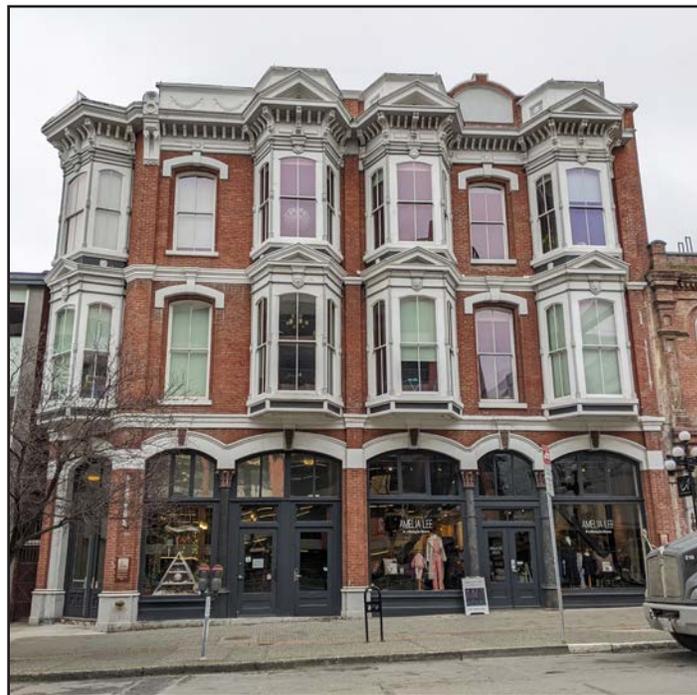
Figs. 3.1a & b: Example late 19th and early 20th century brick buildings in British Columbia. The bottom building has had some retrofit work done, as visible in the store window with the black diagonal bracing. (Sources: Katie Cummer)

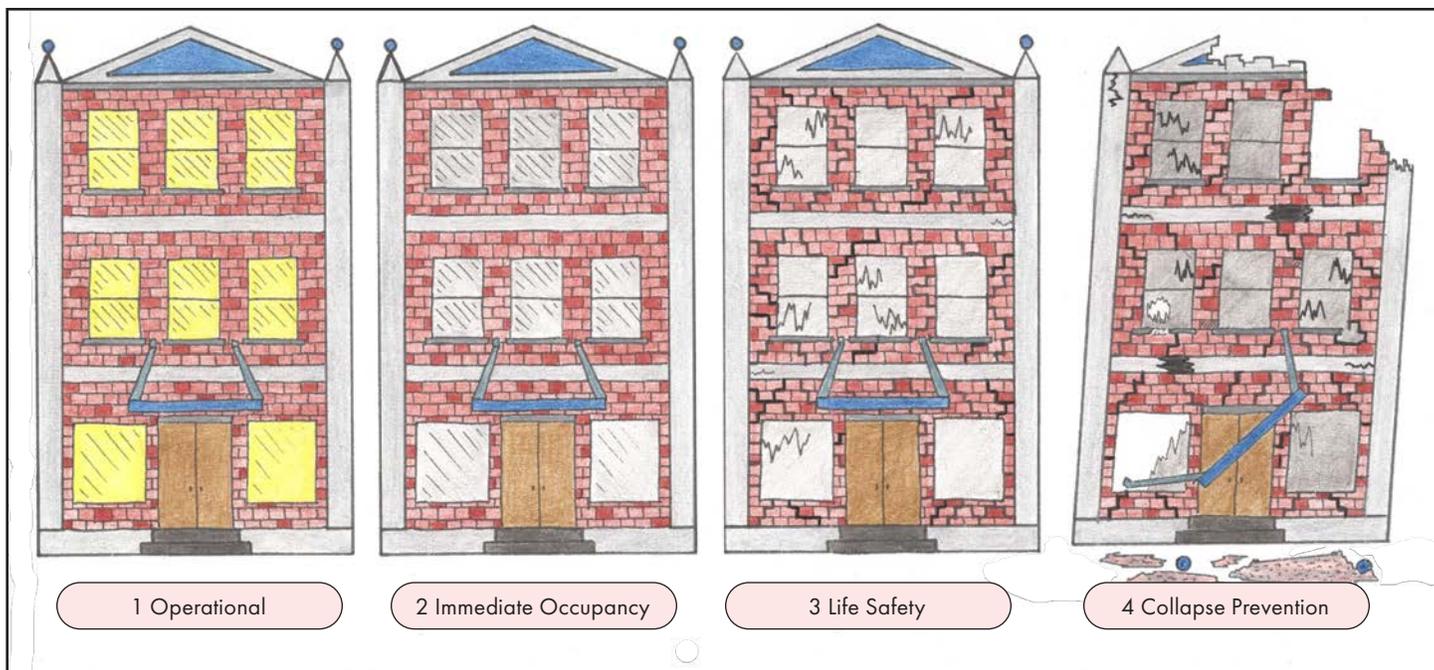
Fig. 3.2: Illustration of the different building performance levels that heritage buildings can be seismically upgraded to. (Source: Ian Babbitt, based on the American Society of Civil Engineers performance level illustration from ASCE 41)

Often, the general public is unaware of the differing “building performance levels” that seismic rehabilitation can be done to (Fig. 3.2) and that often what is being proposed for seismic upgrading is simply to the bare minimum (typically levels 3. or 4.) (Onur 2022; Paxton 2022). The performance of a building in relation to a seismic event falls into four broad categories that rank from higher performance (lower risk) to lower performance (more risk). These four categories are: 1. Operational, 2. Immediate Occupancy, 3. Life Safety and 4. Collapse Prevention. With many buildings only rehabilitated to Life Safety or Collapse Prevention, serious risks are still present for individuals in and around these buildings during a seismic event, even though they have been upgraded to a certain degree.

1. **Operational.** Backup utility services maintain function; the building sustains very little damage.
2. **Immediate Occupancy.** The building remains safe to occupy. Damage and expected repairs are minor.
3. **Life Safety.** The building remains stable and has substantial structural reserve capacity; hazardous non-structural damage is controlled.
4. **Collapse Prevention.** This addresses the most serious life-safety concerns by correcting those deficiencies that could lead to serious human injury or total building collapse. The building remains standing in order for occupants to exit the building; any other damage or loss is acceptable.

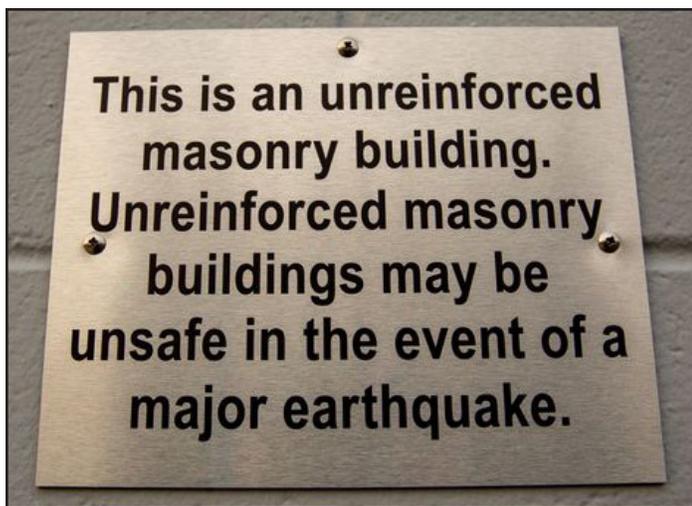
Fig. 4.3: Example of a seismic hazard sign installed on URM buildings in California. (Source: Courtney Sherwood)

o California's targeted URM Law or New Zealand's broader Earthquake-Prone Buildings Act (Building Performance 2018) are useful potential policy development references. Part of these policies include the placement of warning placards at the entrances of at-risk buildings that receive a revised sign once seismic retrofit has been undertaken (Fig. 4.3). They also recommend establishing seismic retrofit standards; adopting mandatory strengthening programmes; and enacting measures to reduce the number of occupants in URM buildings.
