# SEISMIC RISK AND BRITISH COLUMBIA'S HISTORIC STREETSCAPES

CUMMER HERITAGE CONSULTING

KATIE CUMMER, PHD CAHP

Published 2022

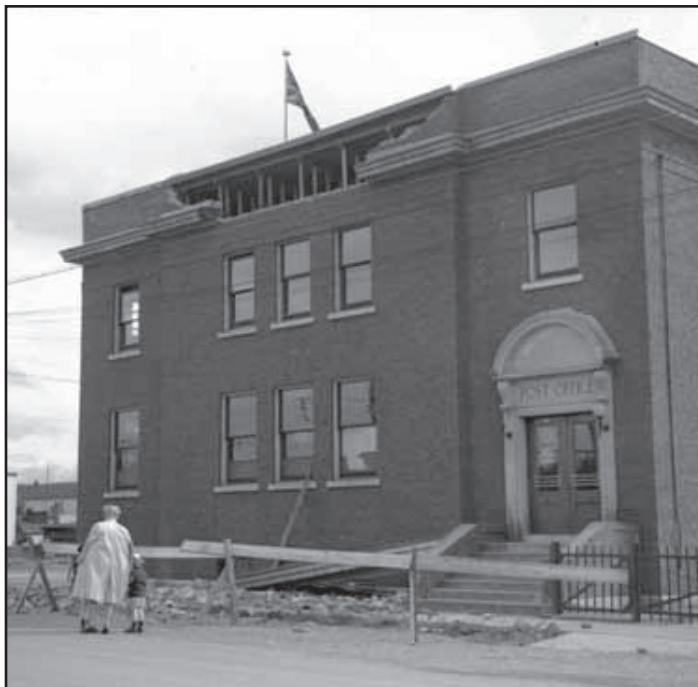
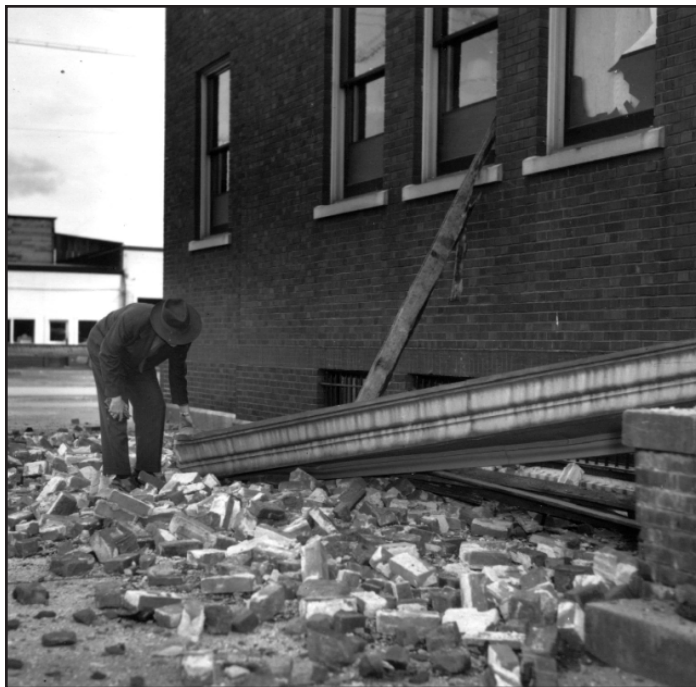
Fig. 2.3: Courtenay Post Office earthquake damage, 1946.  
(Source: Vancouver Public Library, 41749)

Fig. 2.4: Courtenay Post Office earthquake damage, 1946.  
(Source: Vancouver Public Library, 68768A)

As is evident from the descriptions and photographs of the 1940s earthquakes, features of heritage buildings are at great risk of collapsing in a seismic event (Figs. 2.3 to 2.8). Chimneys, parapets and certain building construction types, such as unreinforced masonry (URM) buildings, are particularly vulnerable in an earthquake (Sommer et al. 2019; Paxton et al. 2015; Paxton et al. 2013; and Ingham et al. 2012). “Elsewhere in the world, seismic risk mitigation efforts have been implemented as part of political and emotional responses to earthquake losses” (Paxton et al. 2015, p. 1). However, for British Columbia, as a result of this period of relative seismic calm, there appears to be a lack of awareness (or acknowledgement) of the substantial risk being faced here and some of the mitigation efforts that could be better employed to help minimise the potentially catastrophic impact of the eventual big one, particularly with regards to heritage buildings, as discussed in greater detail in the following sections.

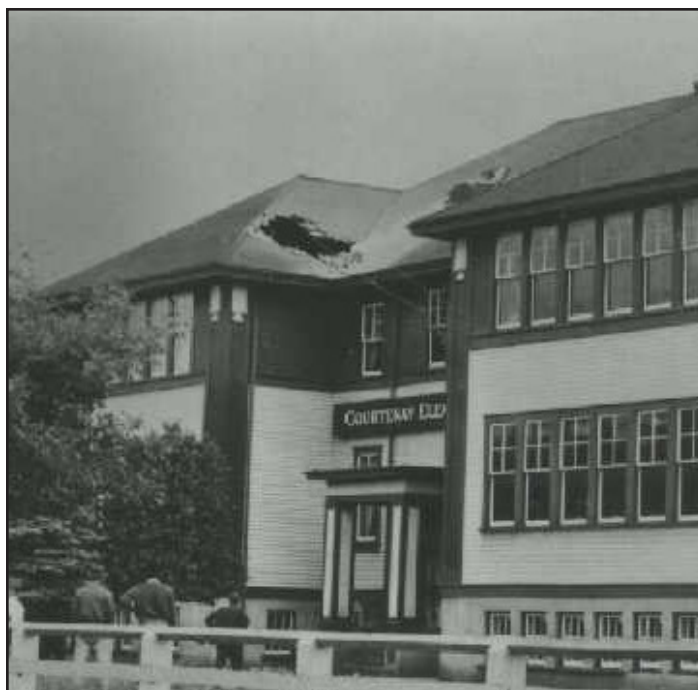
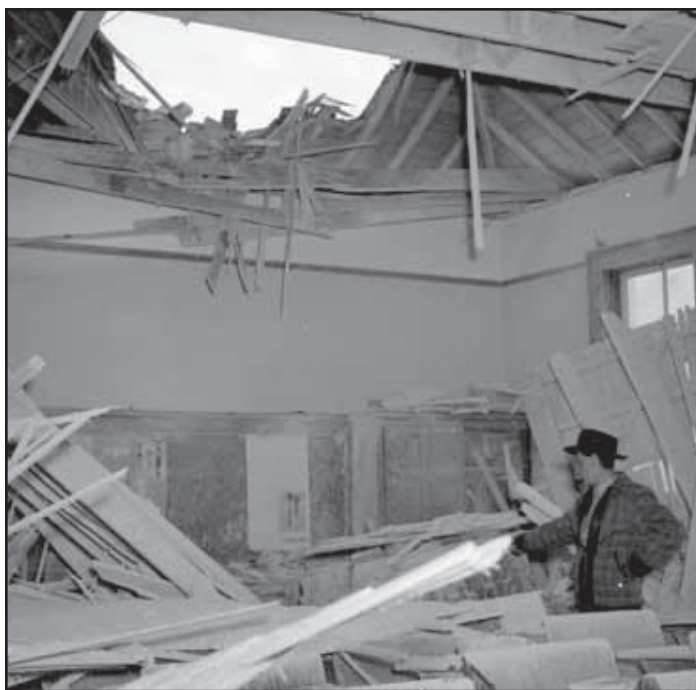
Fig. 2.5: Courtenay School earthquake damage, exterior,  
1946. (Source: Courtenay & District Museum (CDM))

Fig. 2.6: Courtenay School earthquake damage, interior,  
1946. (Source: Vancouver Public Library, 41750B)

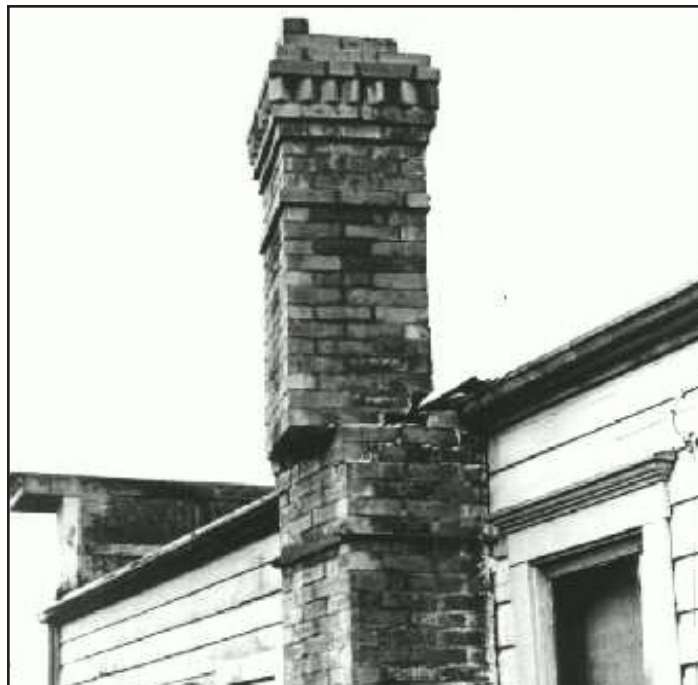
Fig. 2.7: Port Alberni Chimney Damage, 1946, over 70 km away from the earthquake's epicenter. (Source: CDM)

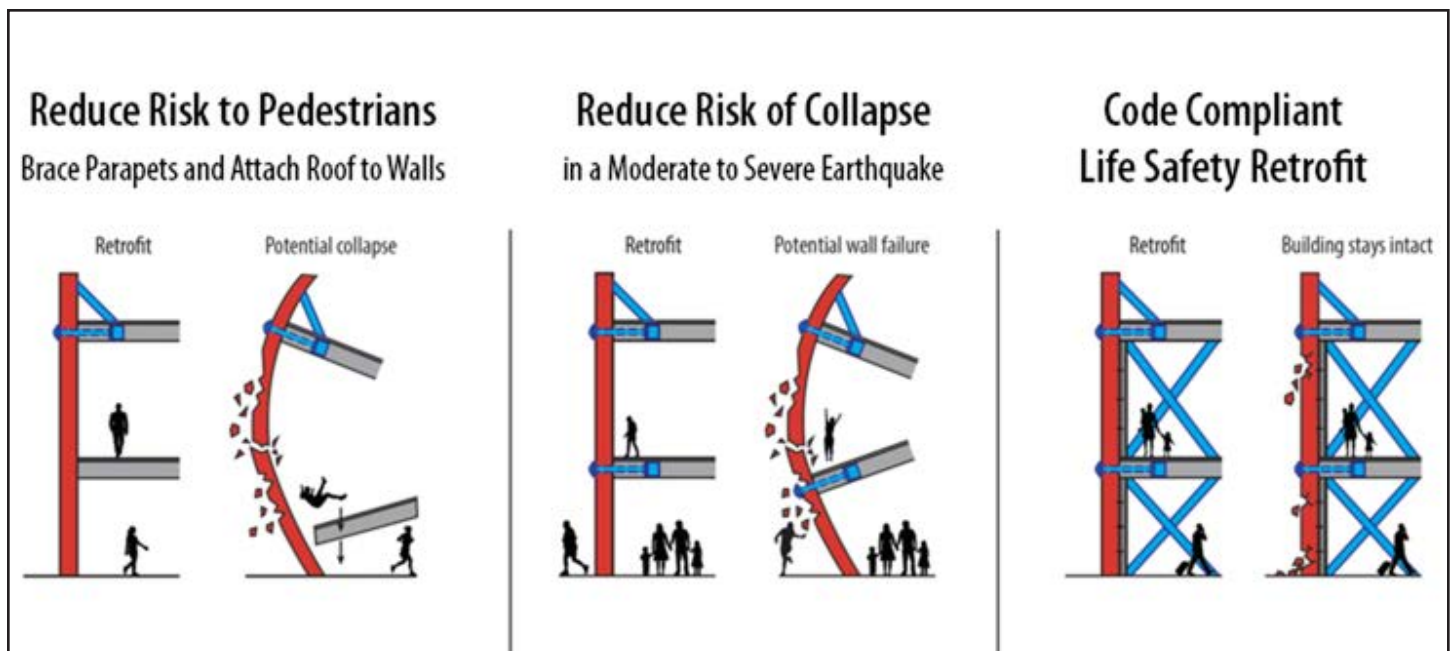
Fig. 2.9: Illustration of the risks posed by existing buildings, particularly unreinforced masonry (URM) buildings. (Source: Portland Government)

All buildings (whether a heritage one or not) are at-risk when an earthquake strikes. They need to be able to withstand the ground shaking caused by an earthquake. Seismic waves cause horizontal and vertical ground movement, which are transferred to a building through its foundation, shaking the structure, objects and people within it. An additional concern with heritage buildings is that many were built when the BC Building Code was either non-existent or not as stringent as it is today. There is therefore a need to upgrade heritage buildings to withstand seismic shaking to minimise damage and save lives (Figs. 2.9 to 2.12).

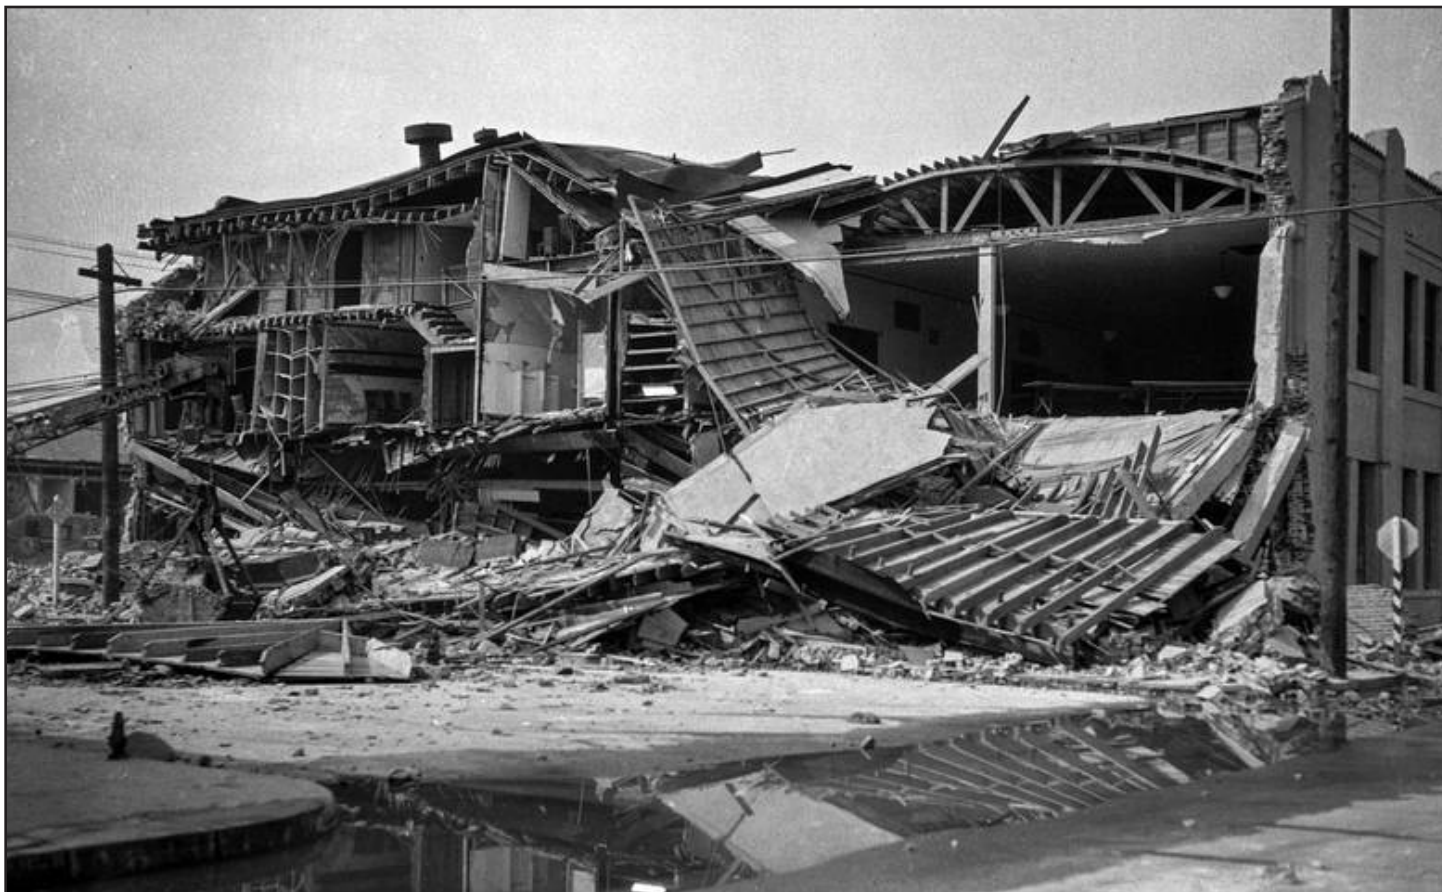
Fig. 2.12: Example earthquake damage, showing a partially collapsed Masonic Temple from the 1933 Longbeach earthquake in California. (Source: The LA Times Archive)

As is visible from the above, one of the biggest concerns with heritage buildings in an earthquake, is elements falling off the building. If not braced, as the building shakes in a seismic event, elements (often character-defining elements of a heritage building) become dislodged, particularly depending on the duration and force of the shaking. This often occurs with features at the roofline, whether parapets, gables and/or chimneys, or with other elements along the facades (such as cornices, windowsills, signage and/or awnings) and of course can include wall failures as well.

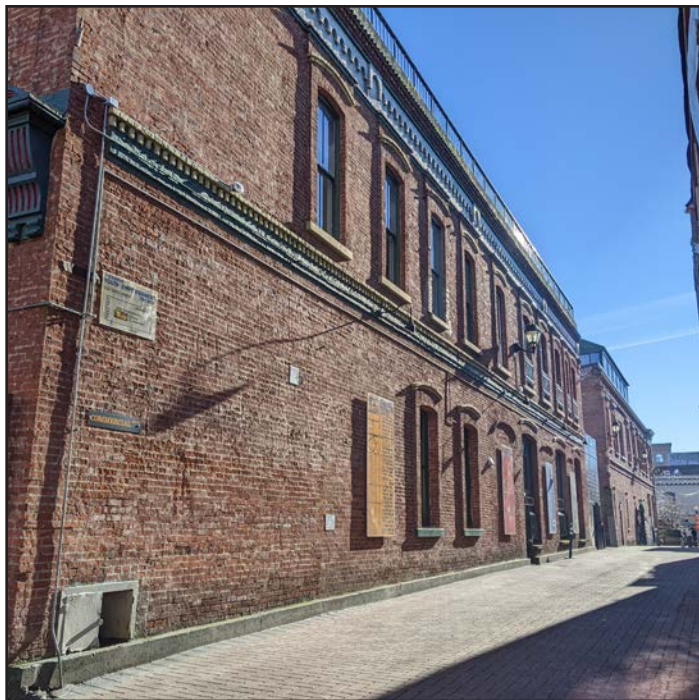
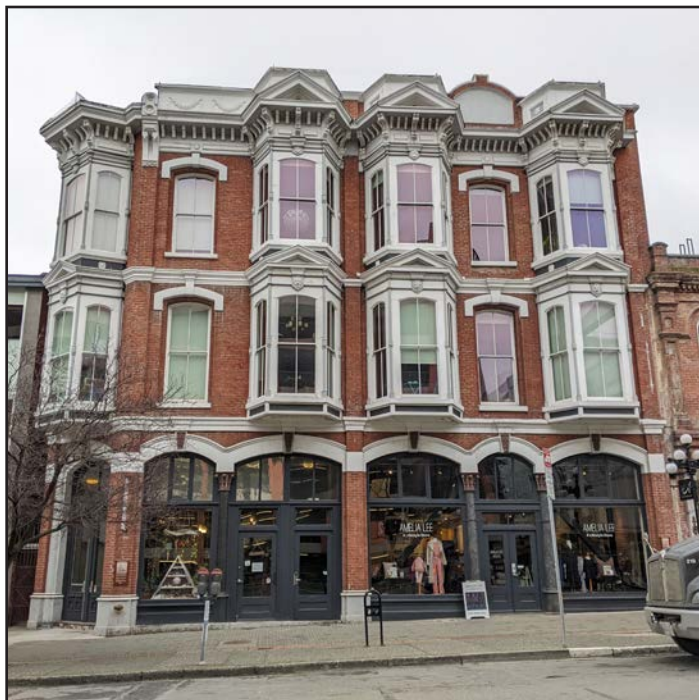
Figs. 3.1a & b: Example late 19th and early 20th century brick buildings in British Columbia. The bottom building has had some retrofit work done, as visible in the store window with the black diagonal bracing. (Sources: Katie Cummer)

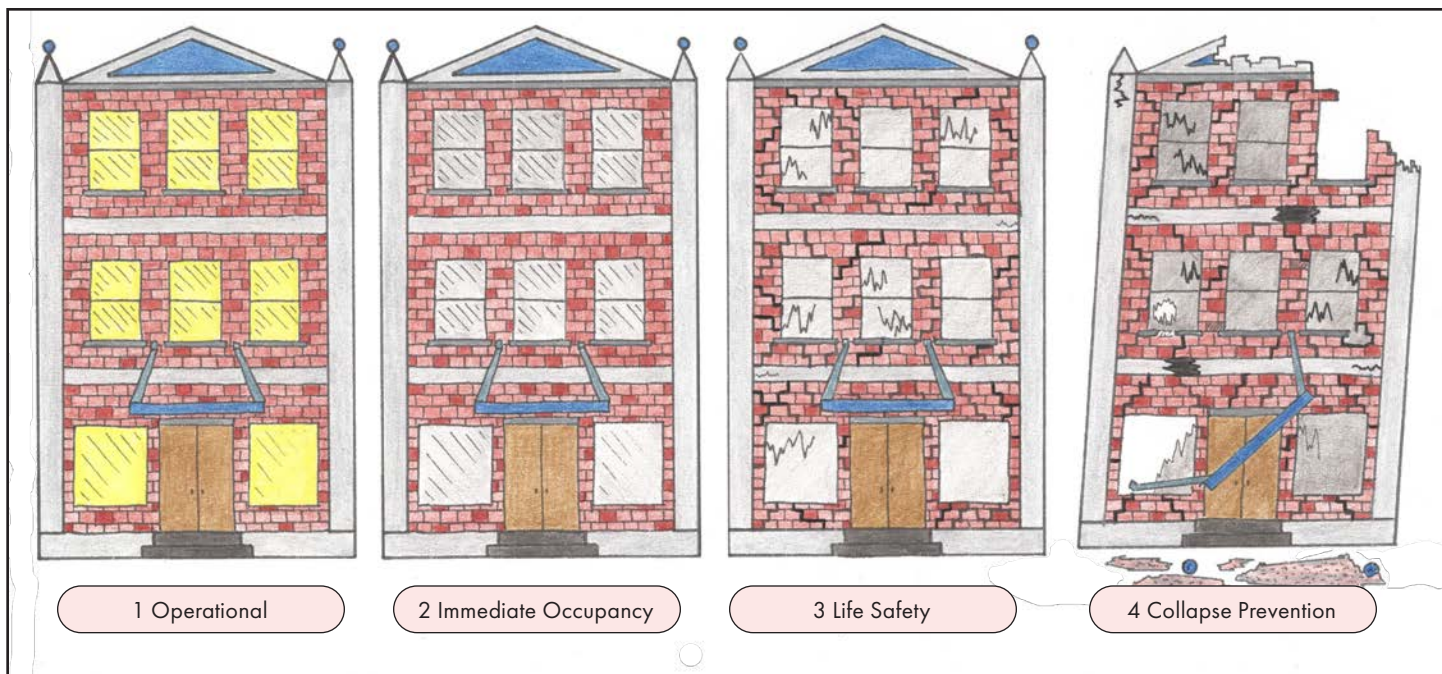
Fig. 3.2: Illustration of the different building performance levels that heritage buildings can be seismically upgraded to. (Source: Ian Babbitt, based on the American Society of Civil Engineers performance level illustration from ASCE 41)

1. **Operational.** Backup utility services maintain function; the building sustains very little damage.
2. **Immediate Occupancy.** The building remains safe to occupy. Damage and expected repairs are minor.
3. **Life Safety.** The building remains stable and has substantial structural reserve capacity; hazardous non-structural damage is controlled.
4. **Collapse Prevention.** This addresses the most serious life-safety concerns by correcting those deficiencies that could lead to serious human injury or total building collapse. The building remains standing in order for occupants to exit the building; any other damage or loss is acceptable.

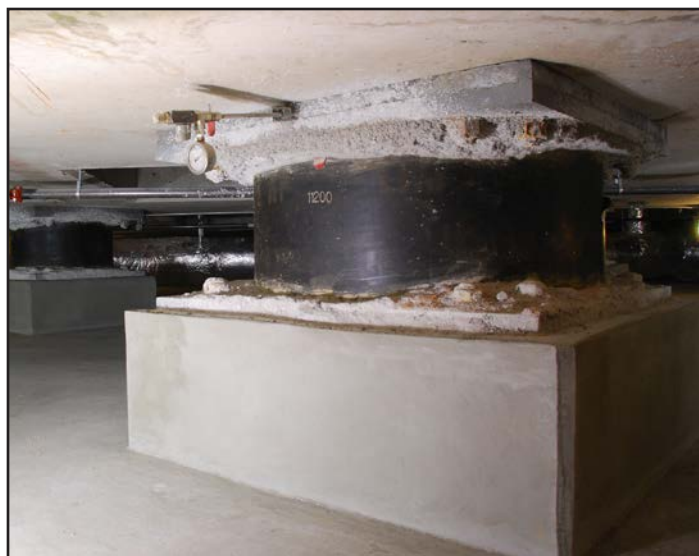
Fig. 3.5: An example of base isolation under the Utah State Capitol Building. (Source: Mike Renlund)

b. Although not commonly practiced in Canada, yet, another more comprehensive rehabilitation option is base isolation. This technique uses ball bearings, springs and padded cylinders (Fig. 3.5), to isolate structures so that they do not sit directly on the ground and are therefore not subjected to the shocks of an earthquake. This technique is more commonly used in Japan and for some civic structures in the United States (Procter 2018).

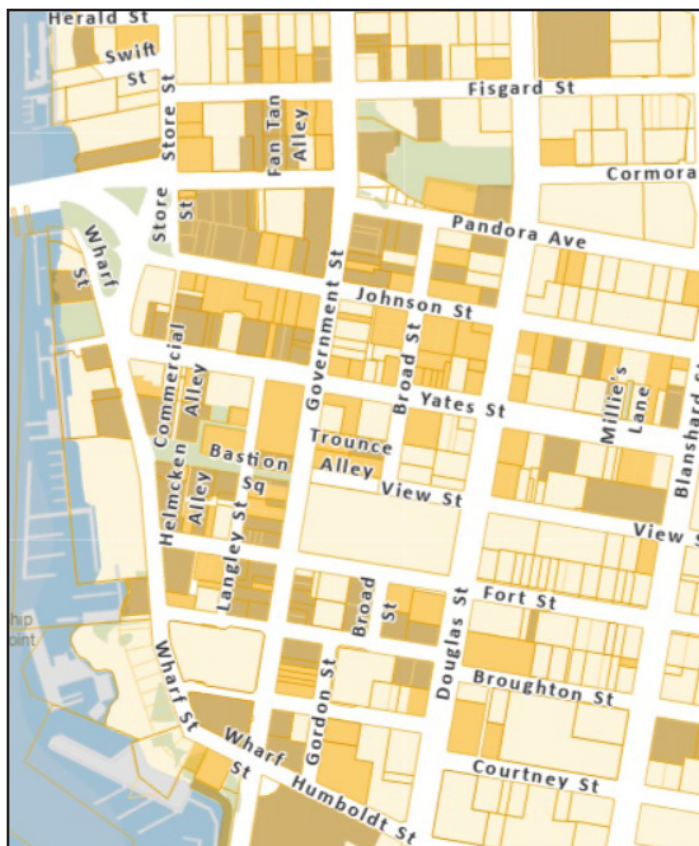
Fig. 4.1: A map showing the heritage buildings in the downtown core of Victoria, the area known as "Old Town," 2022. Brown denotes a heritage-designated building and yellow denotes a heritage-registered building. (Source: VicMap)

Situated on the land of the traditional territory of the Coast Salish and Lekwungen speaking people, specifically the Songhees and Esquimalt First Nations, the colonial history of the City of Victoria dates back to 1843, with the establishment of Fort Victoria by the Hudson's Bay Company as a trading post and fort (City of Victoria). Today, it is the Capital City of British Columbia and is one of the oldest cities in Western Canada, having been incorporated in 1862. The City of Victoria developed and grew through the 19th and early 20th centuries, using various materials and techniques to build numerous buildings, many of which are today either registered or designated heritage buildings (Fig. 4.1). There

are 598 Heritage-Designated properties and 357 Registered properties in the city (City of Victoria 2022), with many of them located in the historic core area known as "Old Town" (Fig. 4.2). Many of these buildings are the aforementioned seismically at-risk unreinforced masonry (URM) types of construction.

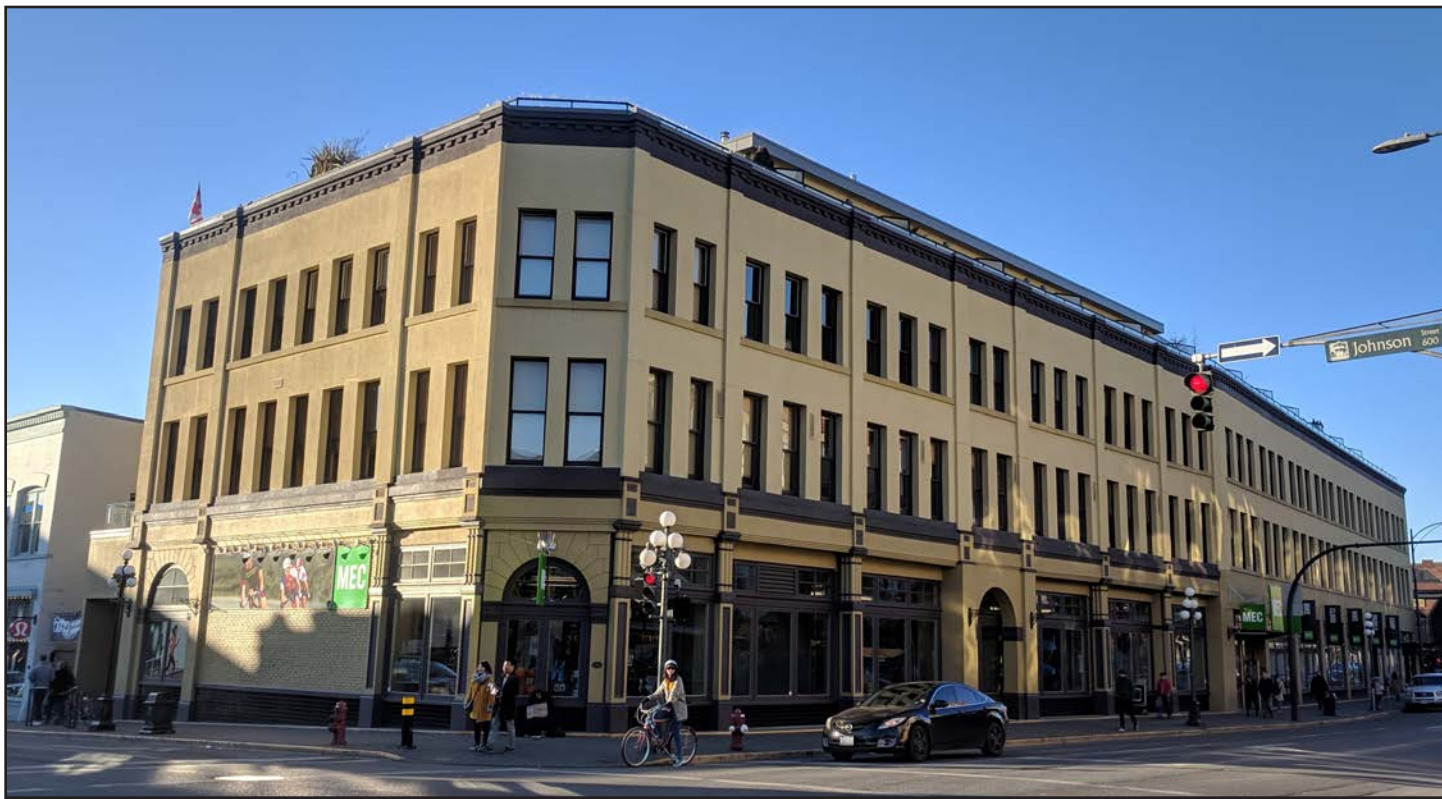
Fig. 4.3: A Tax Incentive Program (TIP) example project in Victoria, BC that was seismically upgraded when being converted into residential units above the ground floor commercial MEC store, in exchange for a 10-year tax exemption. (Source: Katie Cummer)

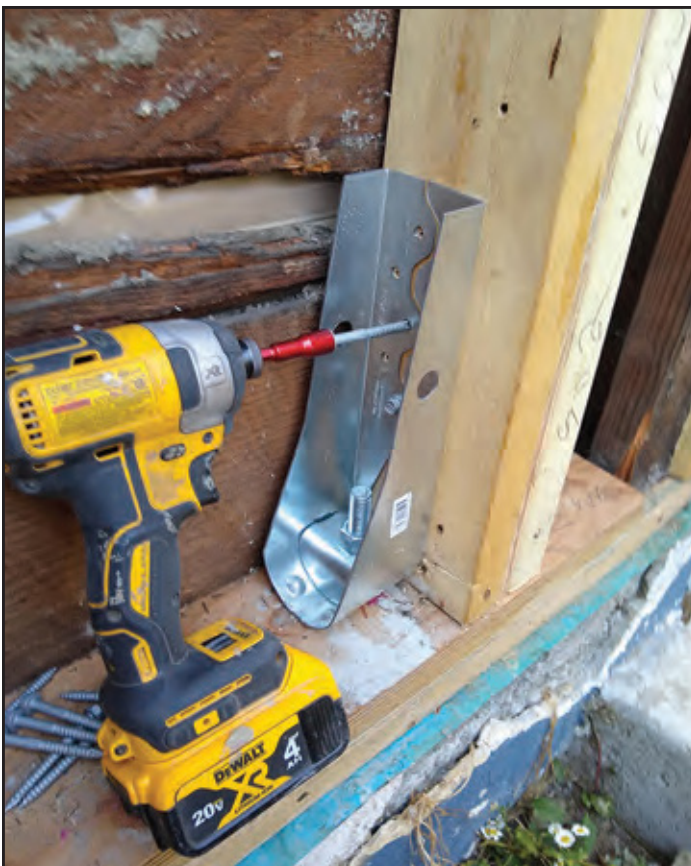
Fig. 4.4: 1270 Balmoral Rd. seismic upgrading work, partially financed by the House Grant program (Source: Victoria Heritage Foundation, 2020).

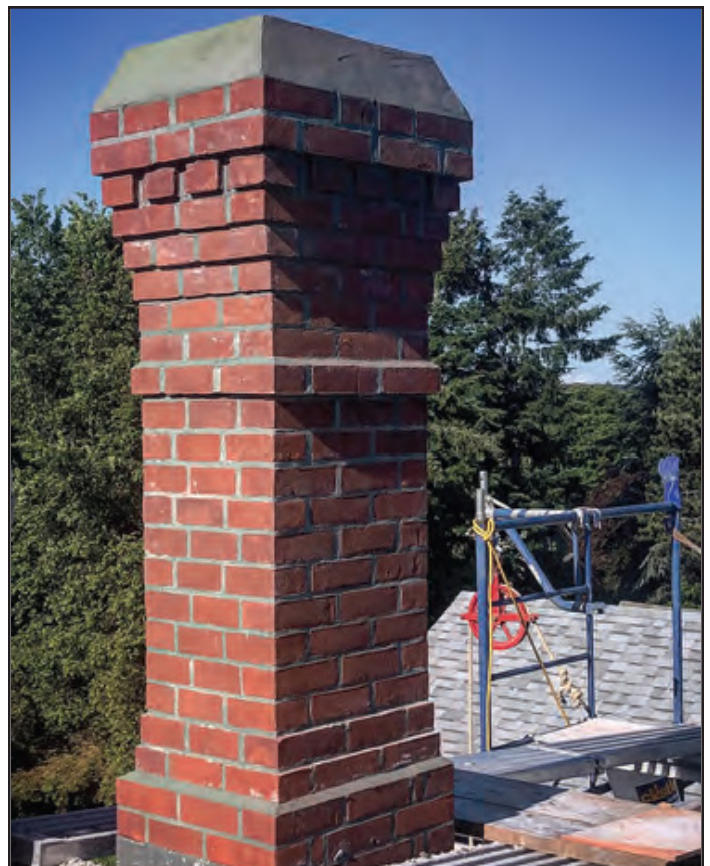
Fig. 4.5: 1260 Denman St. chimney rebuild to address its seismic vulnerability, partially financed by the House Grant program. (Source: Victoria Heritage Foundation, 2020).

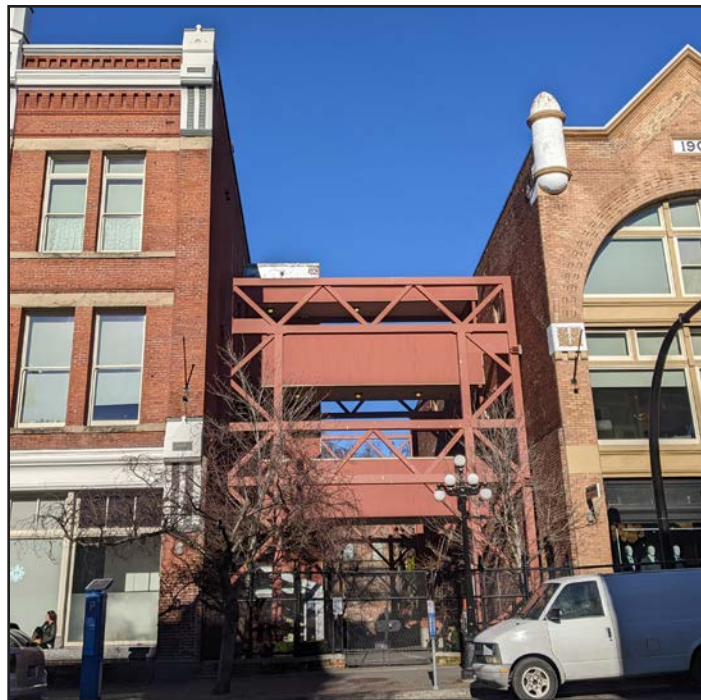
Fig. 4.6: Illustration of the bracing installed between the Leiser Building and the Earle Warehouse as part of its seismic rehabilitation work on Yates Street in Victoria, BC. (Source: Katie Cummer)

- In 2008, a commercial brick building from 1860, located at 536 Yates Street, received financial assistance to add steel bracing and seismic anchors to brace its parapet after its reconstruction.

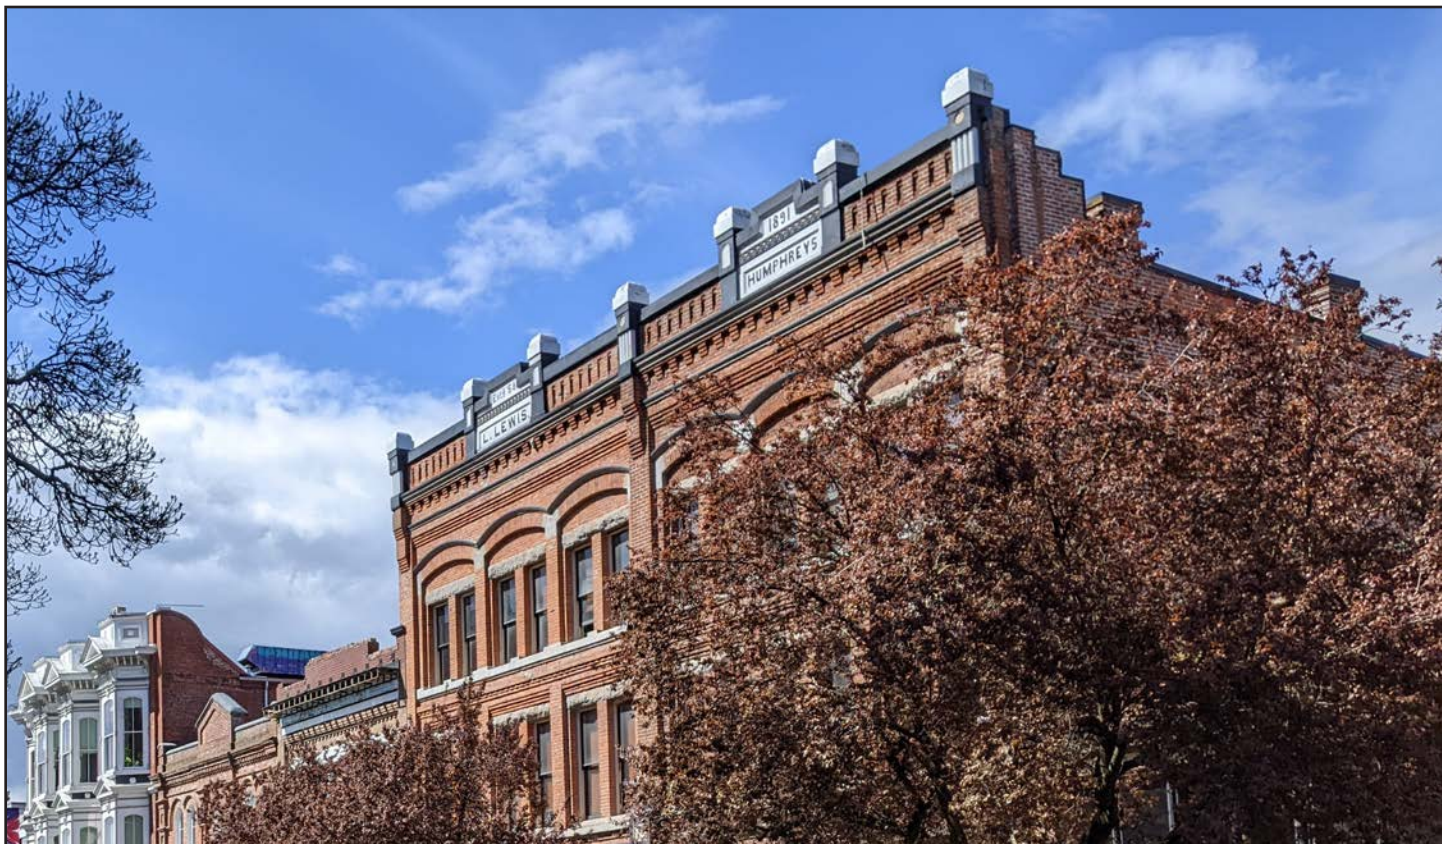
Fig. 4.7: An example parapet in downtown Victoria, BC. Such parapets, if unbraced, are at a high risk of collapse during a seismic event and would be eligible for the Seismic Parapet Incentive Program (PIP) funding. (Source: Ian Babbitt)

Considering the important nature of the seismic upgrading work that this incentive programme promotes, it would be ideal to increase the awareness of the funding available and the importance of parapet bracing to further encourage more owners to do so; thereby reducing damage and potentially saving lives.

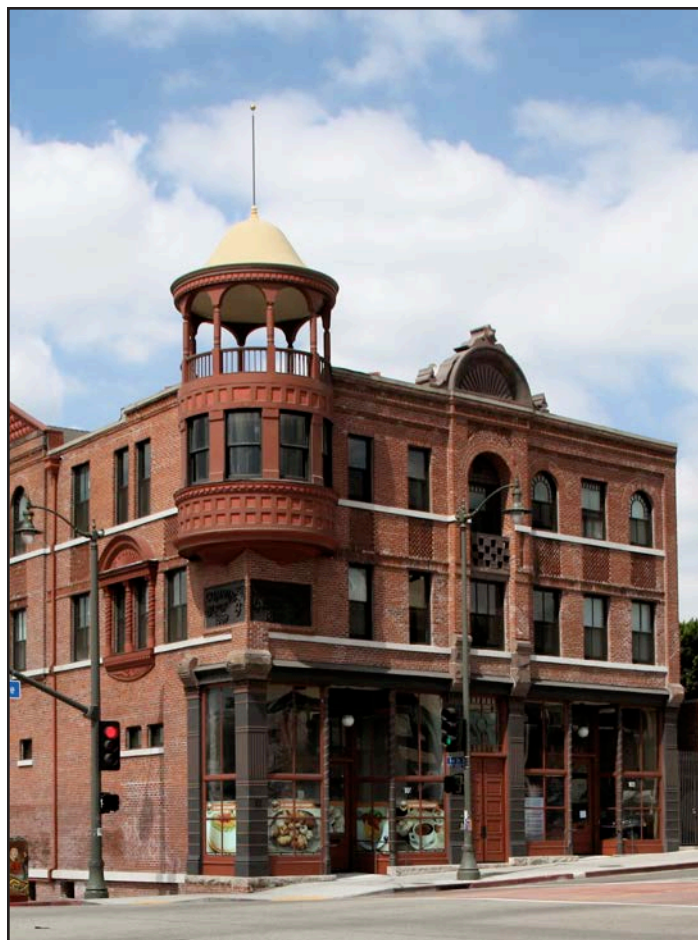
Fig. 5.4: The Boyle Hotel, in East Los Angeles, is an example historic unreinforced masonry (URM) building that received funding from the Federal Historic Preservation Tax Incentive Program for rehabilitation to allow for continued use. (Source: Bruce Bohner)

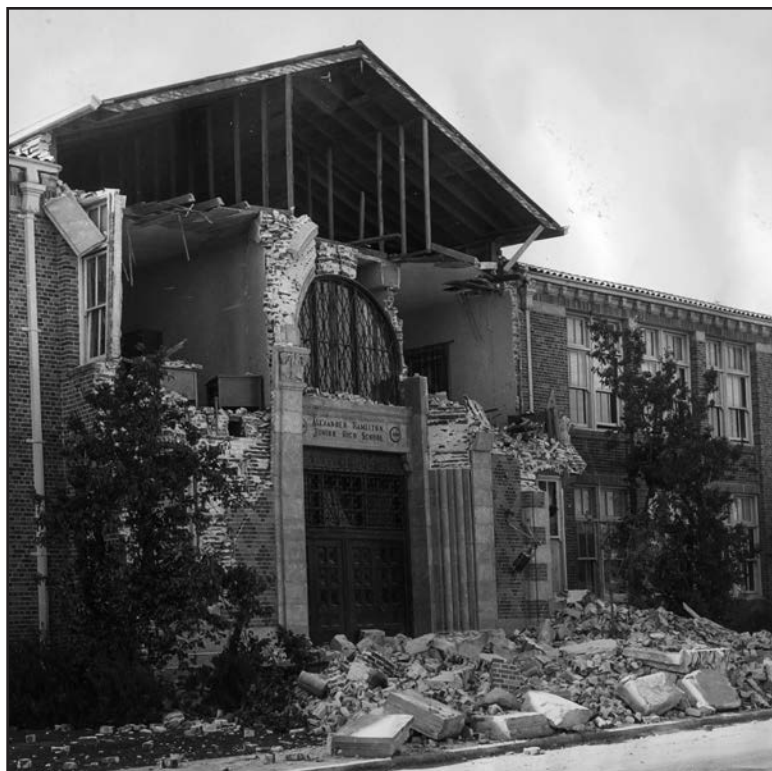
Fig. 5.5: A damaged school from the 1933 Long Beach Earthquake in California. (Source: LA Times Archive)

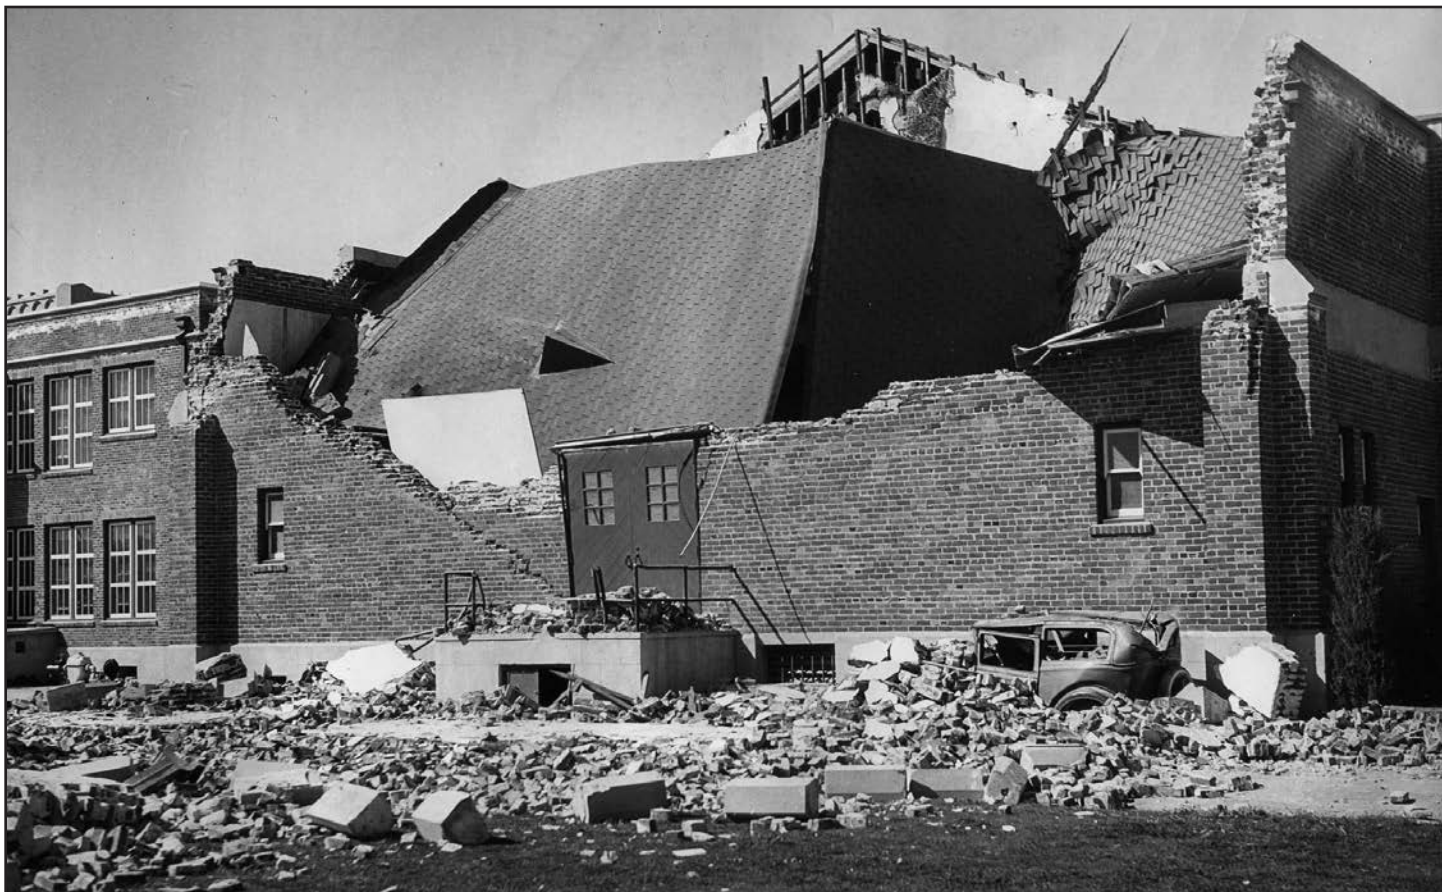
Fig. 5.6: A partially collapsed school from the 1933 Long Beach Earthquake in California. (Source: LA Times Archive)

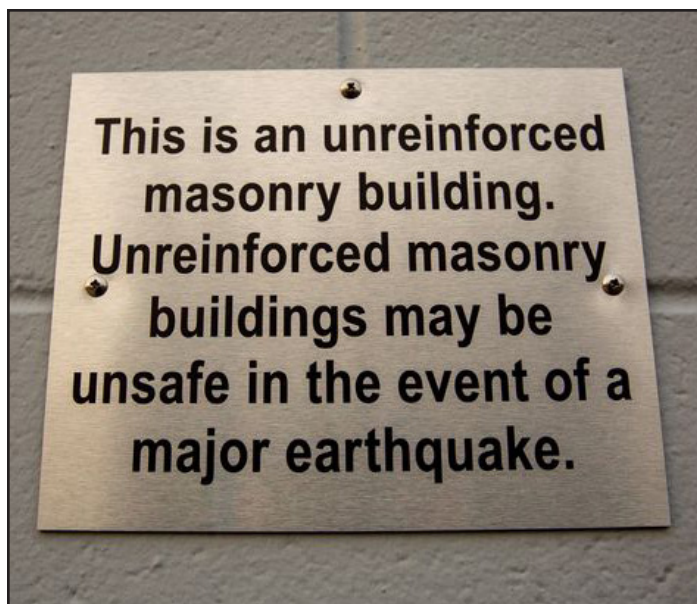
Fig. 5.7: Example of a seismic hazard sign installed on URM buildings in California. (Source: Courtney Sherwood)

Part of this URM law, included a requirement that URM buildings have warning placards placed at their entrance informing the public of the risk associated with the building (Fig. 5.7), with a revised sign once seismic retrofitting had been undertaken. This law also recommended that local governments:

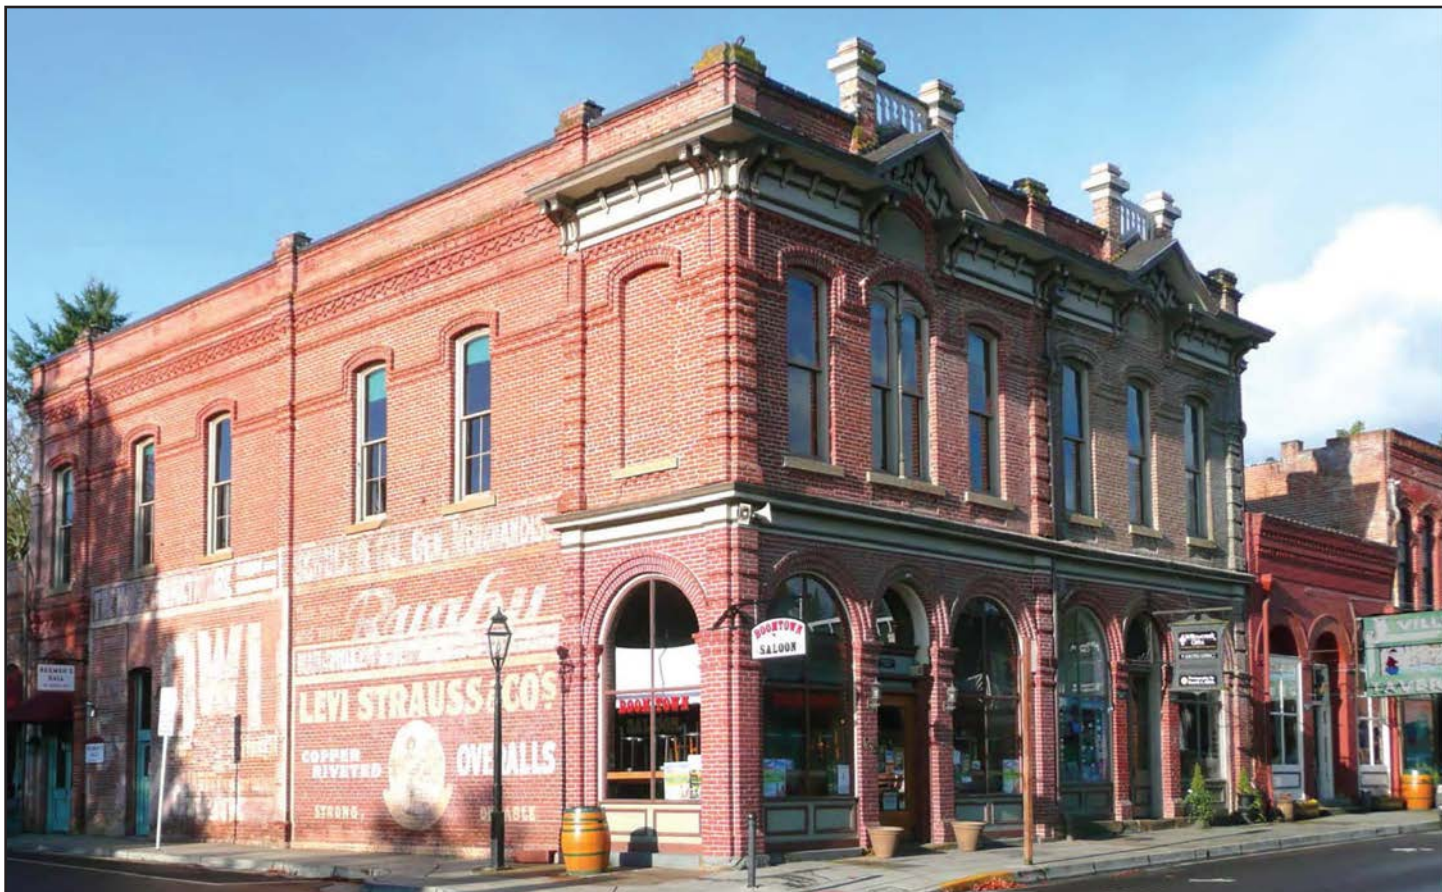
Fig. 5.9: Redman Hall from Jacksonville, Oregon, illustrating one of its seismic at-risk URM buildings. (Source: Restore Oregon)

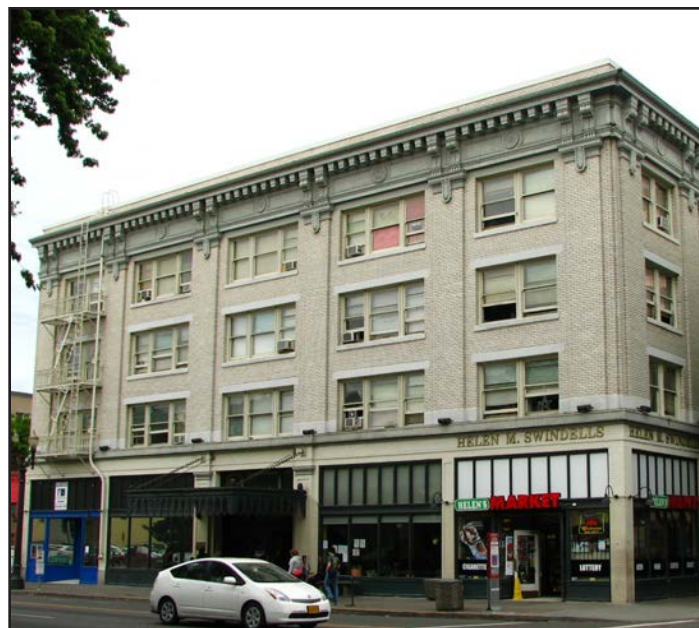
Fig. 5.9: The former Broadway Hotel in Portland, Oregon, illustrating another at risk URM building. (Source: Ian Poellet)

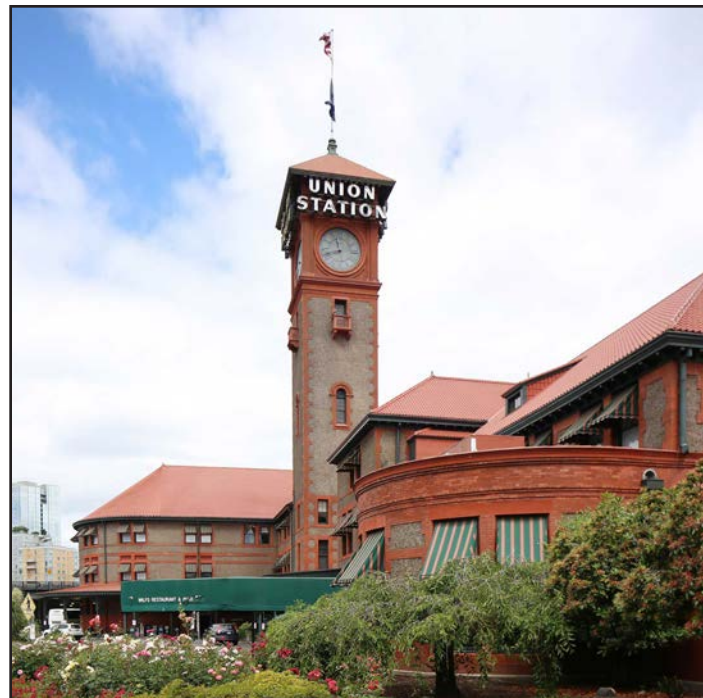
Fig. 5.11: Union Station in Portland Oregon is a URM building that has received a range of seismic upgrades over a several year period. (Source: Jennifer Eggers)

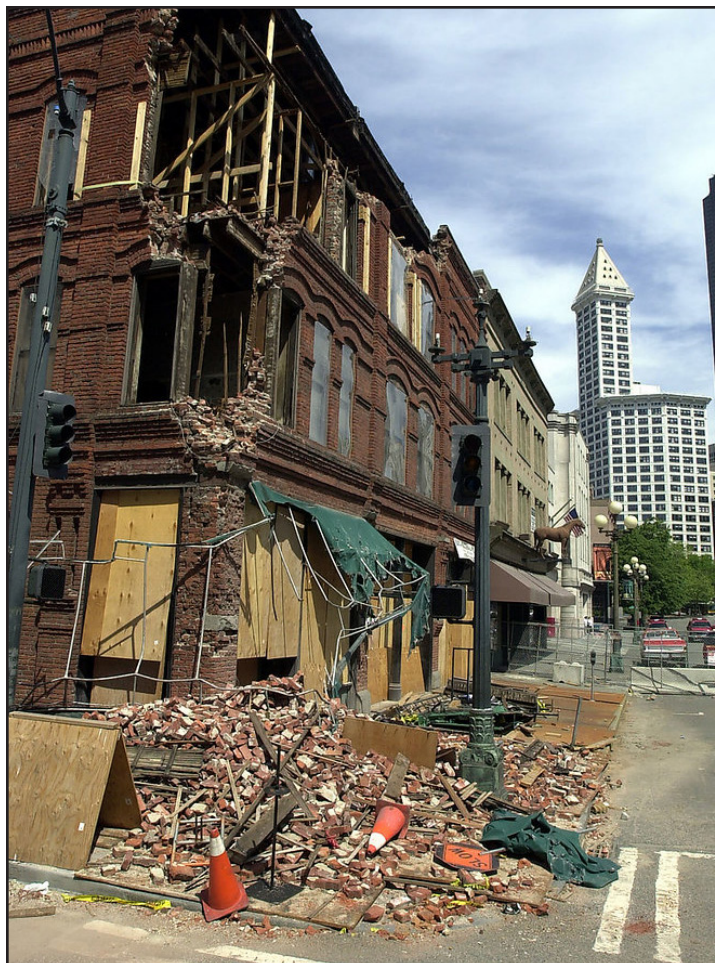
Fig. 5.13: Damage in Seattle from the 2001 Nisqually Earthquake. (Source: Northwest Progressive Institute)

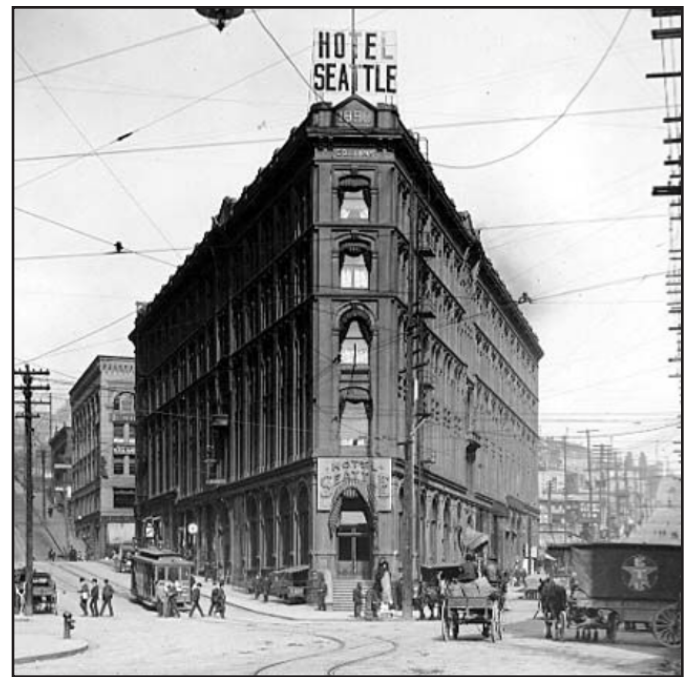
Fig. 5.16: Historical photograph of Hotel Seattle, damaged in the 1949 Olympia Earthquake and ultimately abandoned in 1961. (Source: University of Washington Archives)

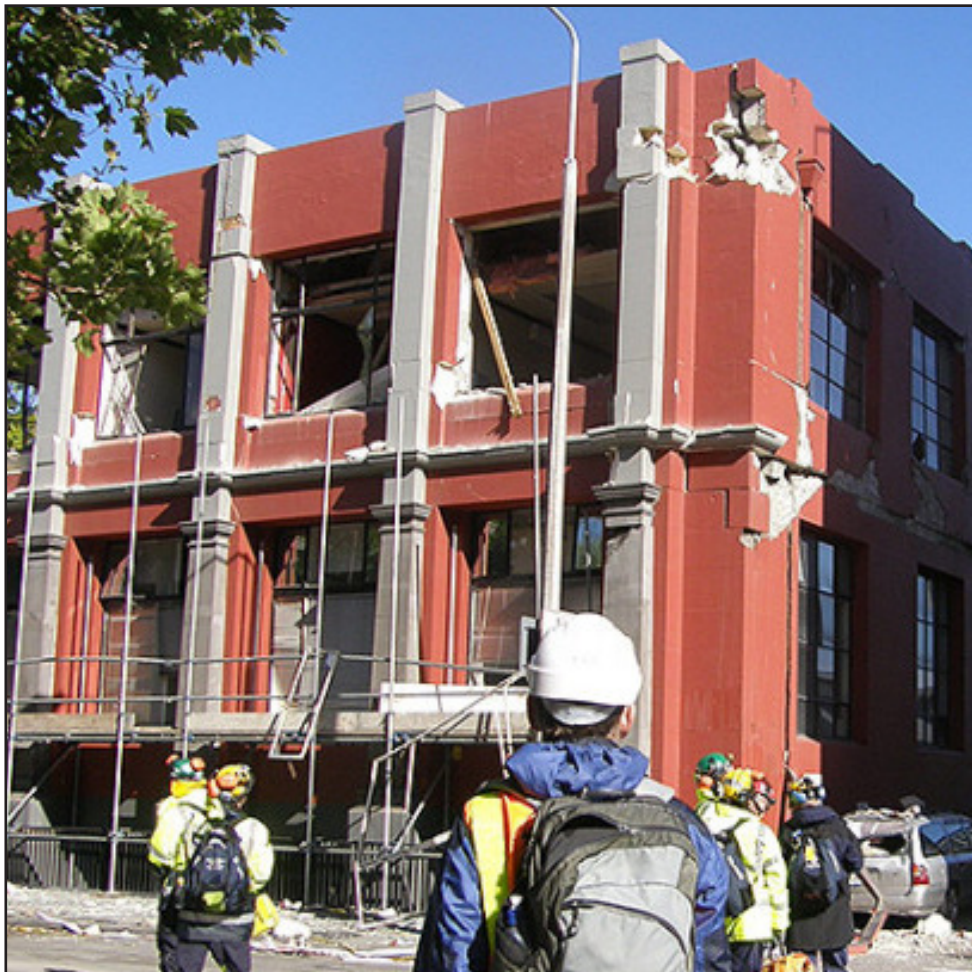
Fig. 5.24: Photograph of earthquake damage used to advertise the REPB Financial Assistance Scheme. (Source: Building Performance, Government of New Zealand)

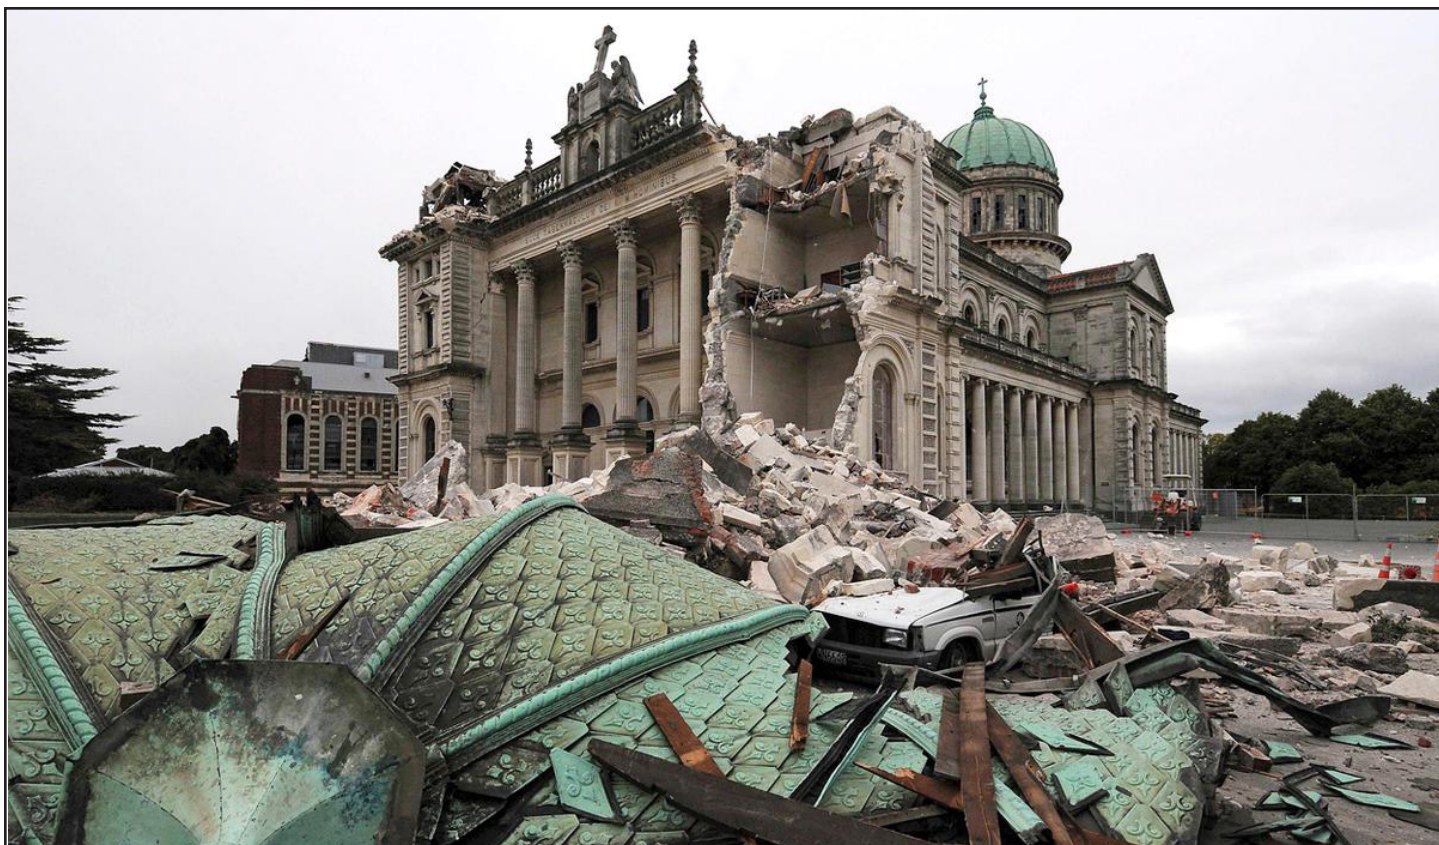
Fig. 5.27: Cathedral of the Blessed Sacrament partially collapsed in the February 2011 Christchurch earthquake. After eight years of debate and the site left in disarray, it was decided in 2019 to demolish the remaining sections of the Category I heritage-listed structure from 1905. (Source: New Zealand Press Association, David Wethey)
