# SEISMIC RISK AND BRITISH COLUMBIA'S HISTORIC STREETSCAPES

CUMMER HERITAGE CONSULTING

KATIE CUMMER, PHD CAHP

Published 2022

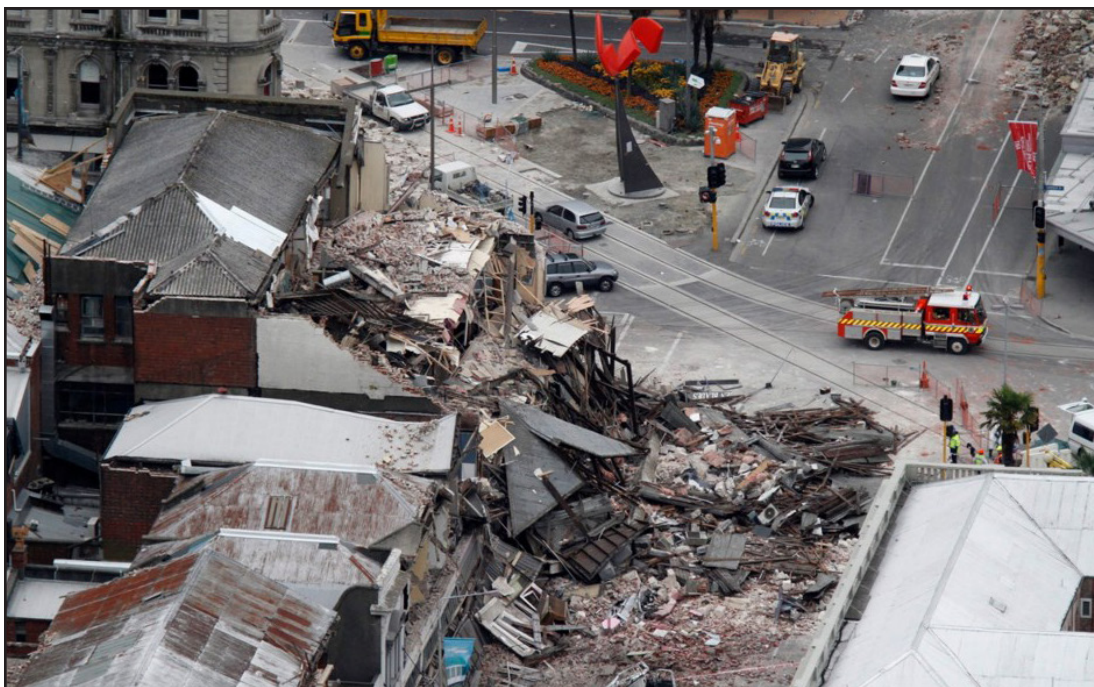
Fig. 5.28: Earthquake damage experienced in Christchurch's Central Business District, at the intersection of Lichfield, Manchester and High Streets in Christchurch, 2011. (Source: Mark Mitchell)

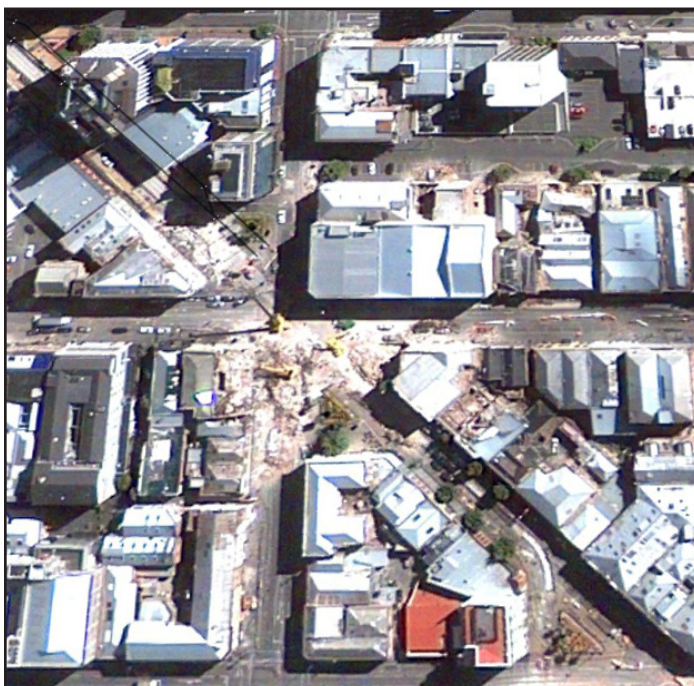
Figs. 5.29a & b: Aerial views of part of Christchurch's CBD showing the intersection of Lichfield, Manchester and High Streets in Christchurch. Left is from Feb. 2011, immediately following the earthquake, showing numerous collapsed buildings, and right is from Feb. 2022, over ten years later, showing the numerous buildings lost with nothing built in their stead. (Sources: Google Earth)
