NANAIMO HERITAGE BUILDING DESIGN GUIDELINES

THE FOUNDATION GROUP
#1 – 2629 West Fourth Avenue, Vancouver, B.C., V6K 1 P8
733-4593

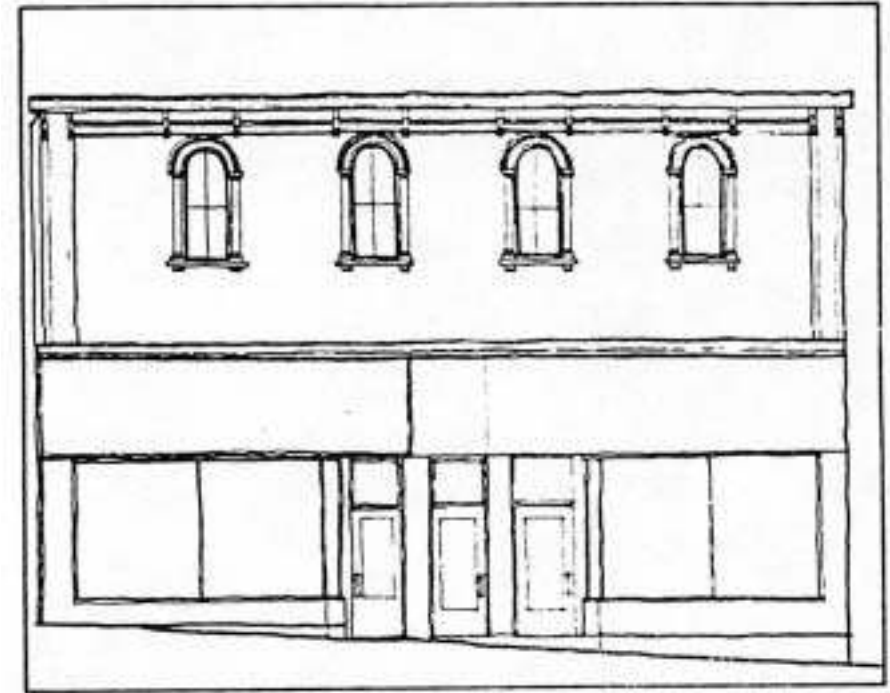
TYPICAL BUILDING TYPE

Within the context of the nineteen listed buildings, several distinct types emerge. None of the buildings rise over three stories in height, and with the exception of the three institutional buildings (St. Paul's Church, the Ashlar Lodge, Eagle's Hall), they are all quite flexible as to potential layout and usage within the existing heritage envelope. The basic construction of these buildings lends itself to a range of alternate interior usages. Adjacent buildings, although not heritage listed, have their own scale and character which should be respected in their future use and development. Infill and new buildings should respect the existing form, scale, and rhythm of the historic district, as well be further outlined in this report.

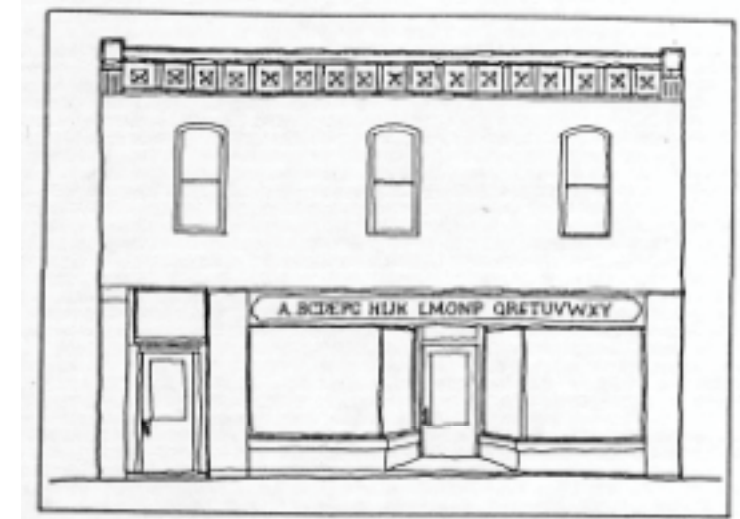
PLACEMENT OF SIGNAGE ON FASCIA

FASCIA SIGNS: are those which are placed on the fascia of a building, mostly in the area between the first and second floors. Fascia signs should not exceed sixty centimeters in height or exceed in length ninety percent of the width of the building. On buildings with two or three storefronts, fascia signs should be centered over the storefront areas. Fascia signs should be mounted flush to the fascia surface and should not interfere with either moldings or building ornamentation. Lettering on fascia signs may be routed or incised, applied flat (painted), cut-out, or carved. Uses of illustrations, sketches, or photographs on the fascia are strongly discouraged. Fascia signage, as all signage, should be in harmony with the nature of the building on which it is applied.

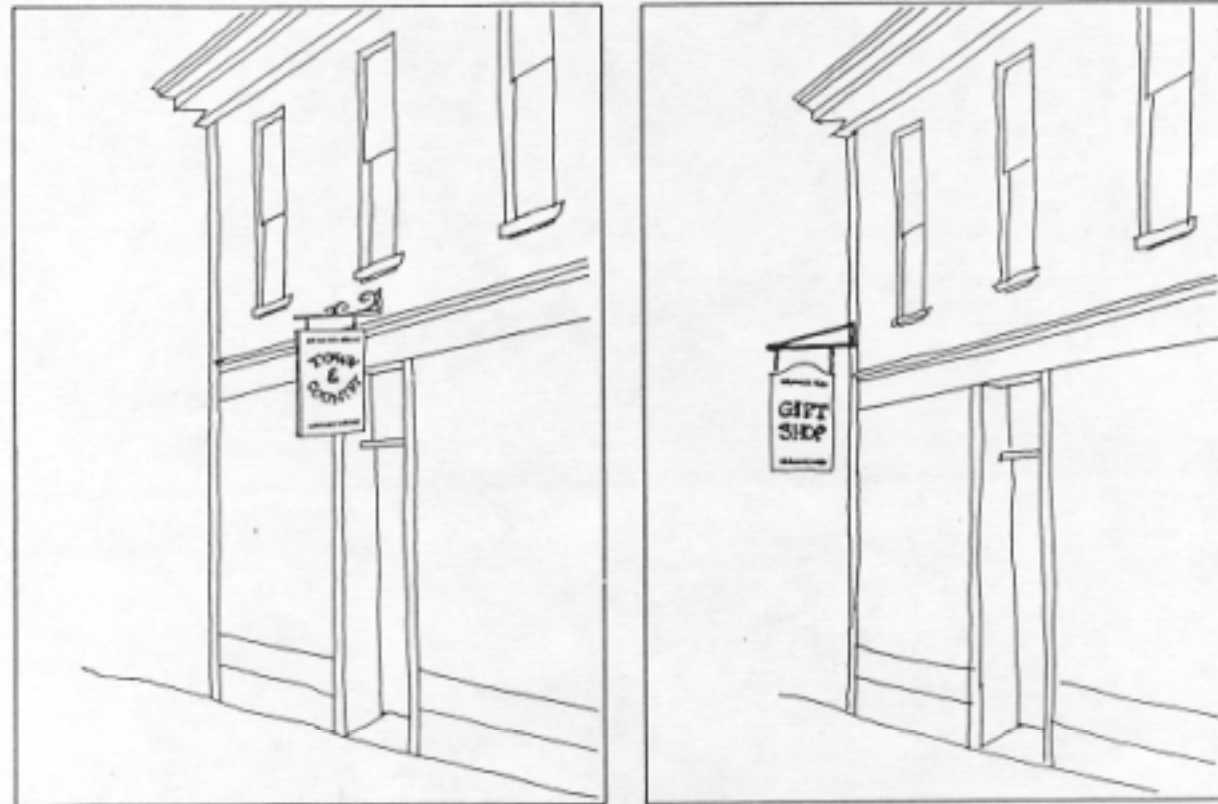
LOCATION OF PROJECTING SIGNS

PROJECTING SIGNS: are those which are hung or fixed at ninety degrees to the face of the building. They serve as an identification device and often convey a secondary message, such as street address or proprietor's name. Sculptural cut-outs in the shape of objects may represent merchandise offered, e.g., a boot advertising a shoe store. Projecting signs should not be mounted lower than three metres and may be mounted almost anywhere on the building as long as they do not extend above the eaves. For best effect, they should be centered above the entrances to building establishments. These signs should be positioned to align with the vertical elements of the building or aligned with the midpoints of windows or doors. The recommended material for projecting signs is wood, either painted, or routed and painted, hung from a wrought iron sign standard.

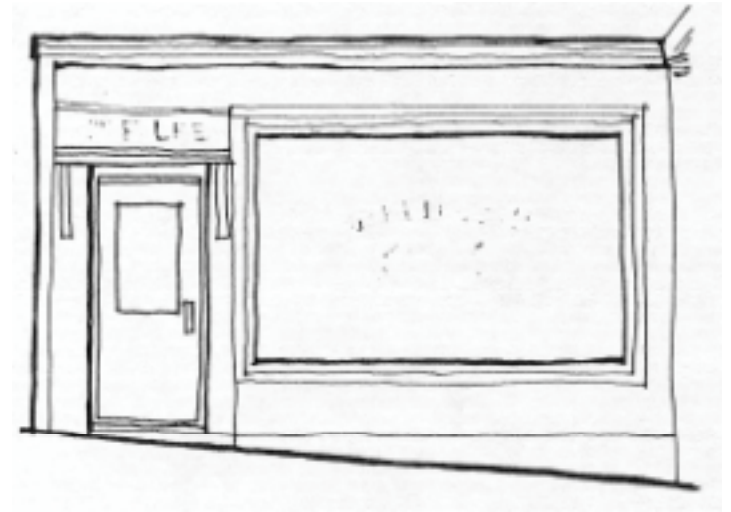
WINDOW SIGN

WINDOW SIGNS: are those which are painted, gold-leafed or otherwise affixed to a window or door, and identify the business within. Storefront windows are the most suitable for window signs. Window signs should occupy no more than thirty percent of the window area, or with door glazing, no more than fifty percent of the glassed area. Type should be simple, traditional and centered.

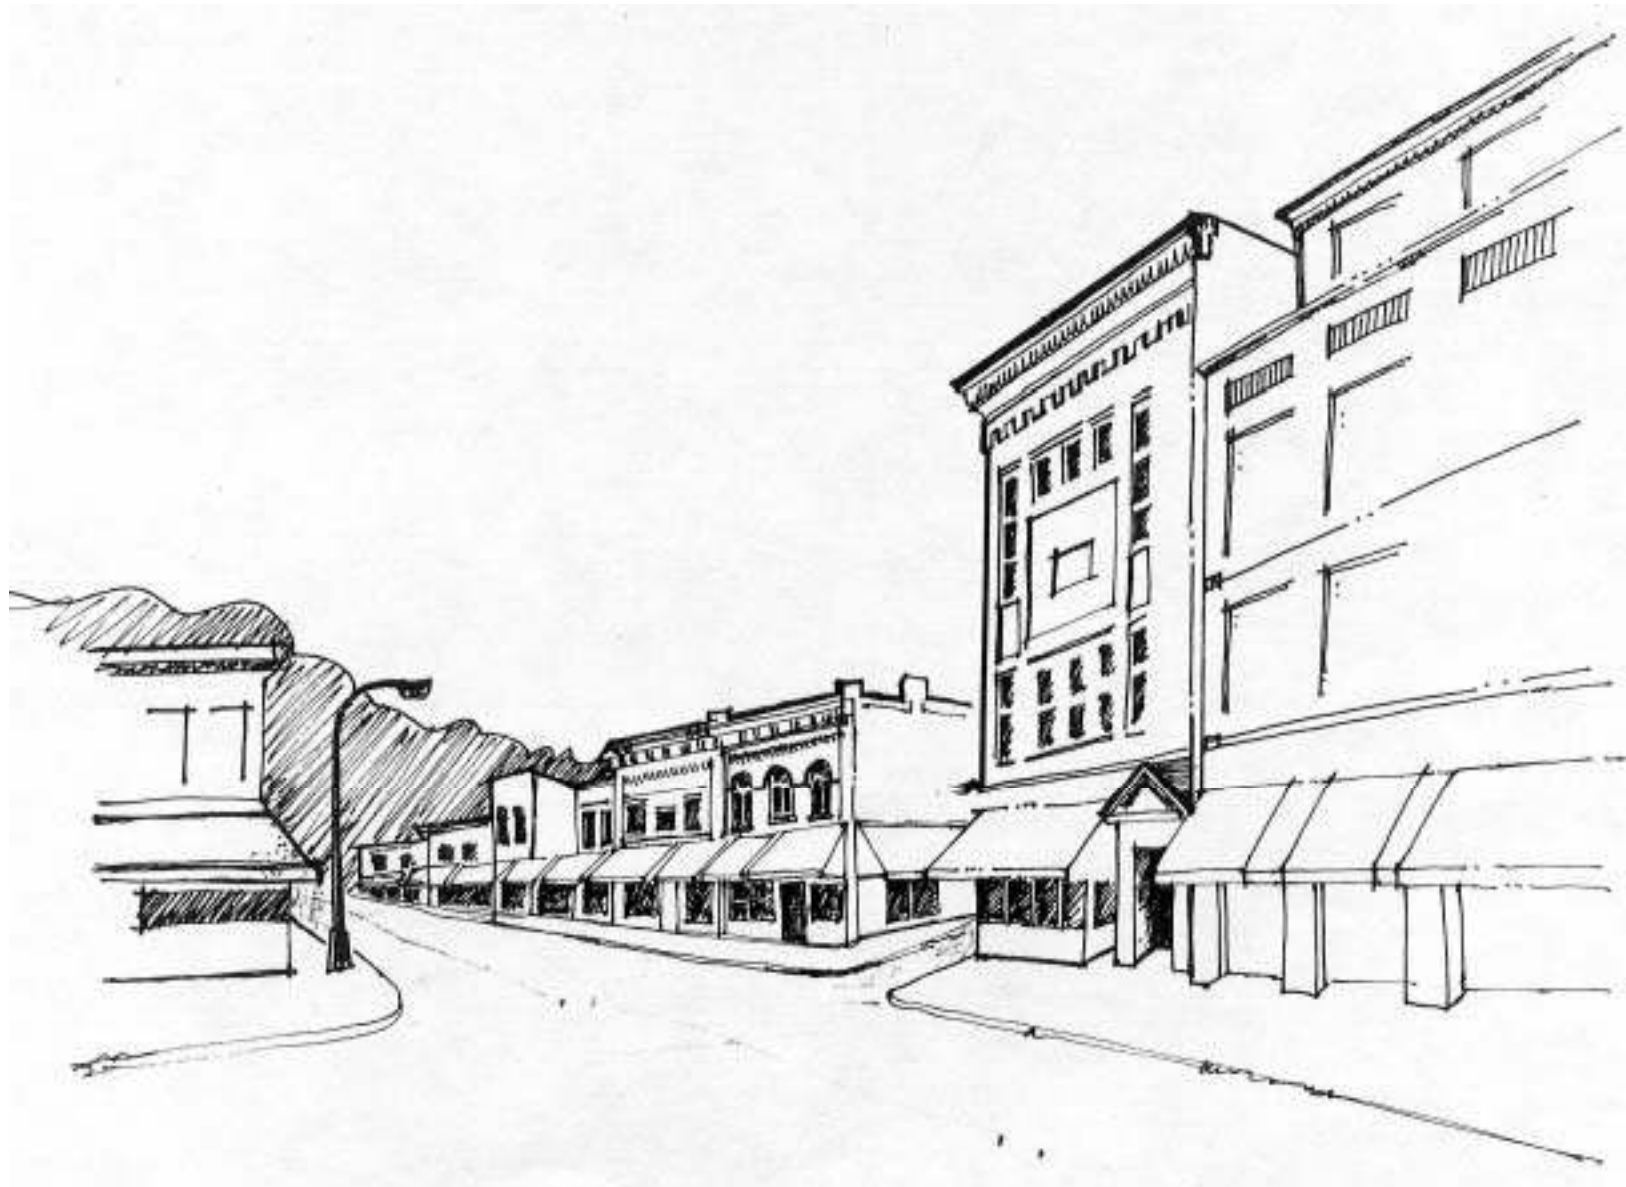
REVITALIZED STREETScape

Information on the design, construction and placement of canopies may be found directly in the Nanaimo Design Guidelines. The most appropriate form of canopy for the older buildings is the 3-point fabric canopy with valence drop. Canopies should be shaped to fit individual structural openings rather than run in a continuous band. Colour should be in harmony with the building facade and with adjacent colour schemes.

Lighting and signage may be integrated in the canopy design for an overall integrated effect. Canopies are the finishing touch for each individual project and emphasize the horizontal continuity of the streetscape.

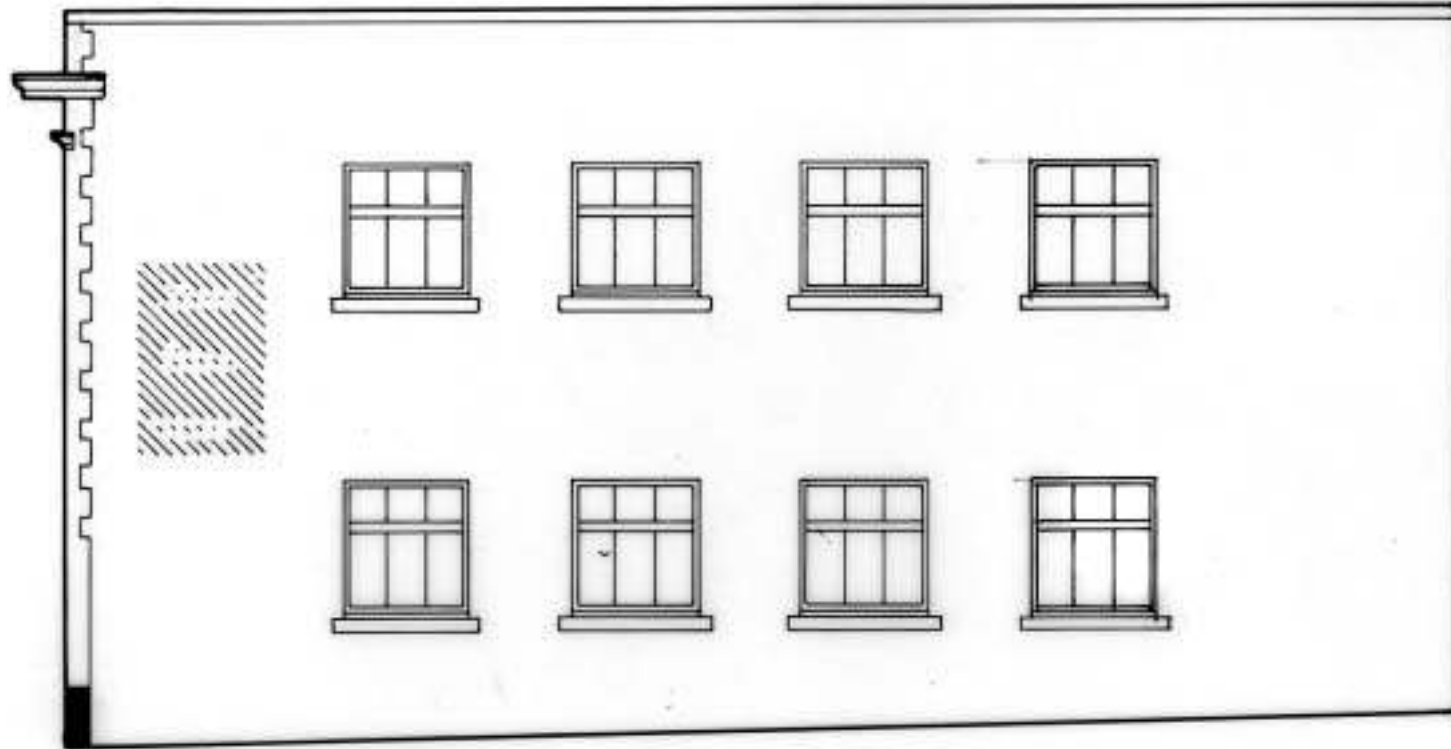
D. Auxiliary components

1. 3-point fabric canopies shaped to fit structural openings
2. Signage recommended on canopy valence, horizontally projecting, or fascia signs

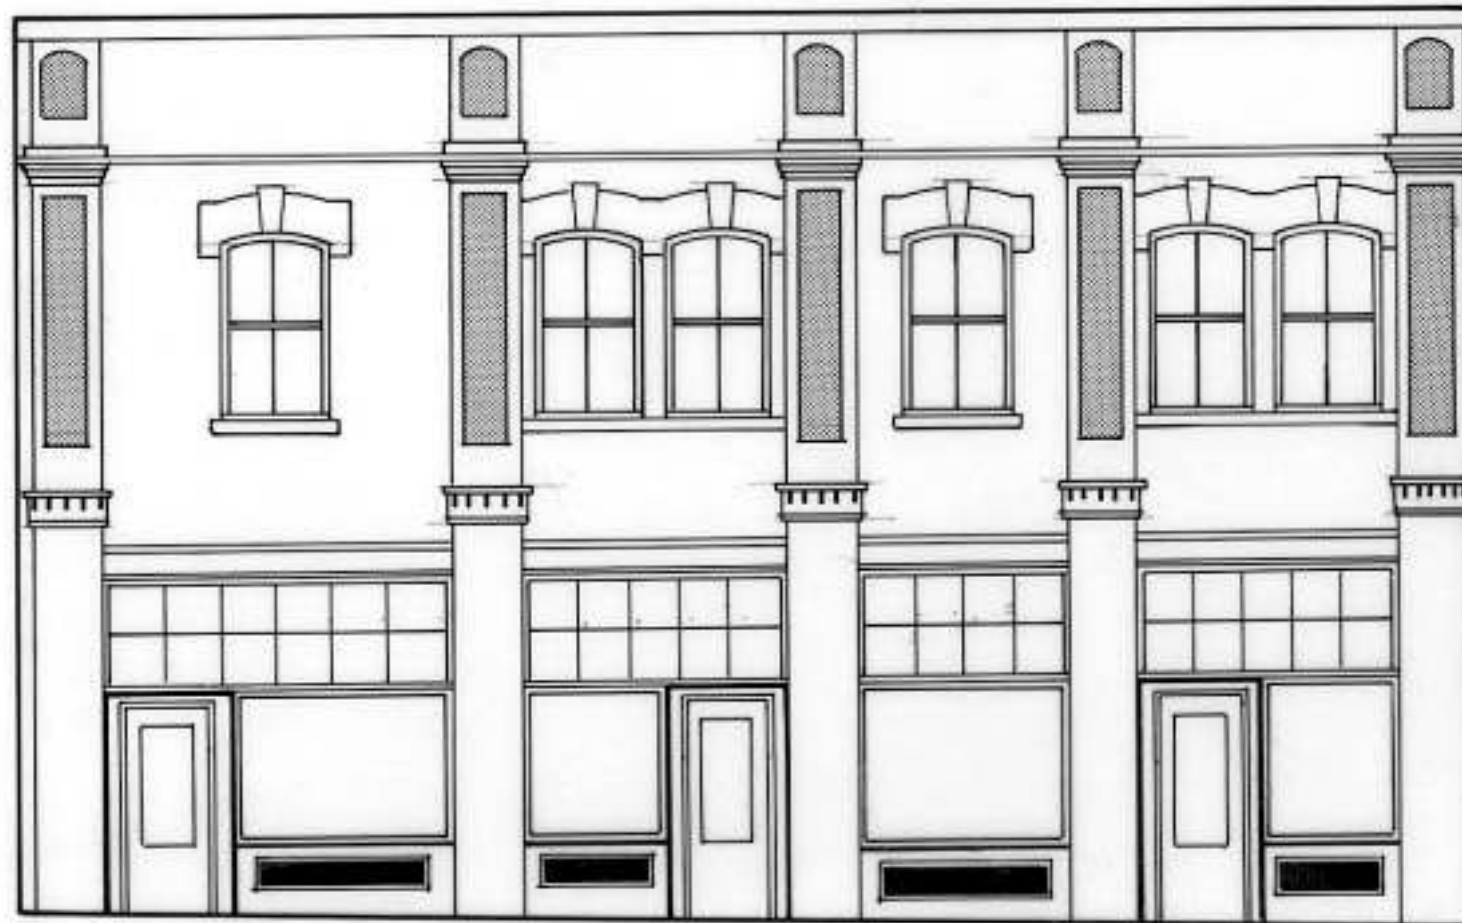
C. Shopfront & fenestration

1. Complete replacement of existing ground floor elements:
 - shop windows
 - canopy
 - doors
2. Replacement of missing piers to match original

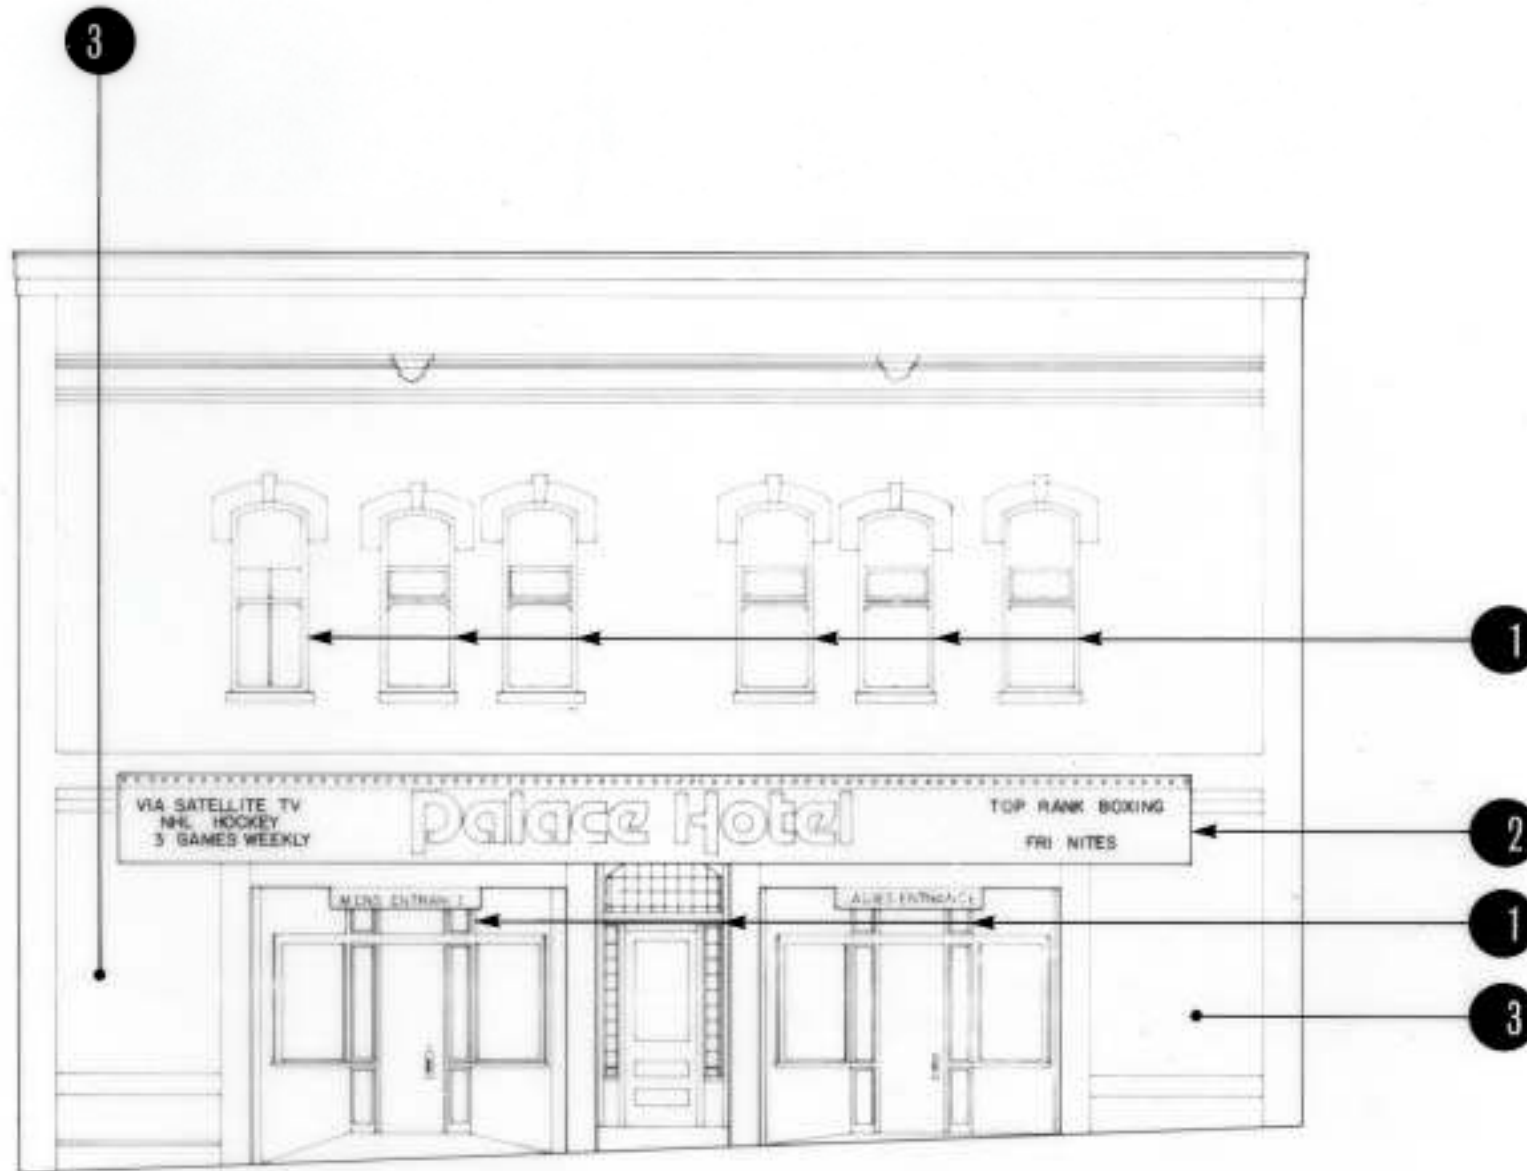
B. Recommended design

1. Existing signage removed
2. Brick removed from blocked-in ground floor arched openings. Blind fenestration added
3. Sympathetic surfacing materials to be used around entrances

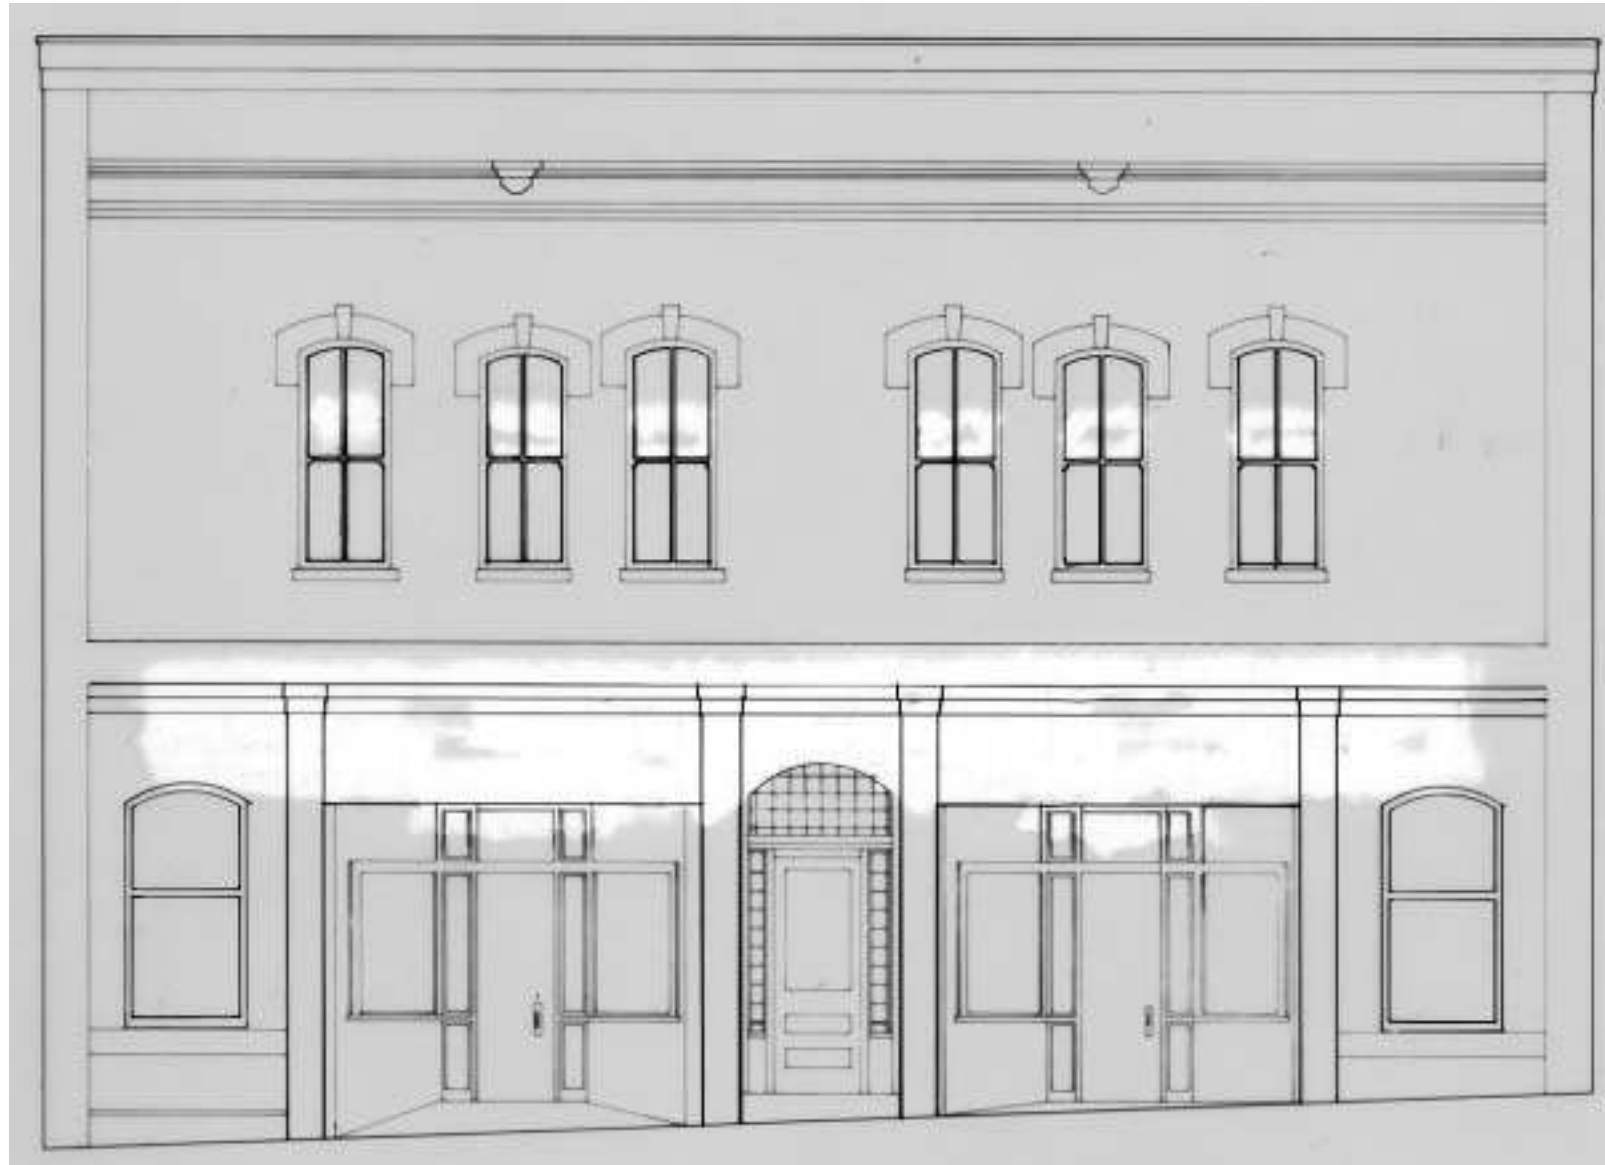
D. Auxiliary components

1. 3-point fabric canopies shaped to fit ground floor structural openings
2. Signage recommended along canopy valences, horizontally projecting from building face, painted or raised lettering on fascia, painted on glass, or neon tubing behind blind fenestration
3. Lighting recommended as part of canopy design

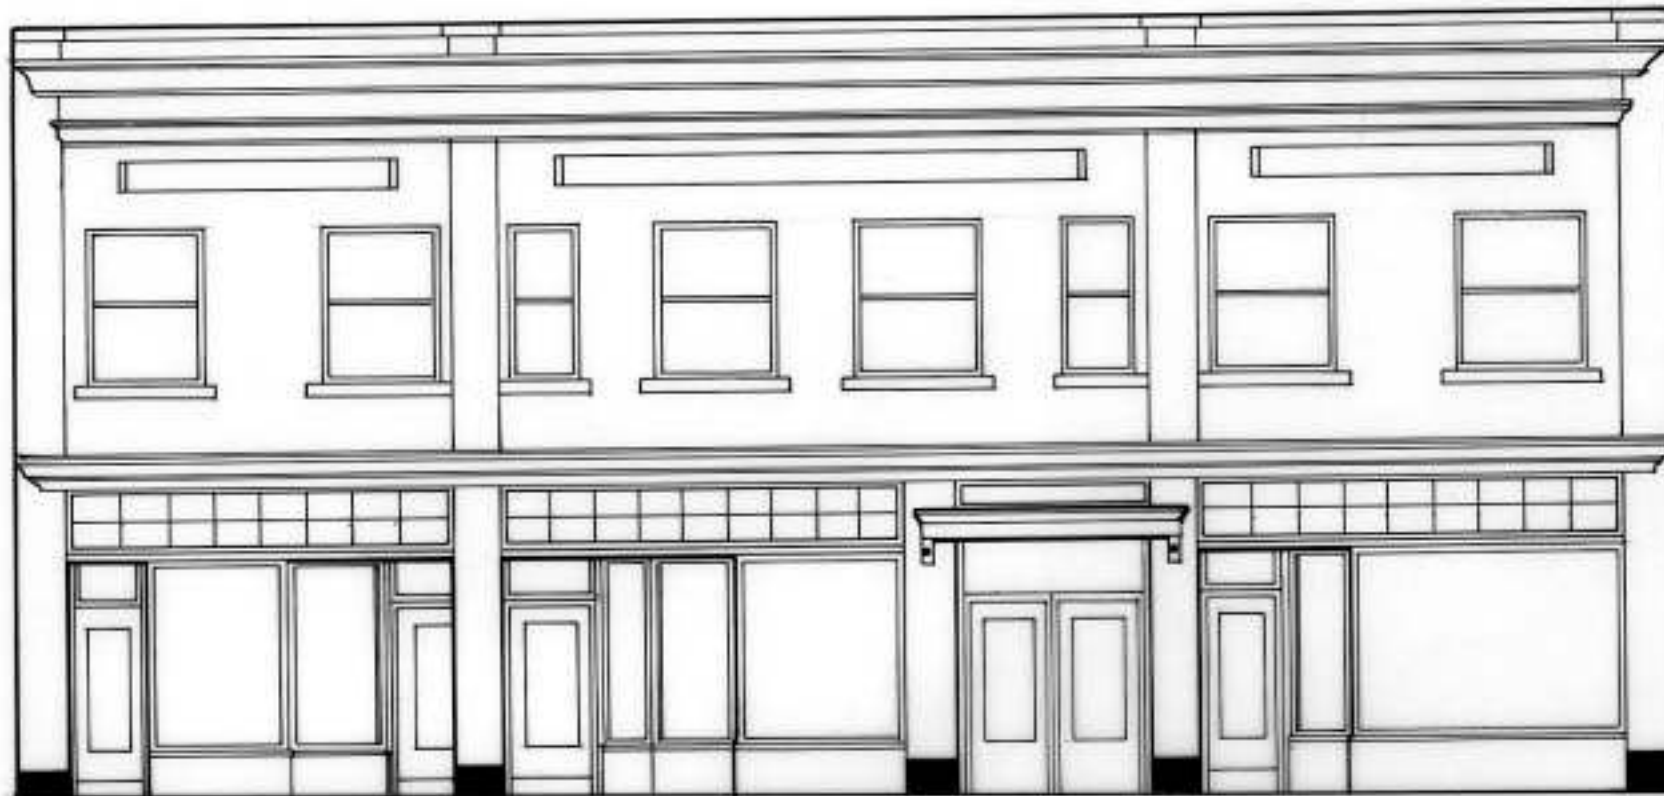
B. Recommended design

1. Replacement of existing signage
2. Replacement of second storey windows
3. Rebuilding of storefront elements

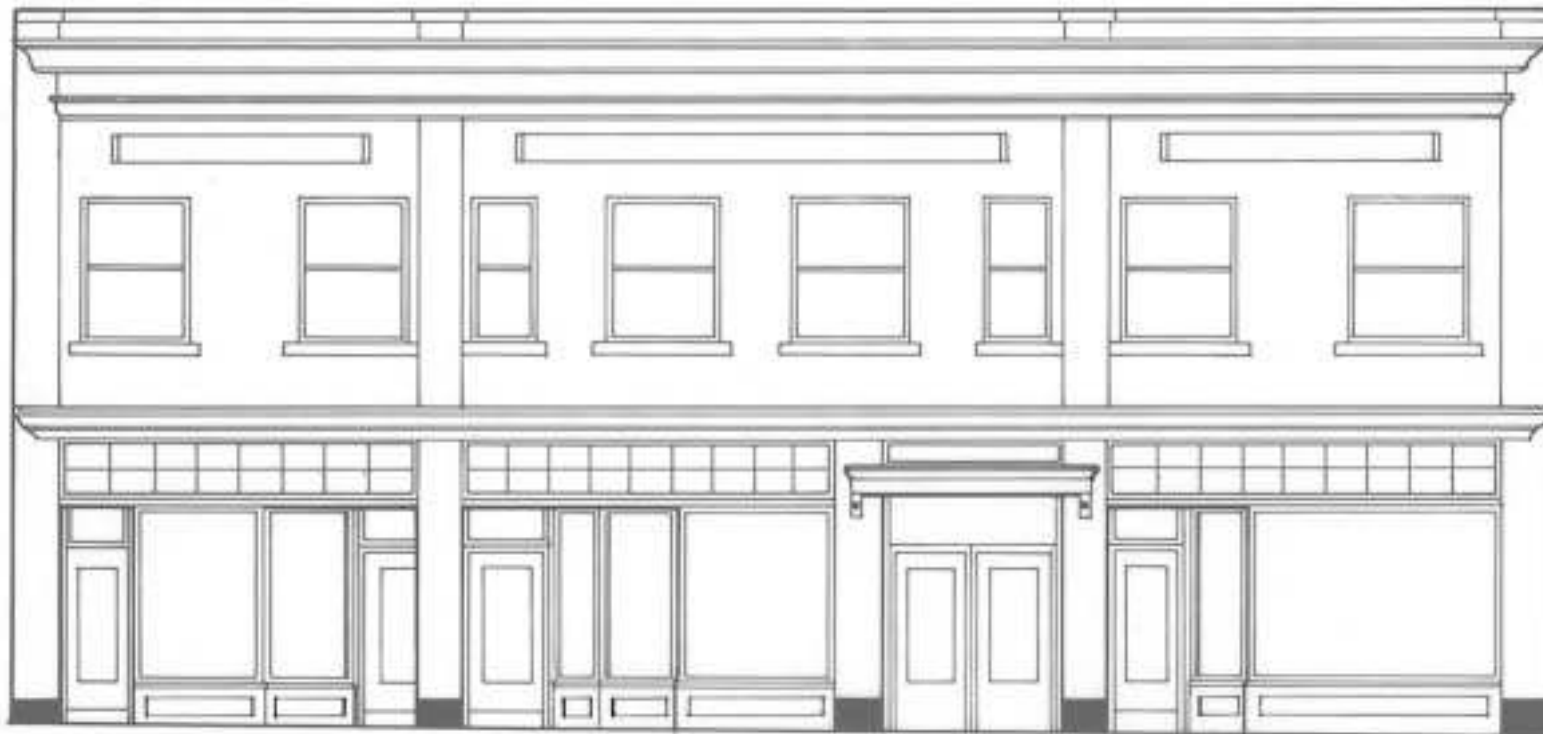
C. Shopfront & fenestration

1. Rebuilding of storefront elements with sympathetic materials
2. Replacement of second storey windows with double-hung wooden sash windows
3. Removal of unsympathetic surfacing materials

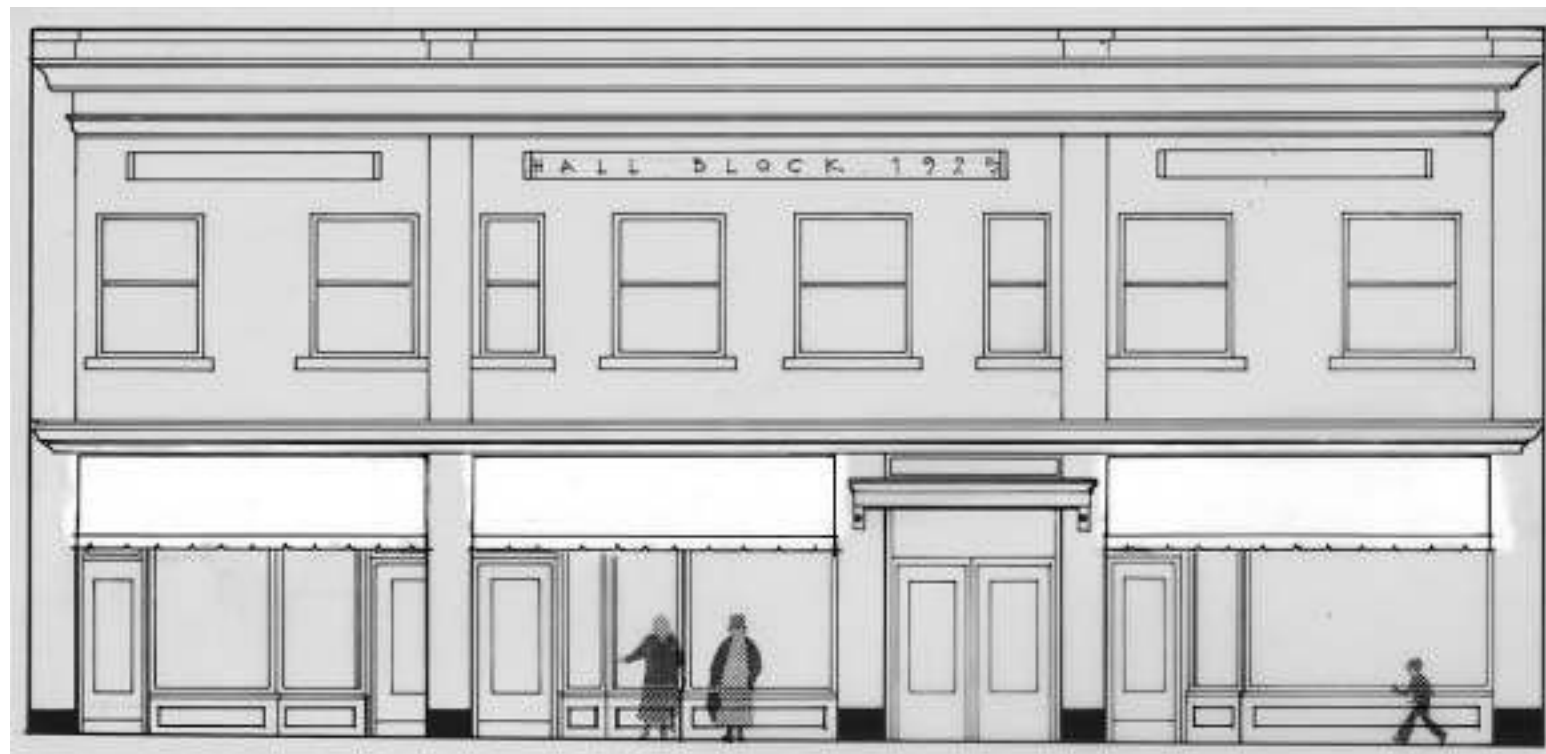
D. Auxiliary components

1. 3-point fabric canopies shaped to fit structural openings
2. Signage recommended along canopy valences, under canopies, horizontally projecting, or painted on glass

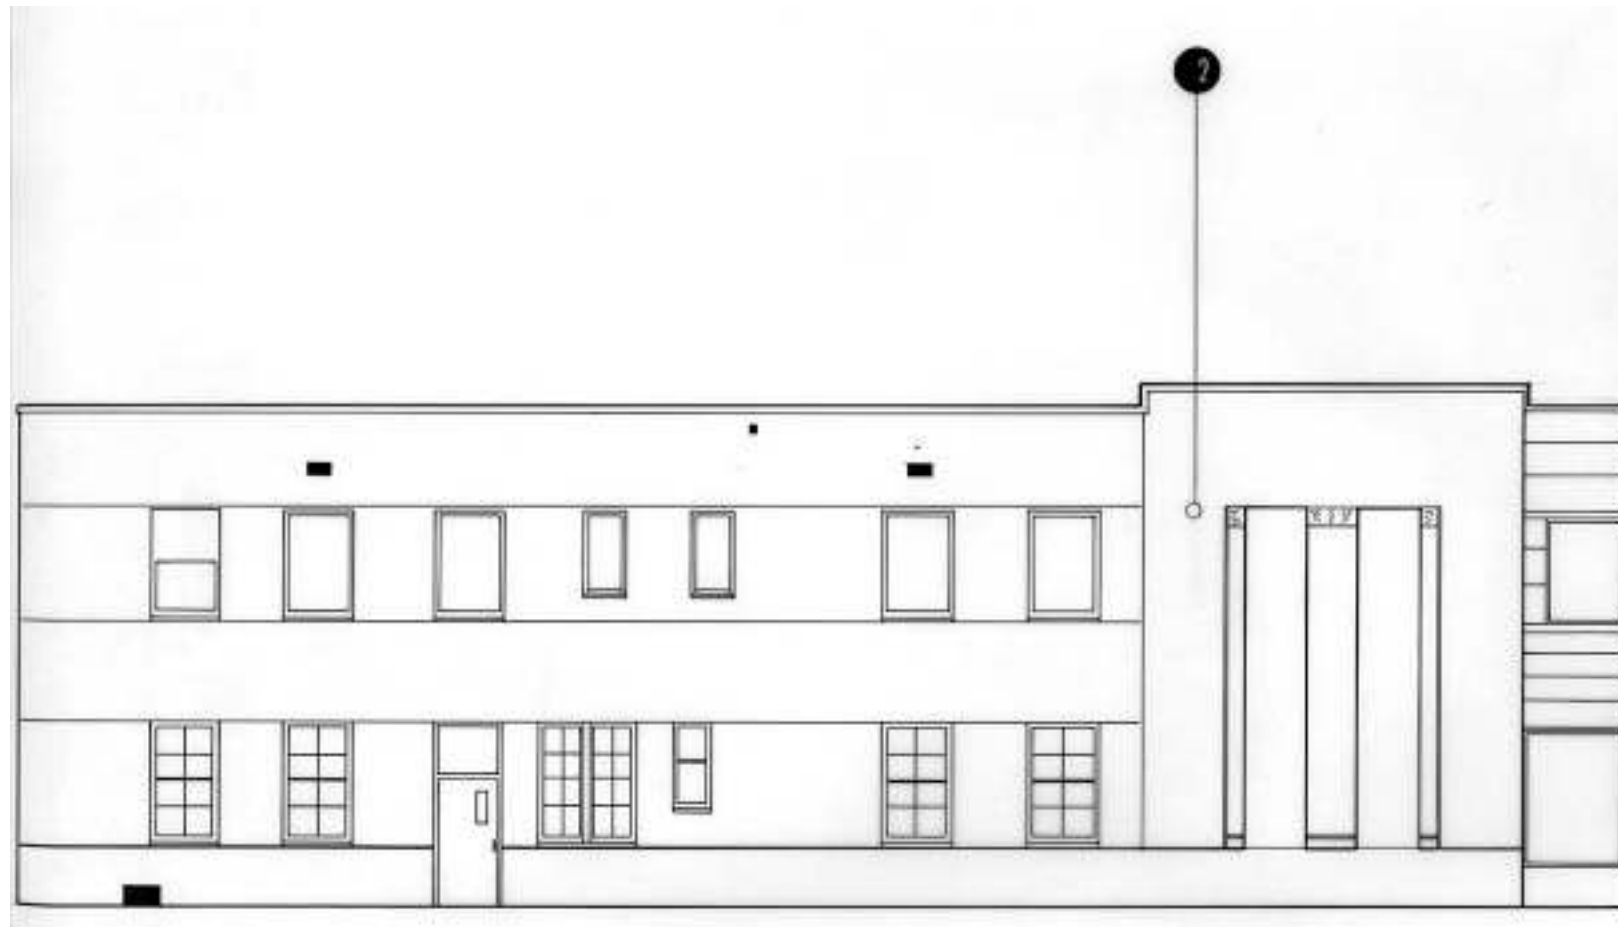
UNSUITABLE MODIFICATIONS

2. Extremely inappropriate colour scheme
3. Plastic fascia panels

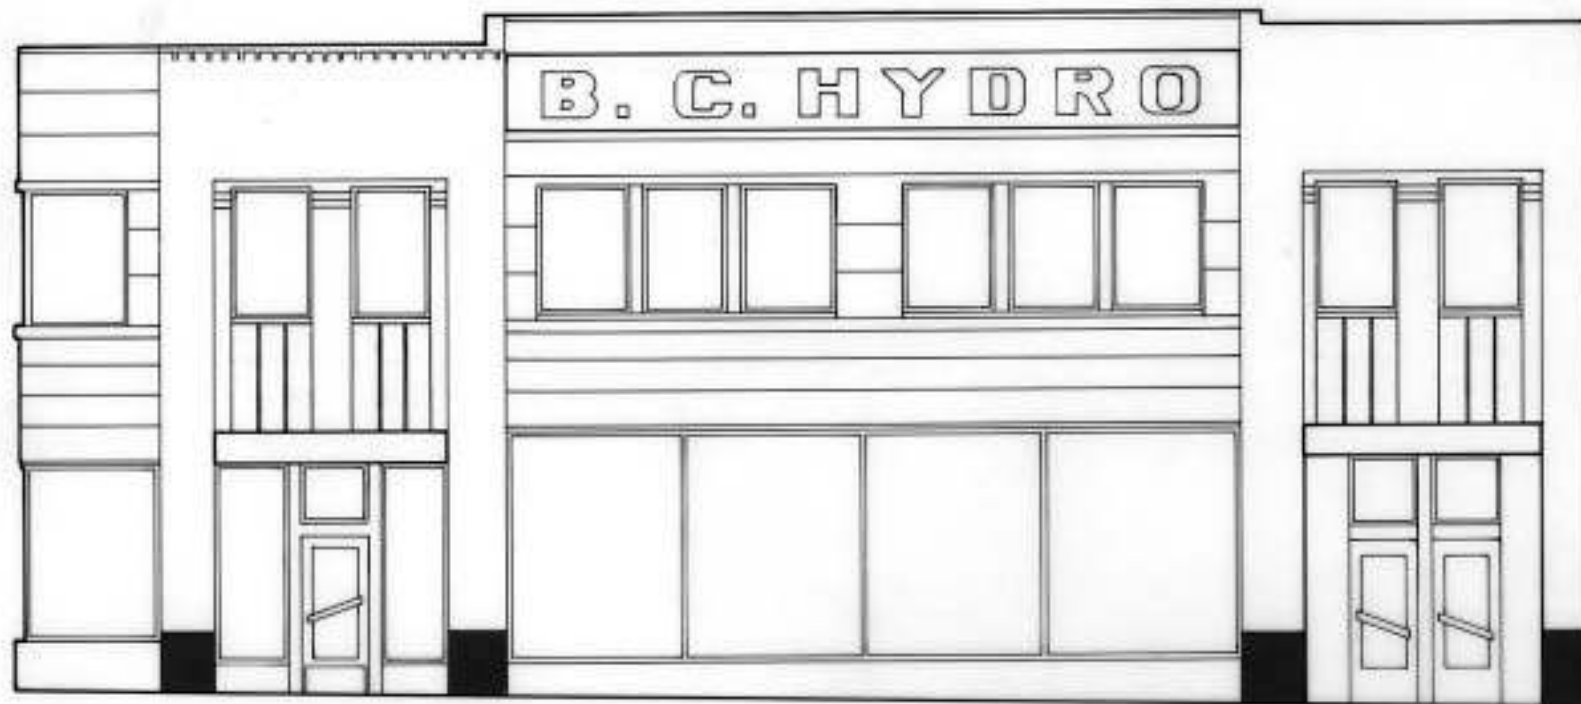
B. Recommended design

- Essentially, all original elements are intact and should at all costs be preserved
- 1. Plastic panels should be removed
- 2. Entire building should be repainted
- 3. Existing awnings, if replaced, should be similar in appearance and placement

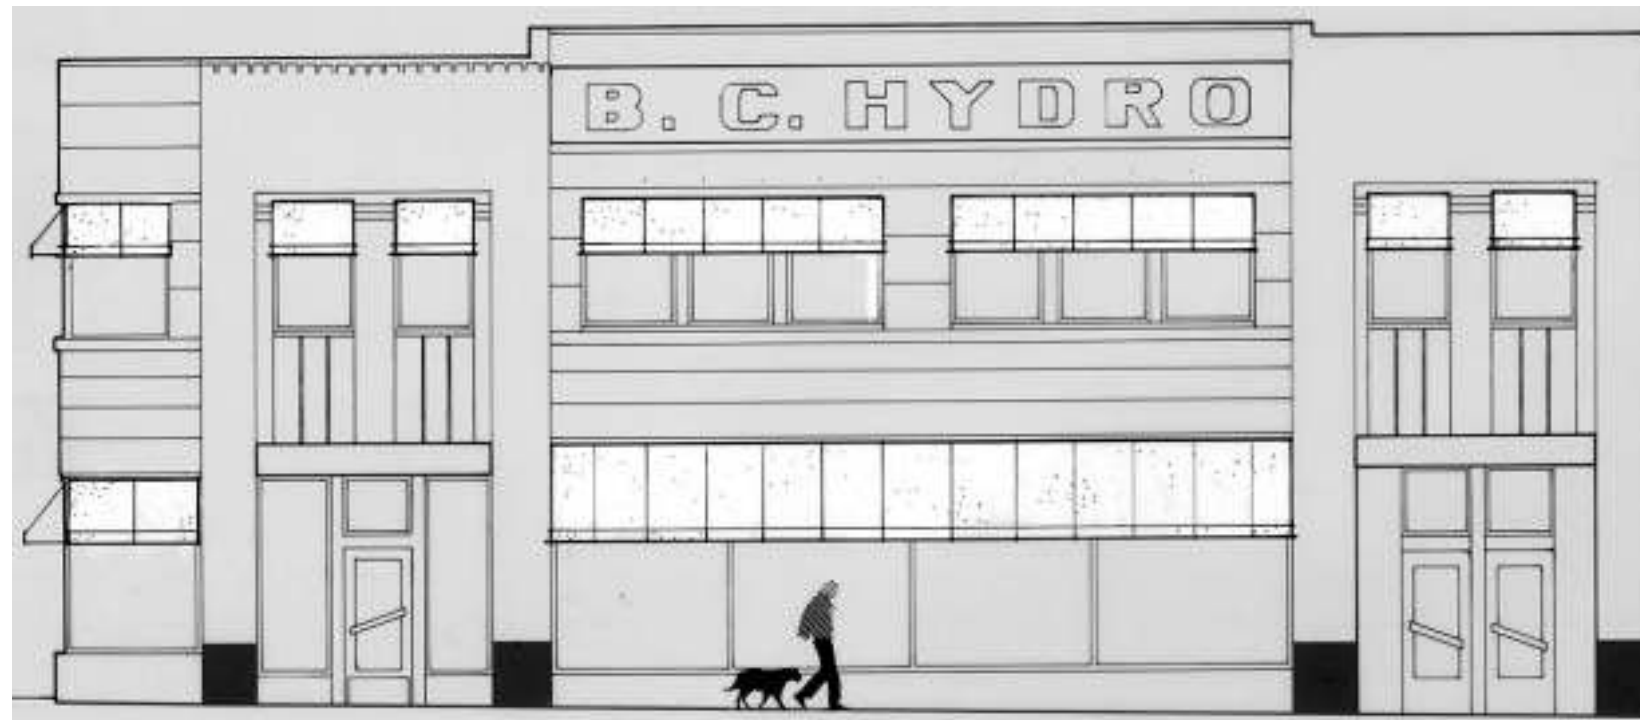
D. Auxiliary components

1. If required, 3-point canopies shaped to fit structural openings should be used
2. If additional signage is required, it should be placed along the canopy valence, under canopy, painted on glass, or neon tubing

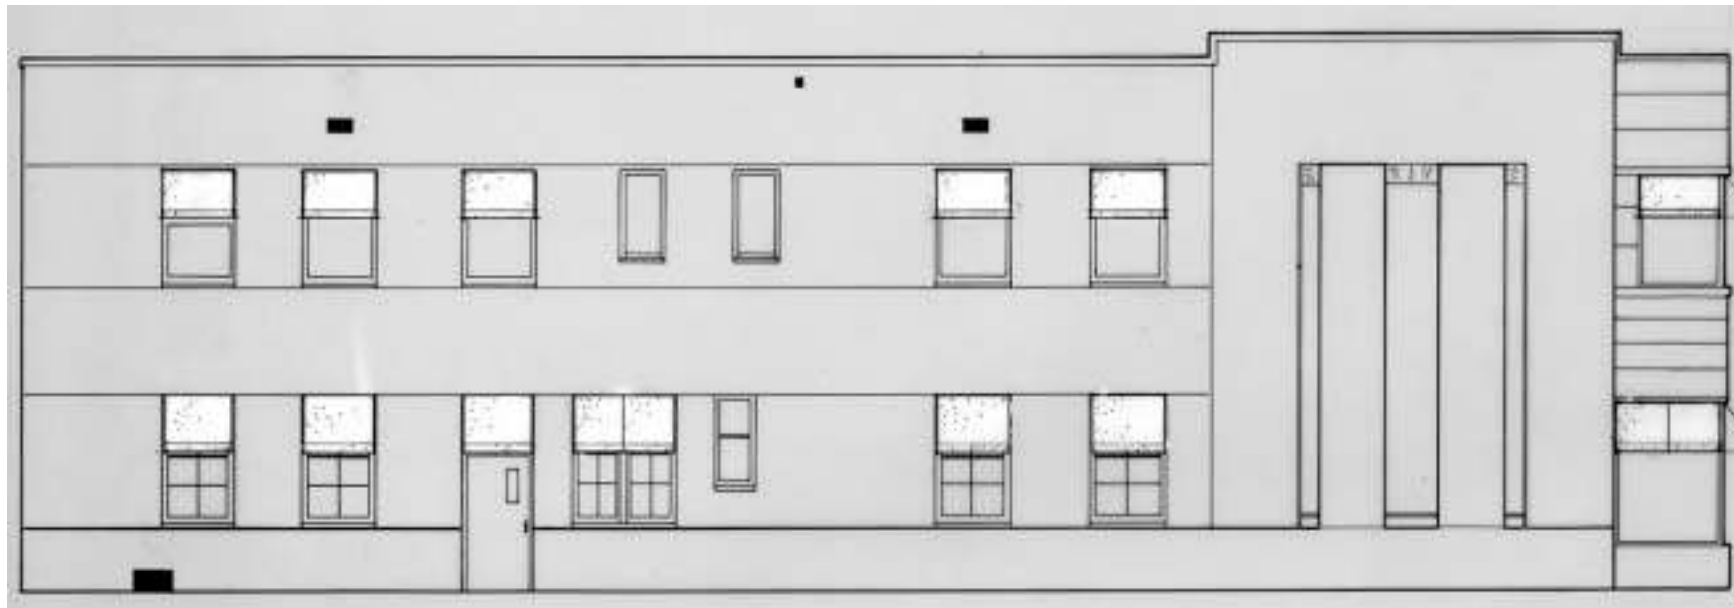
D. Auxiliary components

1. If required, 3-point canopies shaped to fit structural openings should be used
2. If additional signage is required, it should be placed along the canopy valence, under canopy, painted on glass, or neon tubing

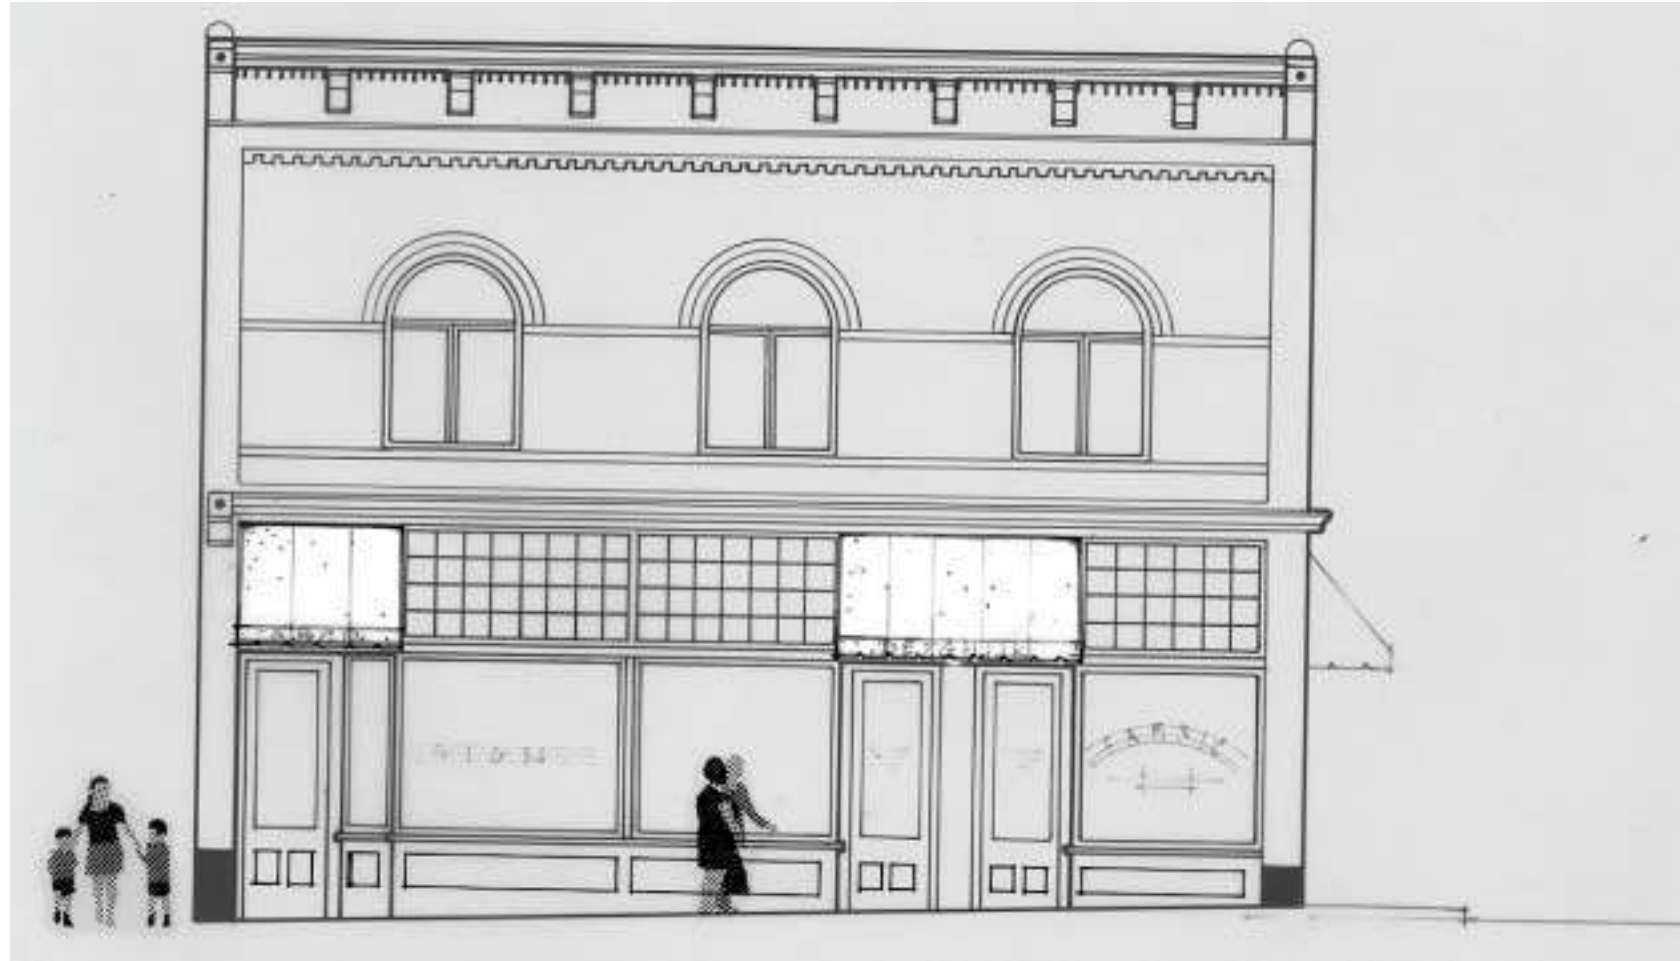
D. Auxiliary components

1. Existing canopy replaced with 3-point fabric canopies shaped to fit storefront openings
2. Signage recommended along canopy valence, under canopy, or painted on glass
3. Lighting recommended as part of canopy design
