NANAIMO HERITAGE BUILDING DESIGN GUIDELINES

THE FOUNDATION GROUP
#1 – 2629 West Fourth Avenue, Vancouver, B.C., V6K 1 P8
733-4593

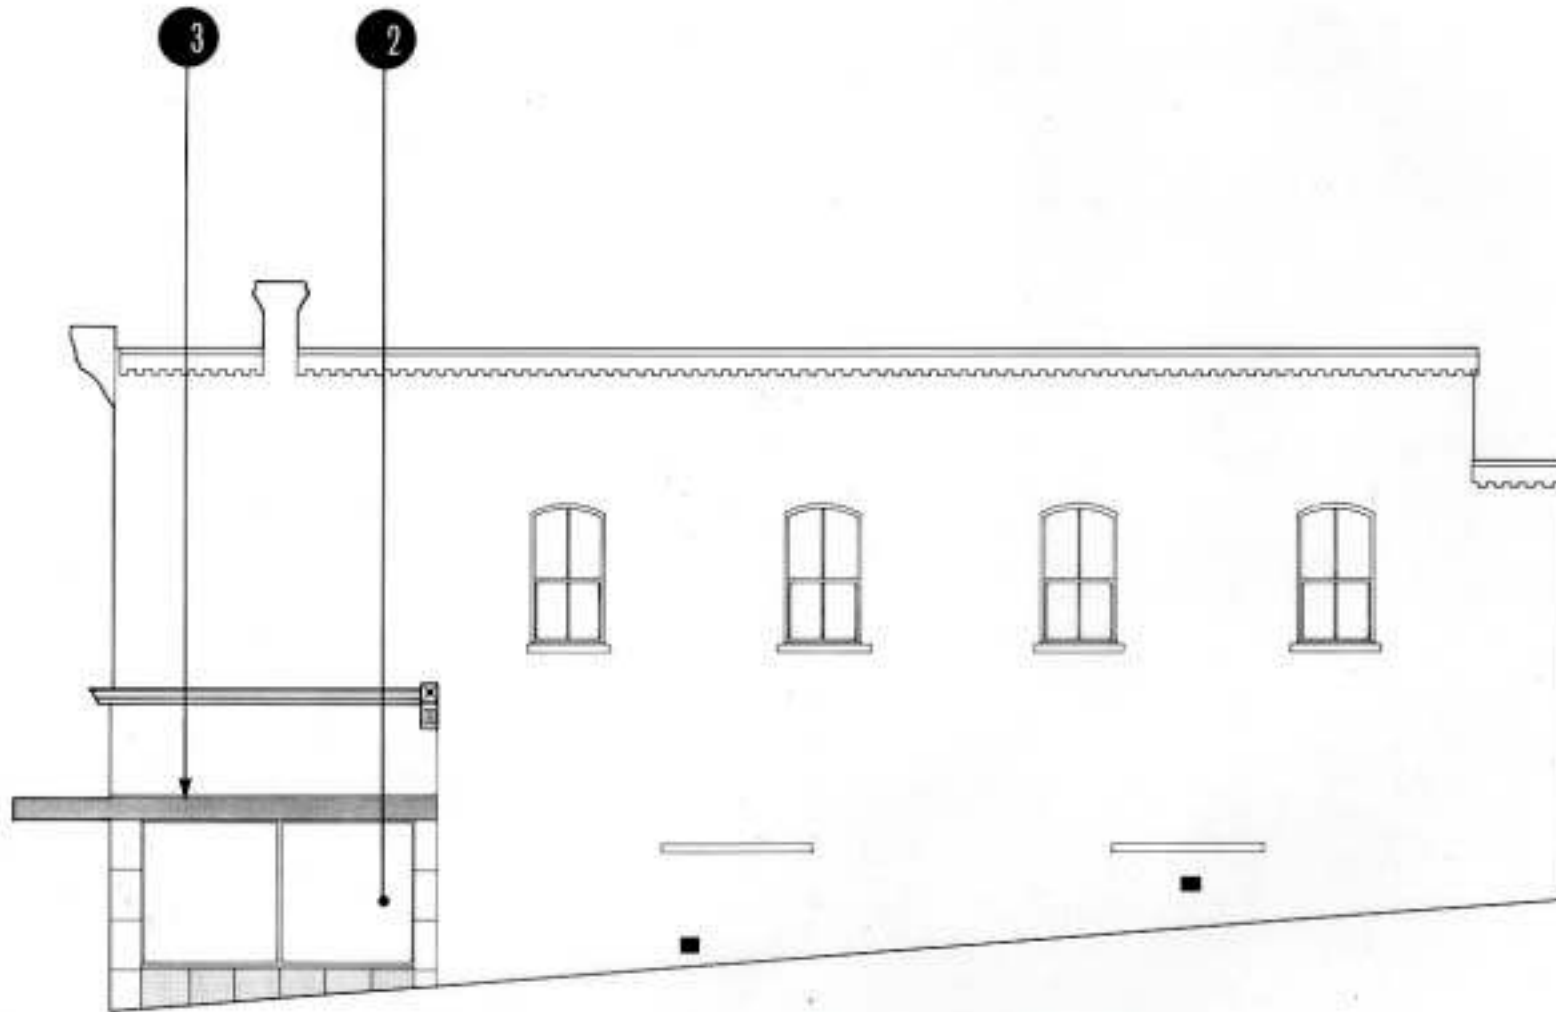
A. Existing condition

2. Entire ground floor shopfronts are out-of-keeping with the heritage nature of the building
3. Projecting canopy
4. Blocked-in fascia panel on ground floor

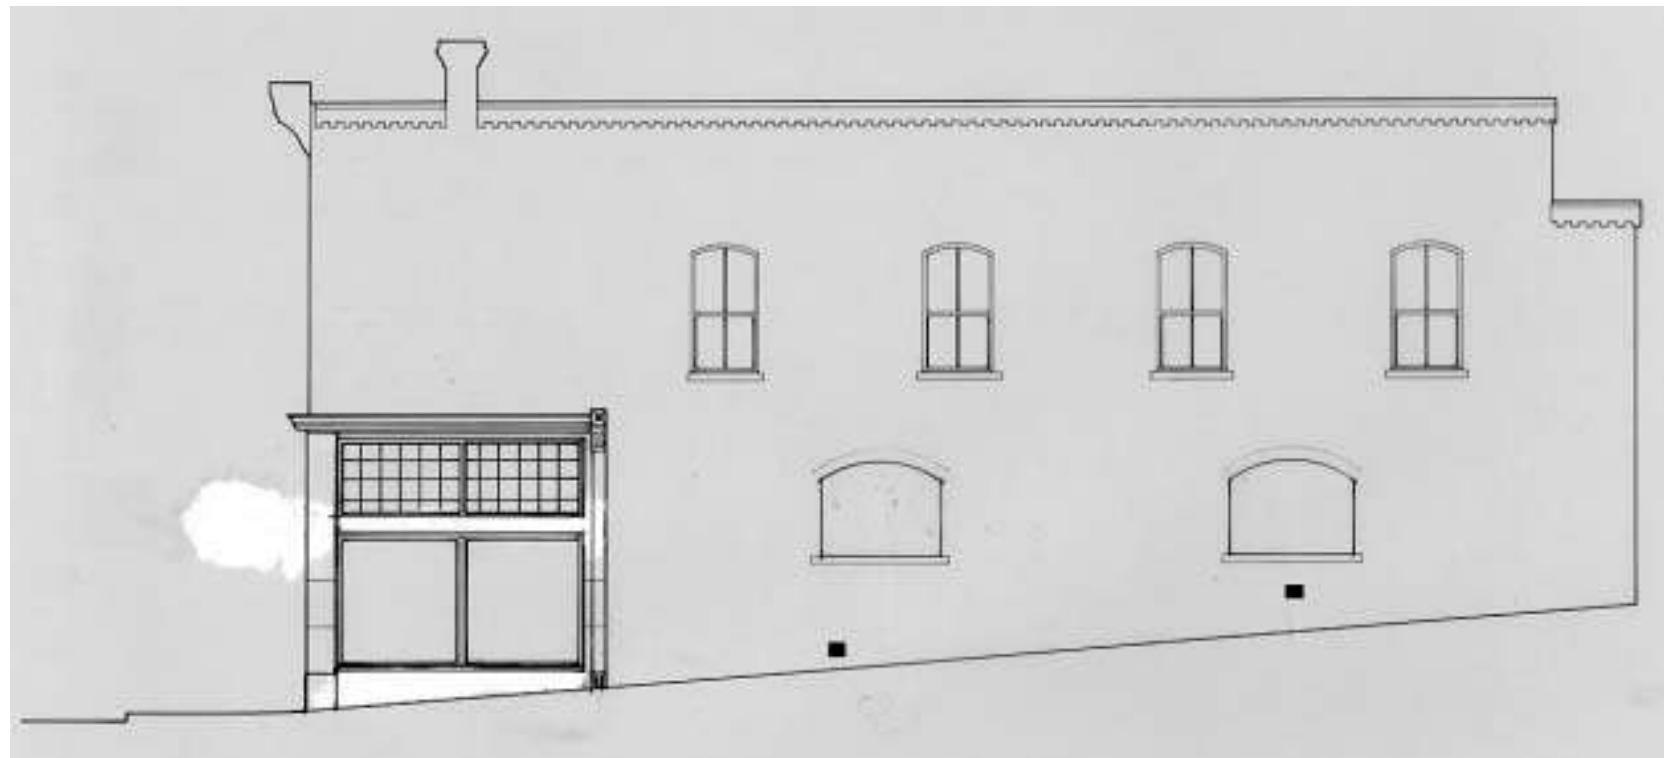
B. Recommended design

1. Removal of canopy
2. Rebuilding of storefront elements.
A more sympathetic period treatment is desired, with potential for full-height windows
3. Brick cleaned when possible

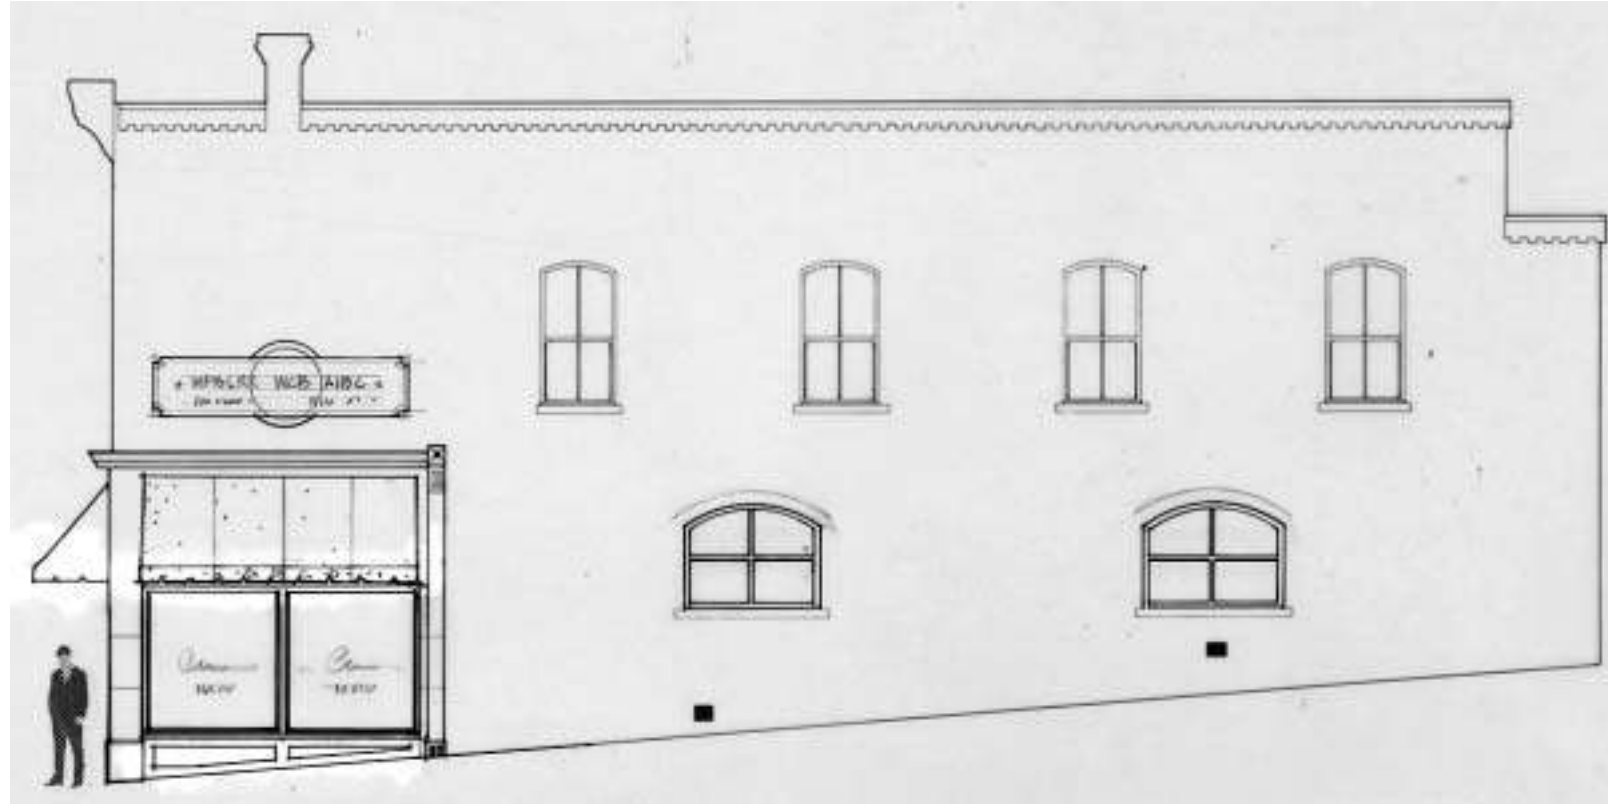
D. Auxiliary components

1. Existing canopy replaced with 3-point fabric canopies shaped to fit storefront openings
2. Signage recommended along canopy valence, under canopy, or painted on glass
3. Lighting recommended as part of canopy design

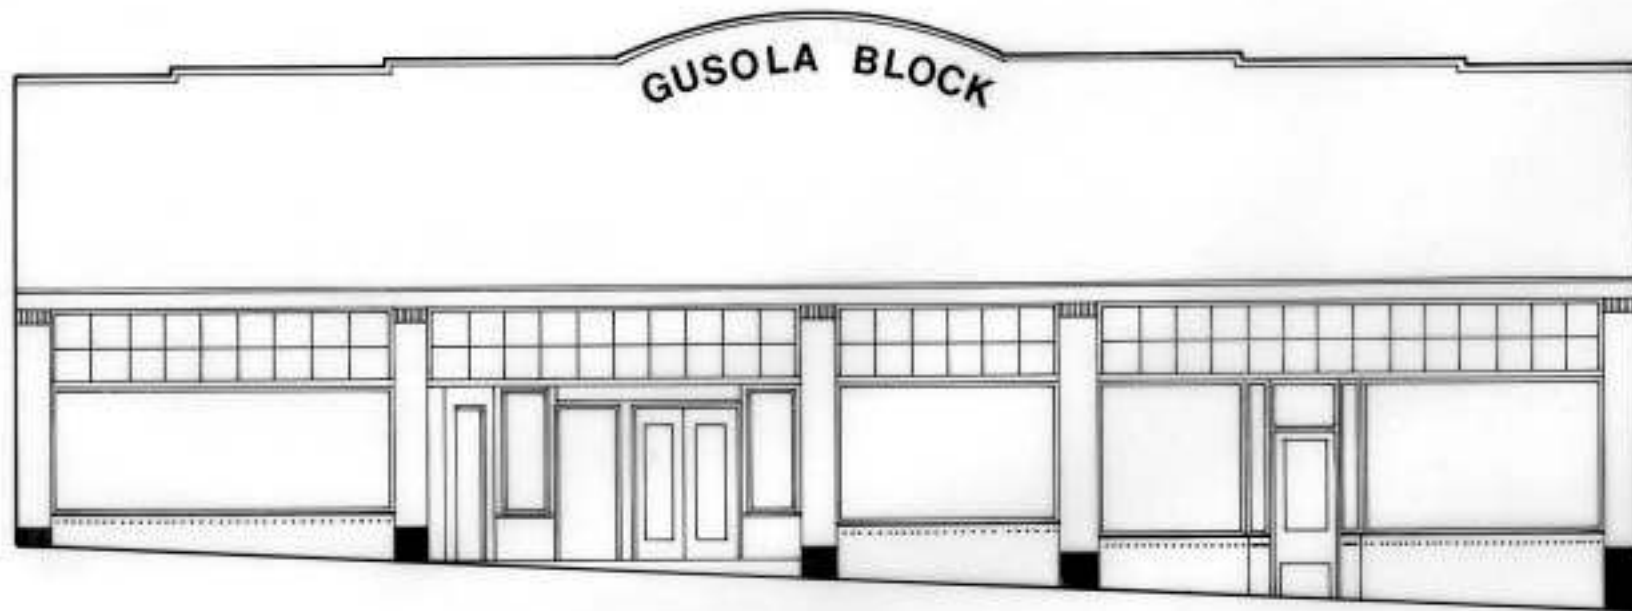
B. Recommended design

1. Rebuilding of most storefront elements. The southernmost storefront should remain intact

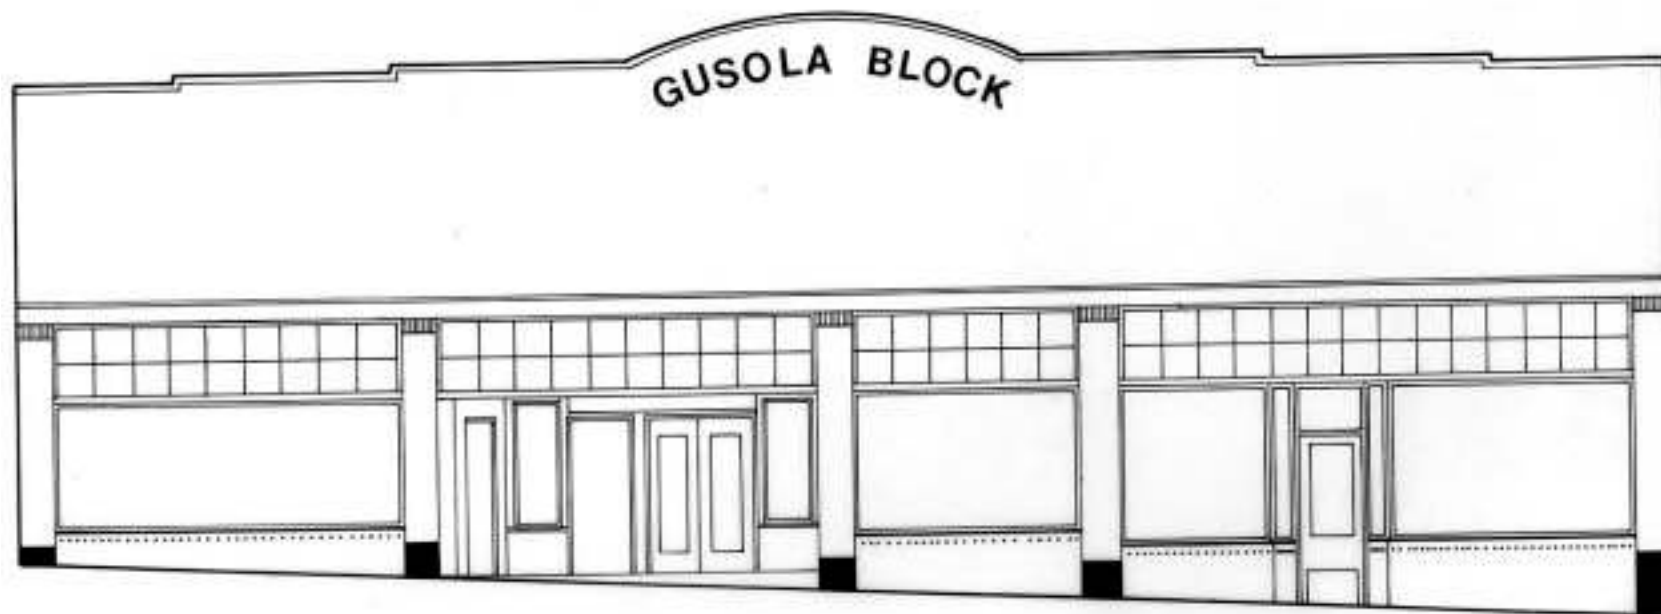
C. Shopfront & fenestration

1. Rebuilding of storefront elements, including windows, doors, and wall surfaces

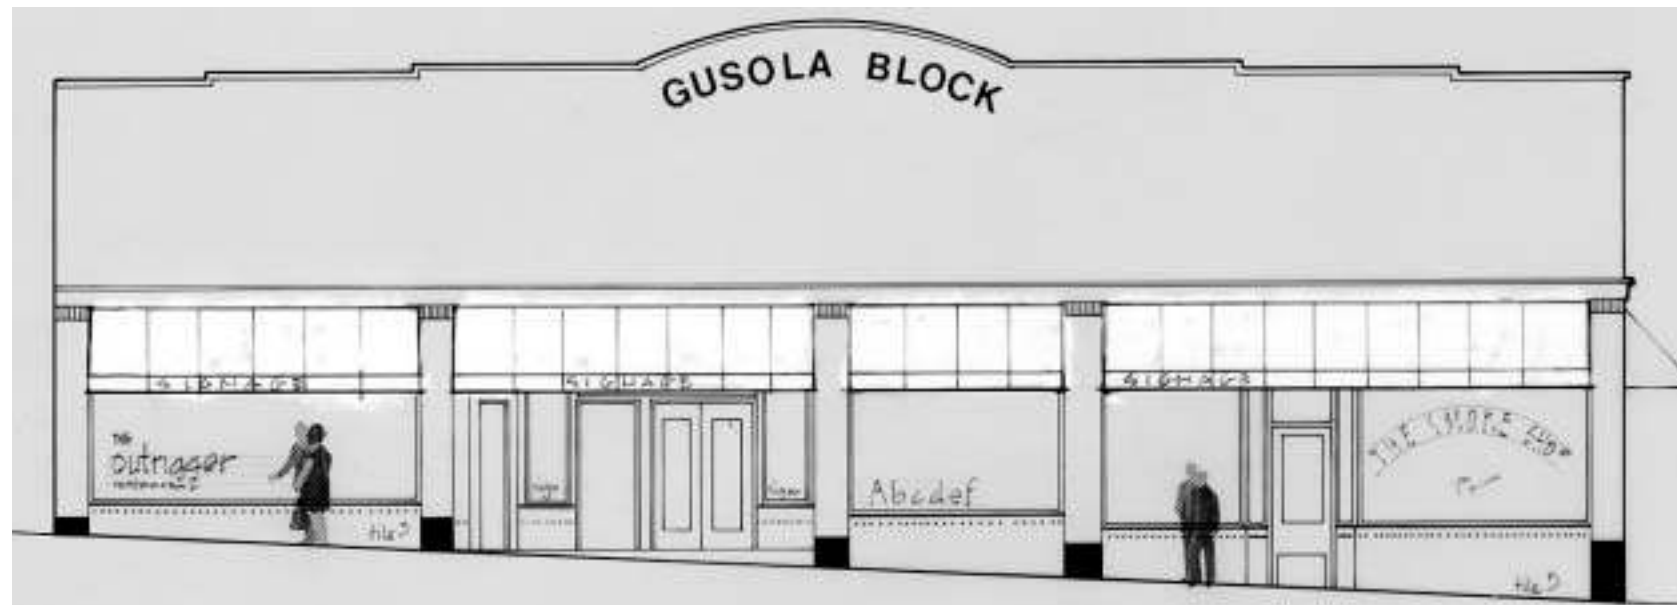
D. Auxiliary components

1. Existing 'strip' canopy should be modified to fit structural openings
2. Signage recommended along canopy valences, under canopies, or painted on glass
3. Lighting recommended as part of canopy design

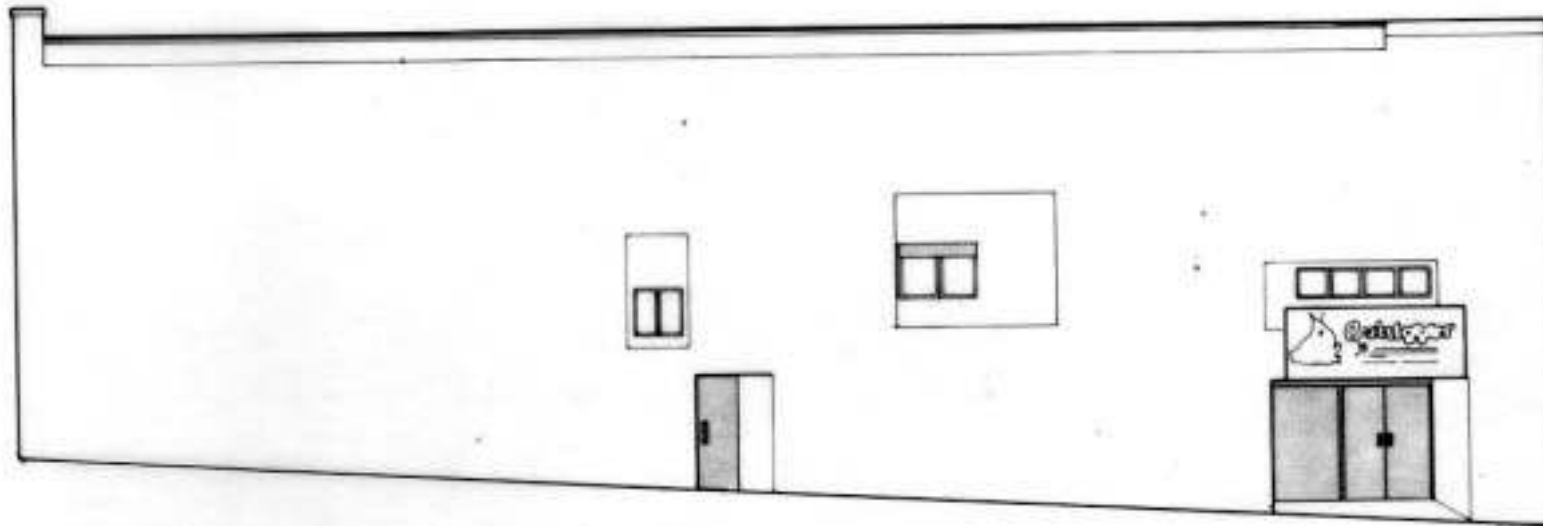
UNSUITABLE MODIFICATIONS

2. Entire facade is unsympathetic to heritage nature of the area.

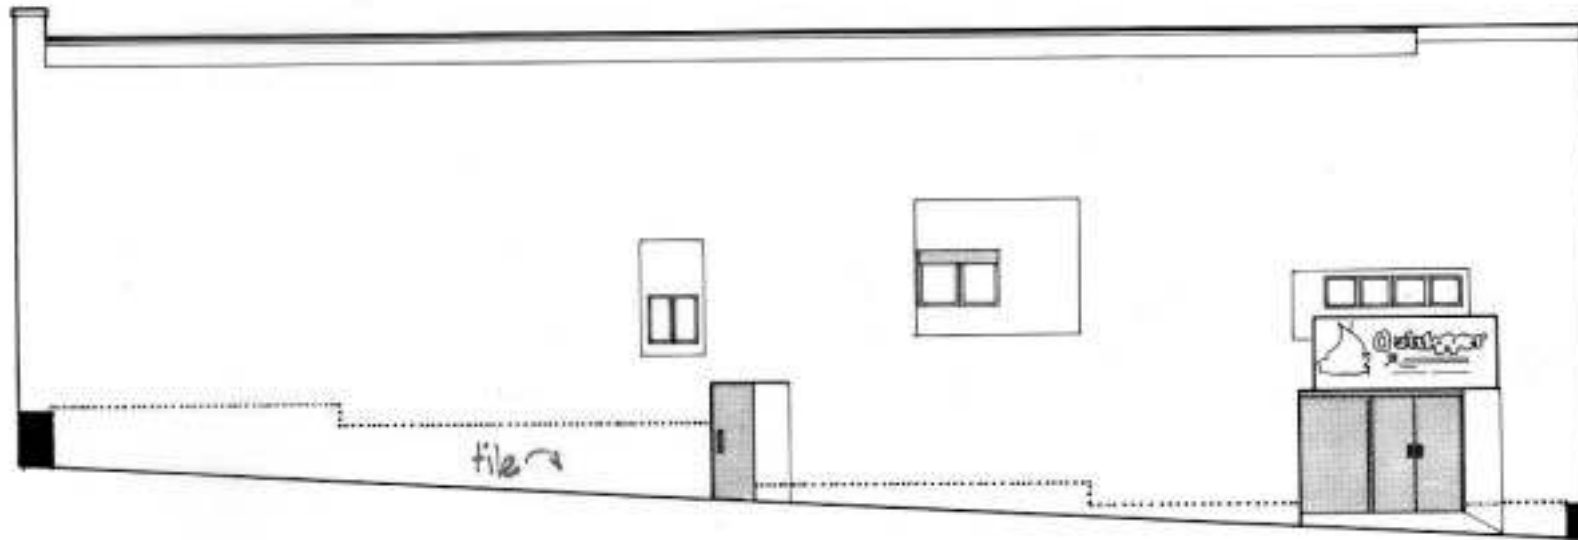
B. Recommended design

1. Canopies and colour should be used to soften impact of blank facade on the streetscape
2. Contrasting surface materials could be used for accenting and highlighting at street level

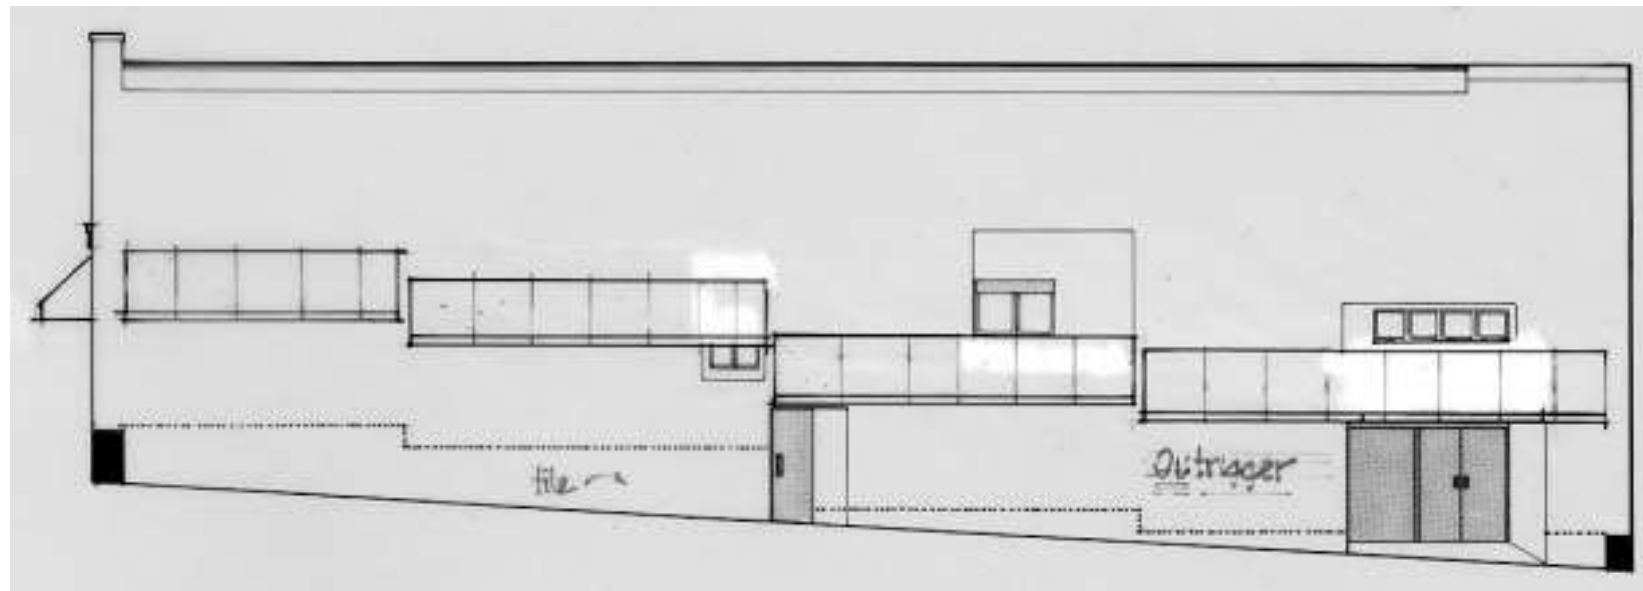
D. Auxiliary components

1. Canopies placed to shelter pedestrian traffic
2. Signage recommended along canopy valences
3. Lighting recommended as part of canopy design

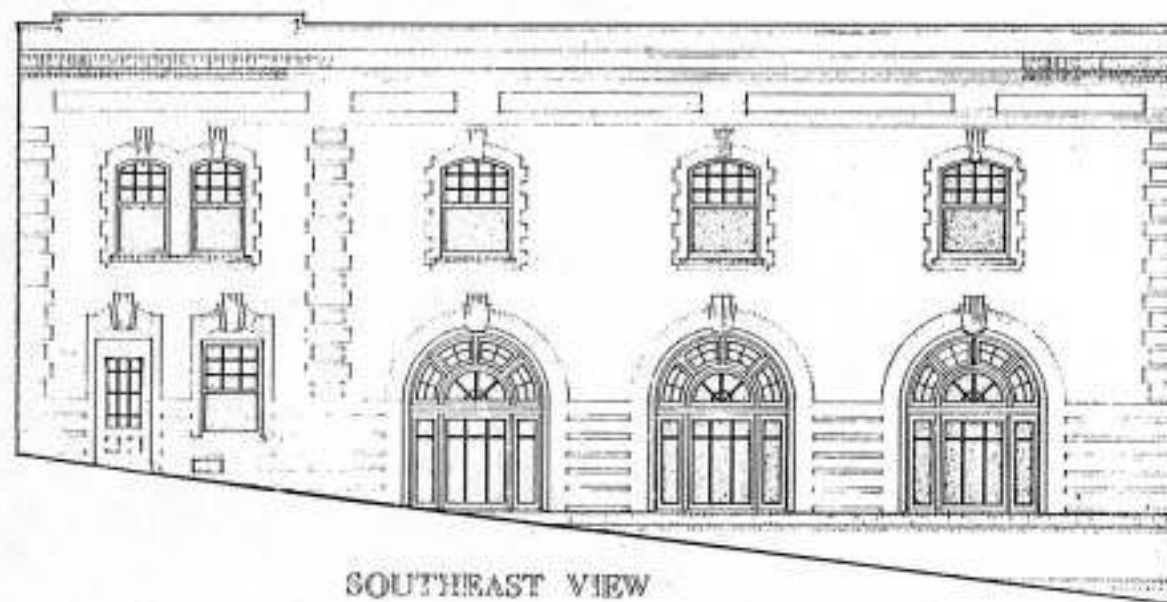
SOUTHEAST VIEW

As much as is possible, a return to the original appearance is strongly recommended. References should be made to original photographs and the measured drawings that have been prepared

1. Stucco to be removed
2. Second storey entrance to be modified
3. Cornice to be restored

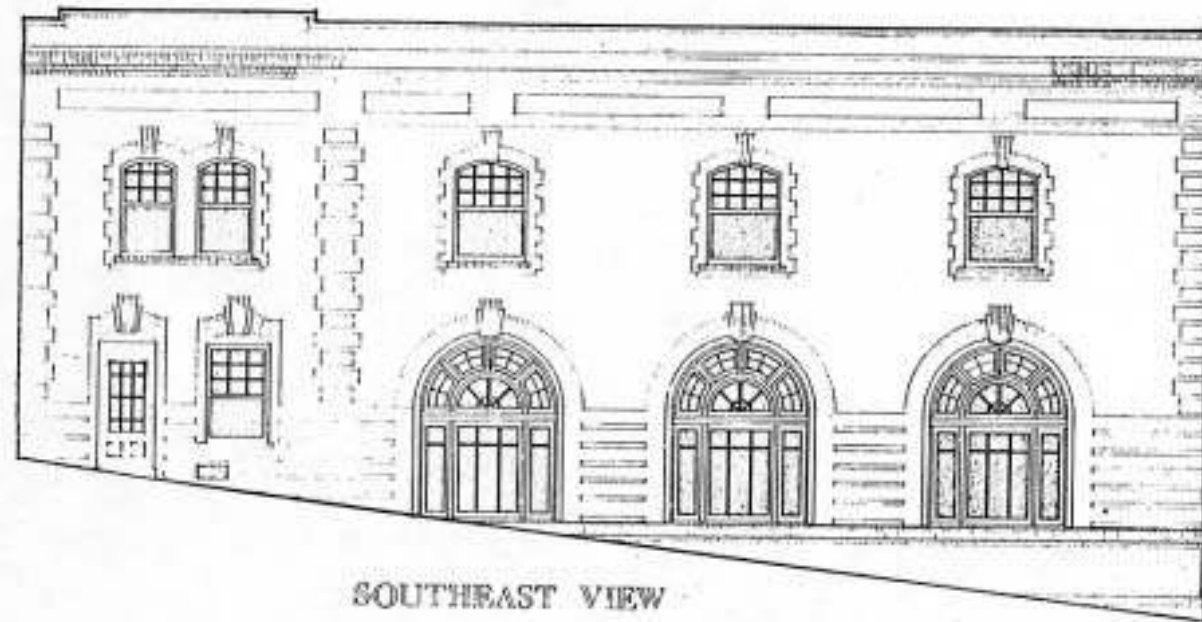
C. Shopfront & fenestration

1. Fenestration to be retained except for main entry doors
2. Second floor entry door to be replaced

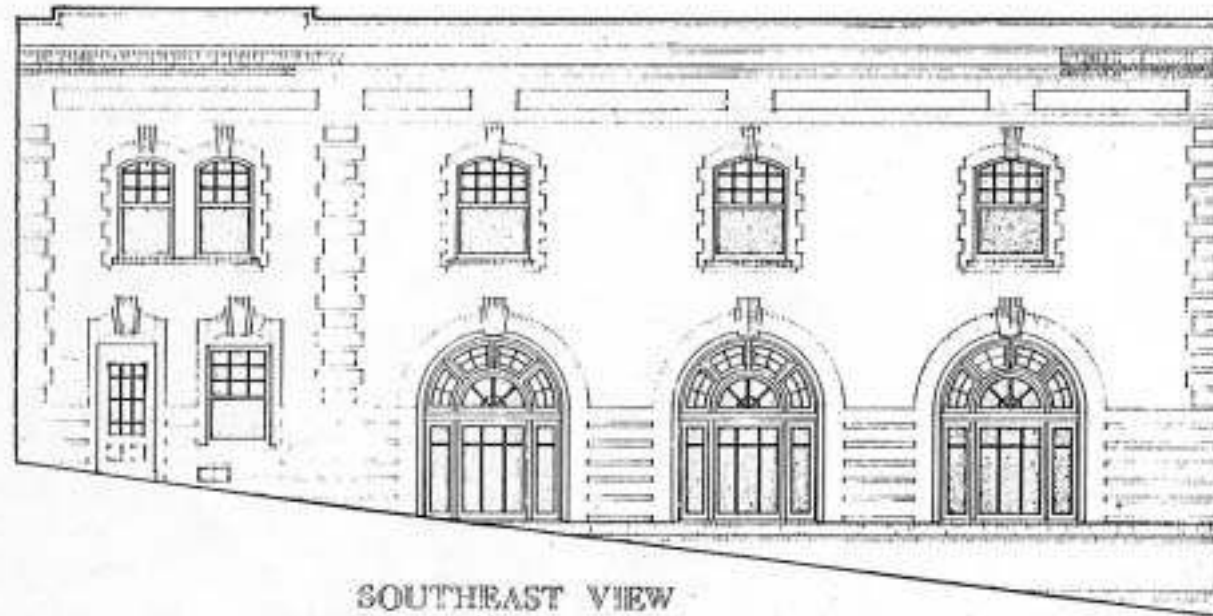
D. Auxiliary components

1. Canopies not recommended except over second floor entry
2. Signage recommended painted on glass or horizontally projecting
3. Spotlighting recommended if the building is restored

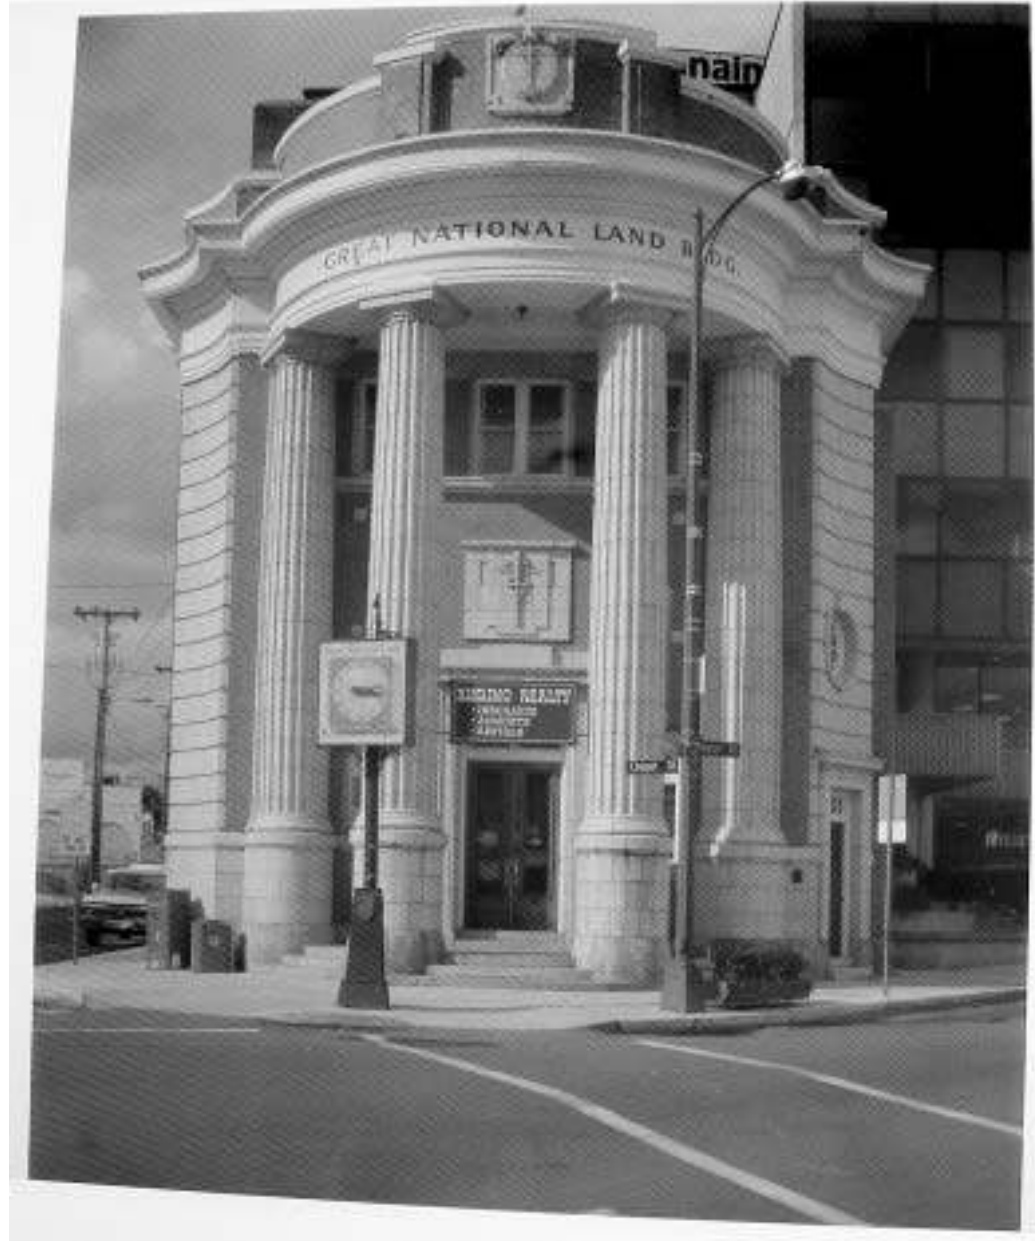
Case Study
**Great National
Land Building**

A. Existing condition

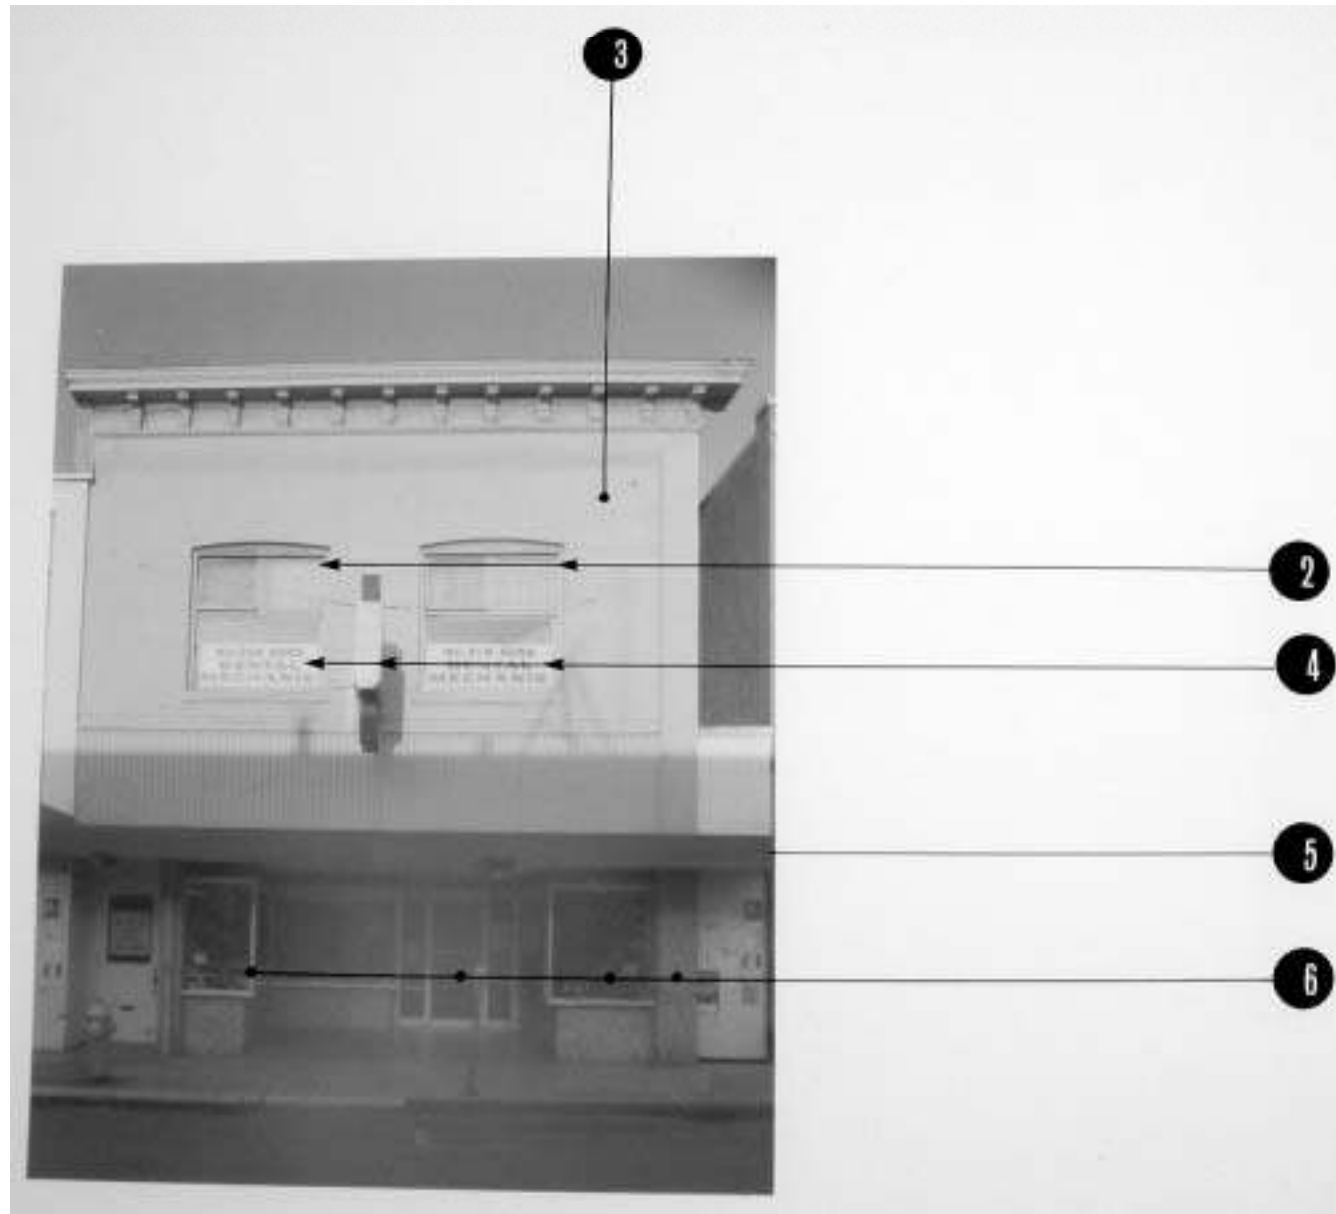
B. Recommended design

1. Replacement of second storey windows
2. Removal of metal canopy and ground floor fascia panel
3. Removal of inappropriate signage
4. Rebuilding of storefront elements
5. Replacement with new signage, canopies, and lighting
6. Remove stucco; repair and patch brickwork

The stucco covering the original brick should be removed as discussed in Section 2.2.1 and Appendix C. The storefront components should be replaced and the metal sheathing removed to expose what is behind.

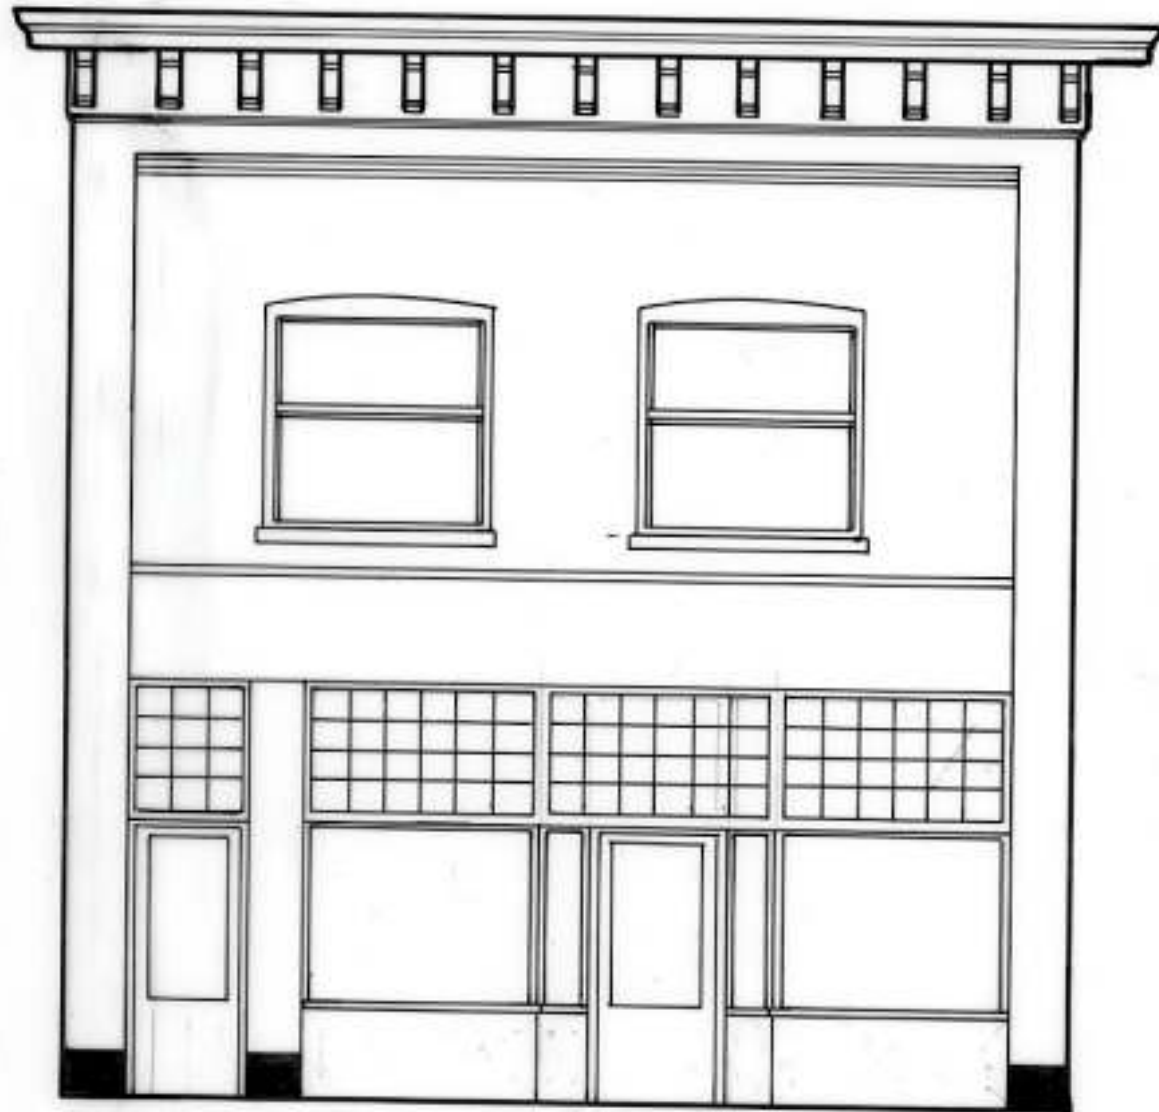
1. Replacement of second storey windows
2. Replacement of aluminum storefront window frames with sympathetic wooden elements
3. Replacement of existing doors
4. Replacement of tilework with sympathetic surfacing elements

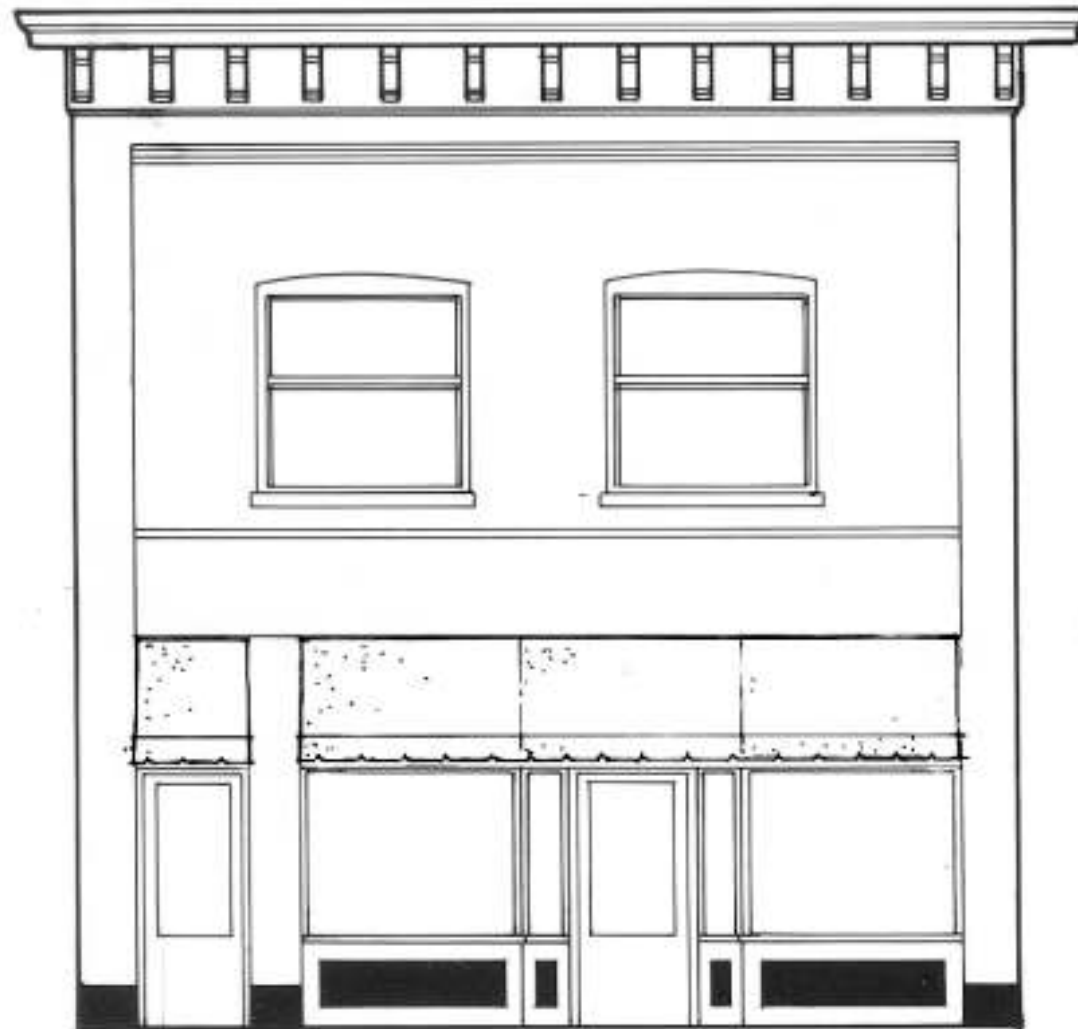
D. Auxiliary components

1. Metal canopy replaced with 3-point fabric canopy shaped to fit storefronts
2. Signage recommended along canopy valence, under canopies, or painted on glass
3. Lighting recommended as part of canopy design

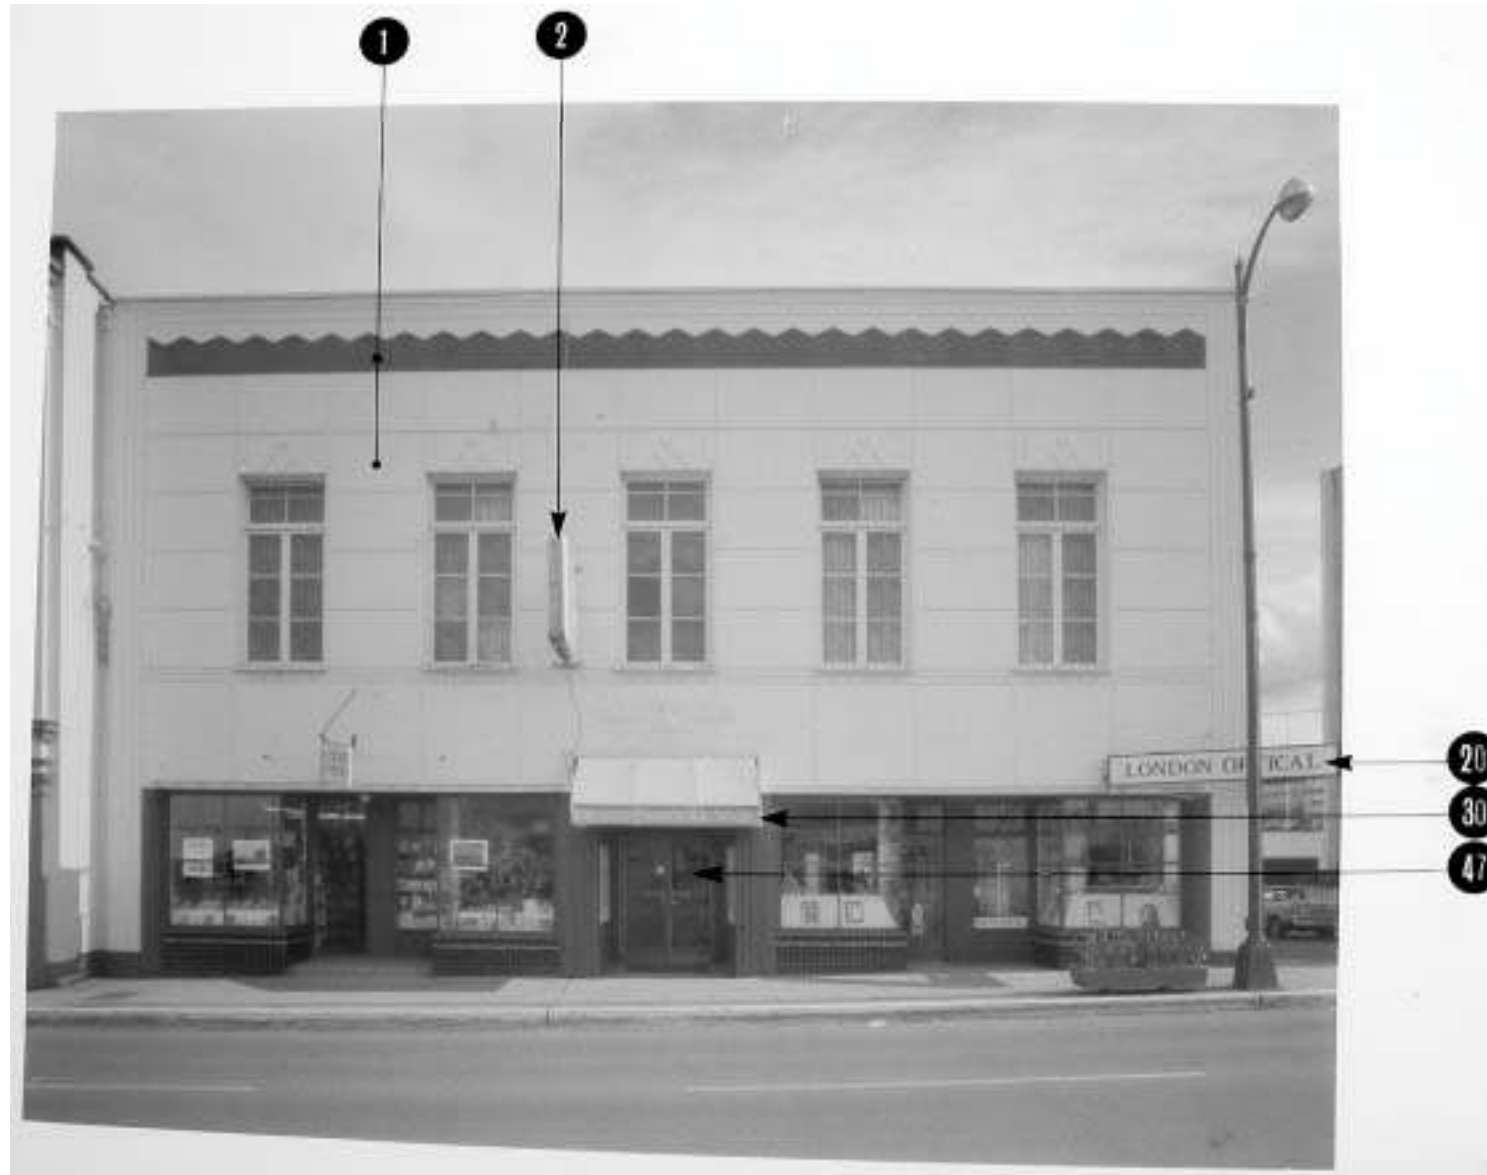
B. Recommended design

1. Removal of existing cloth canopy
2. Replacement of existing main entrance doors
3. Original elements of the building should be preserved at all costs

The storefronts are original and should be retained intact, with minor repairs as necessary. The entrance canopy and doors should be replaced with more sympathetic components. This is stylistically a very important building and should be maintained intact.

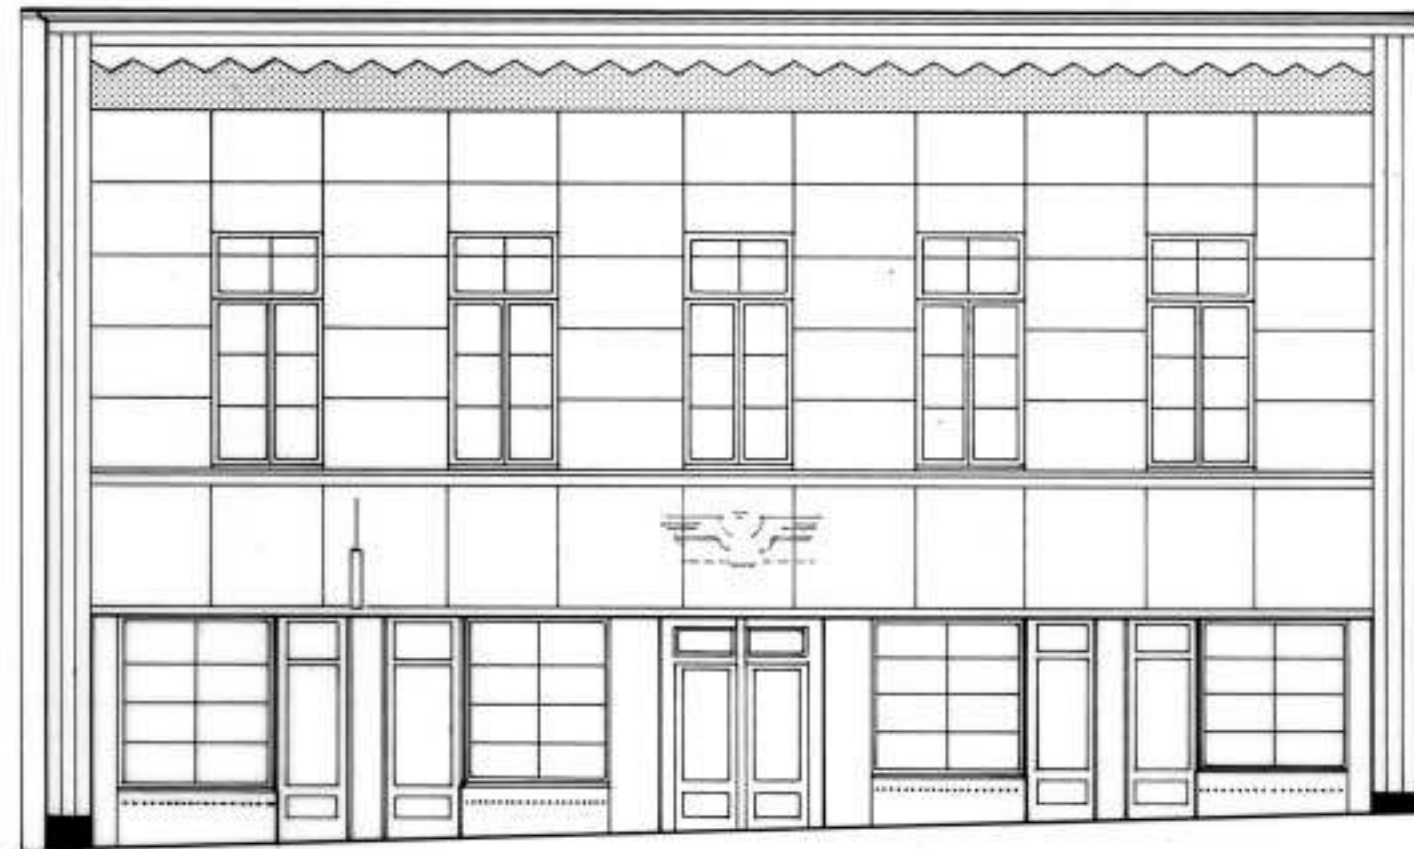
D. Auxiliary components

1. 3-point fabric canopies may be used over shopfronts if shaped to fit structural openings
2. Signage recommended along canopy valence, painted on glass, or neon tubing
3. Lighting recommended as part of canopy design
4. Colours should be used to highlight architectural elements
