NANAIMO HERITAGE BUILDING DESIGN GUIDELINES

THE FOUNDATION GROUP
#1 – 2629 West Fourth Avenue, Vancouver, B.C., V6K 1 P8
733-4593

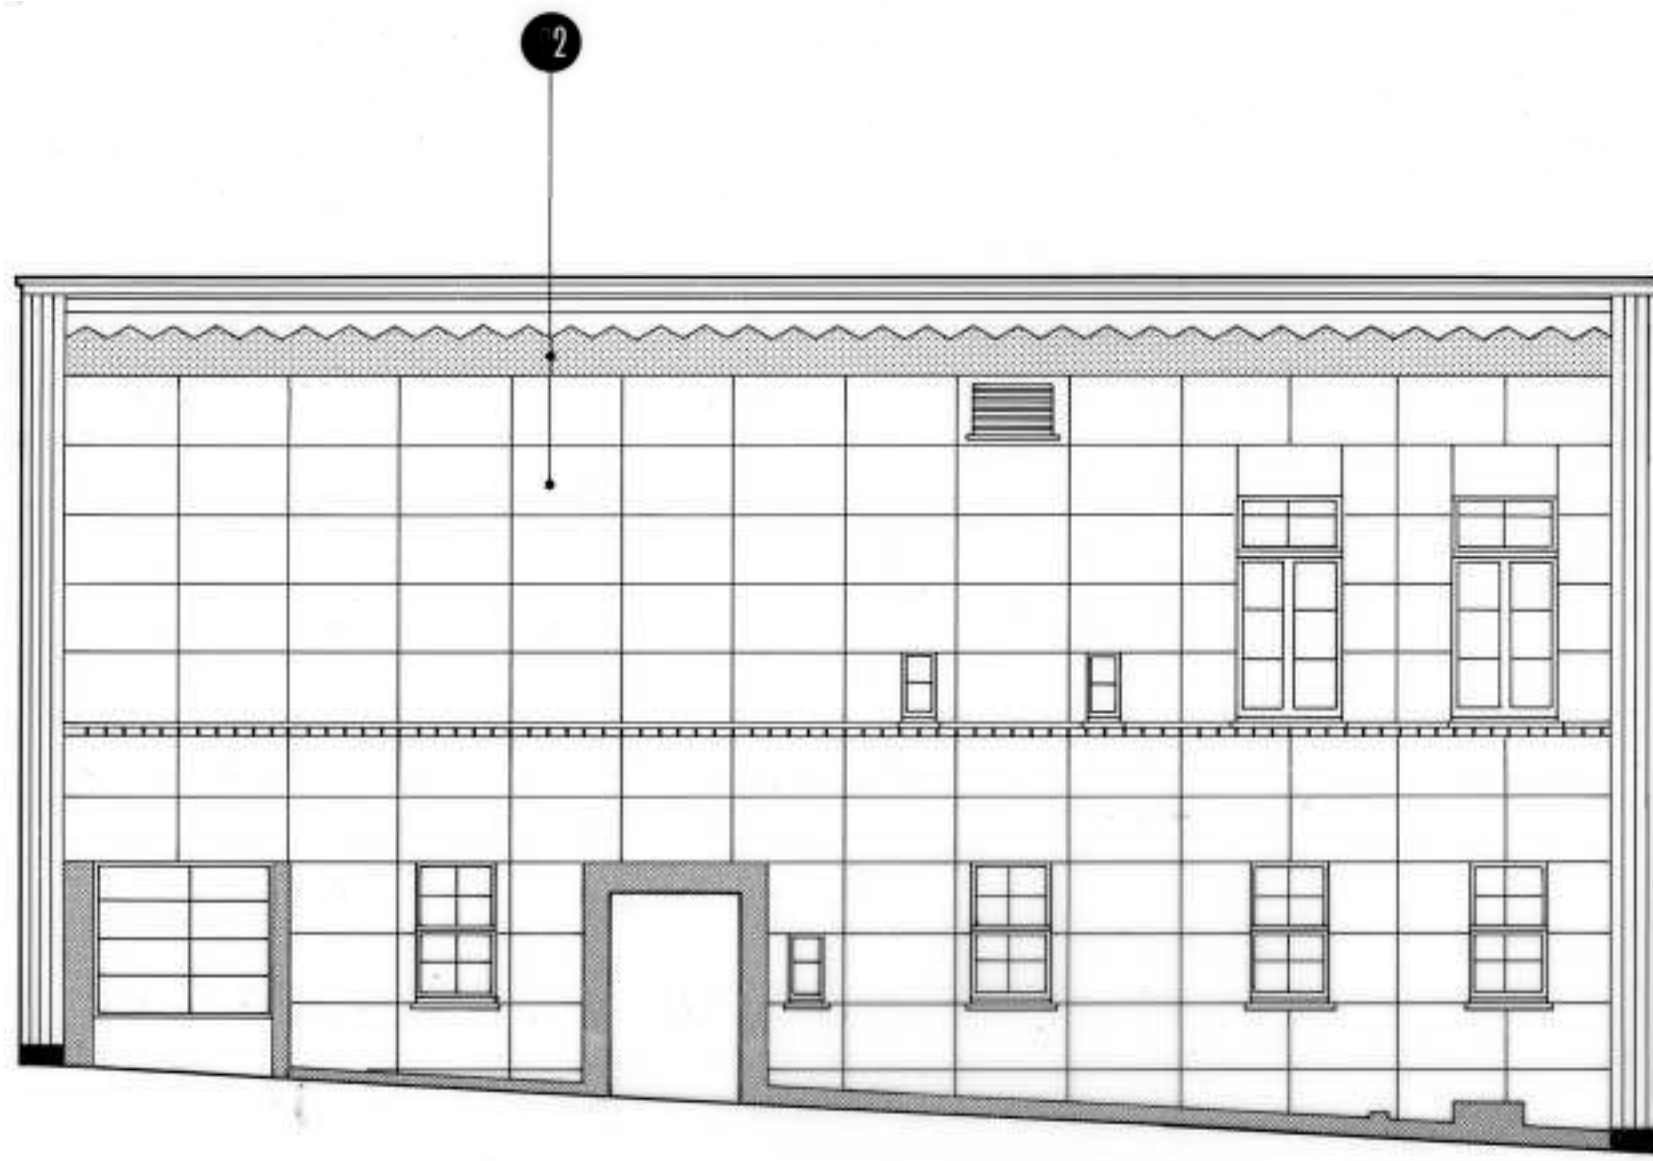
1. 3-point fabric canopies may be used over shopfronts if shaped to fit structural openings
2. Signage recommended along canopy valance, painted on glass, or neon tubing
3. Lighting recommended as part of canopy design
4. Colours should be used to highlight architectural elements

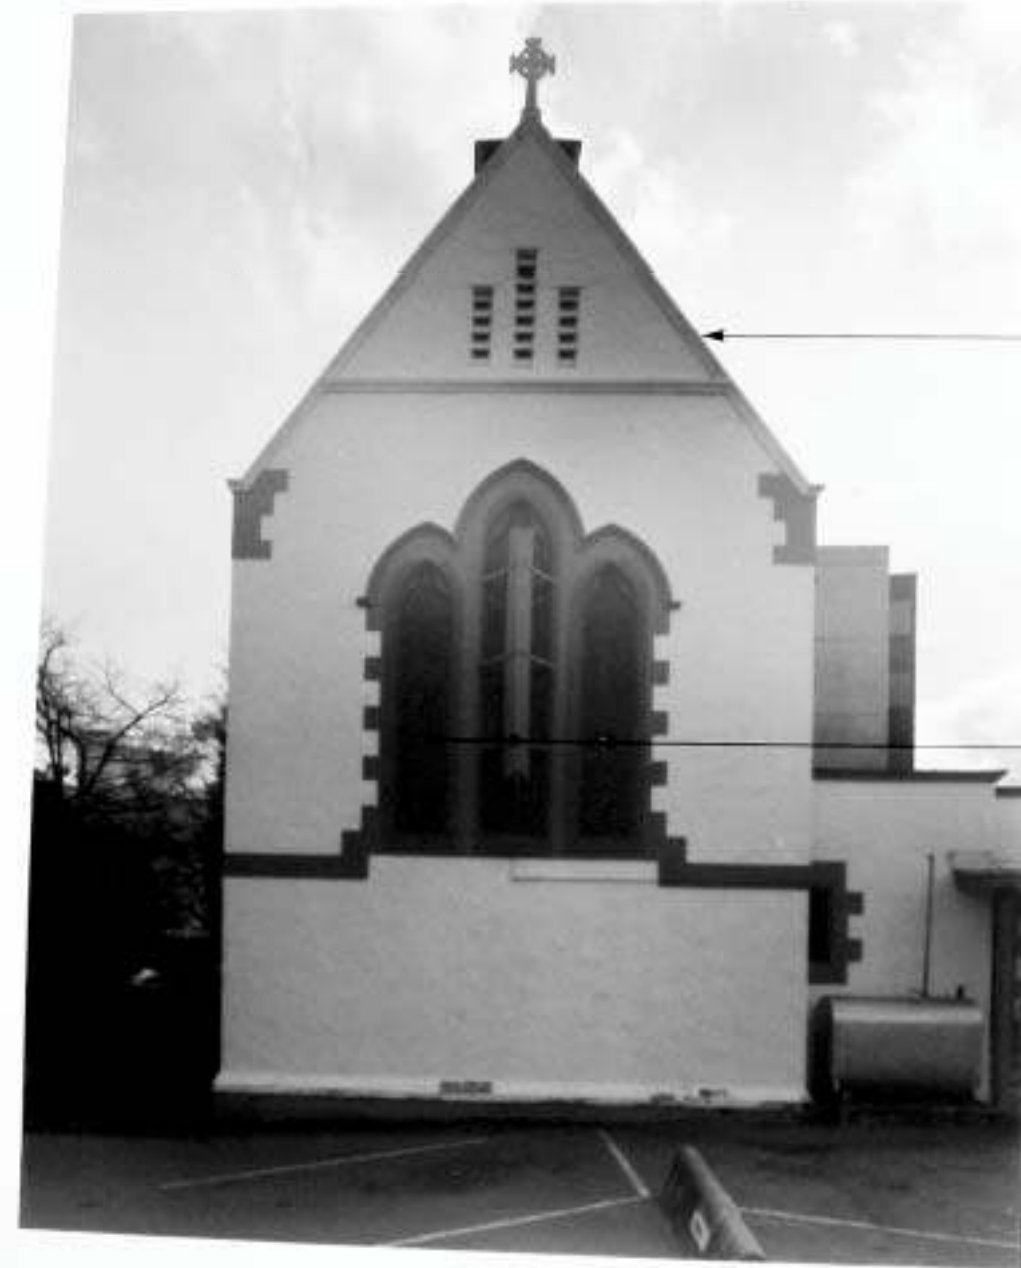
A. Existing condition

1. Leakage along flashing and seepage into walls and interior-- flashing requires attention but slate roof appears to be sound

RECOMMENDED MODIFICATIONS

2. Plexiglass or tempered glass coverings over stained glass windows for breakage protection and additional insulation. Frames to be unobtrusive

The church is in significantly original condition and should be maintained as such. There is some concern as to leakage along the flashing and around the windows, which should be attended to in order to preserve the interior and exterior fabric of the building.

It may be desirable to mount plexiglass or tempered glass panels over the stained glass windows to provide impact protection as well as added insulation. In this case, the framing elements should be dark toned and as unobtrusive as possible. The small-scale bullrush motif fence along Church Street is significant and should be repaired and maintained. Some consideration might be given to improving the appearance of the side buildings from the parking lot through the use of screens or vegetation.

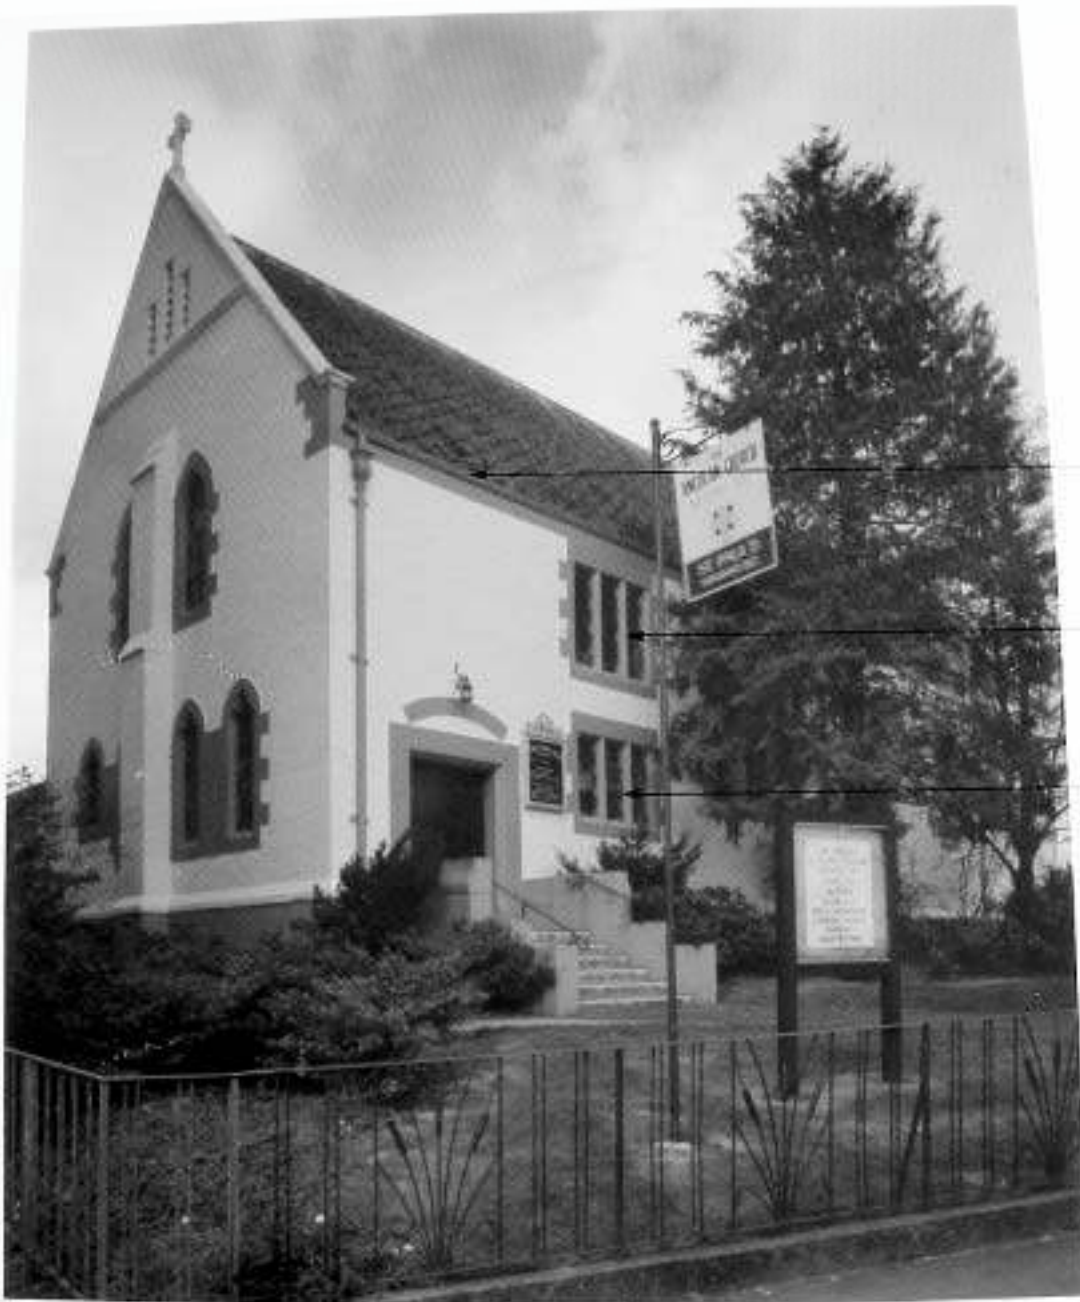
A. Existing condition

1. Leakage along flashing and seepage into walls and interior-- flashing requires attention but slate roof appears to be sound

RECOMMENDED MODIFICATIONS

2. Flexiglass or tempered glass coverings over stained glass windows for breakage protection and additional insulation. Frames to be unobtrusive

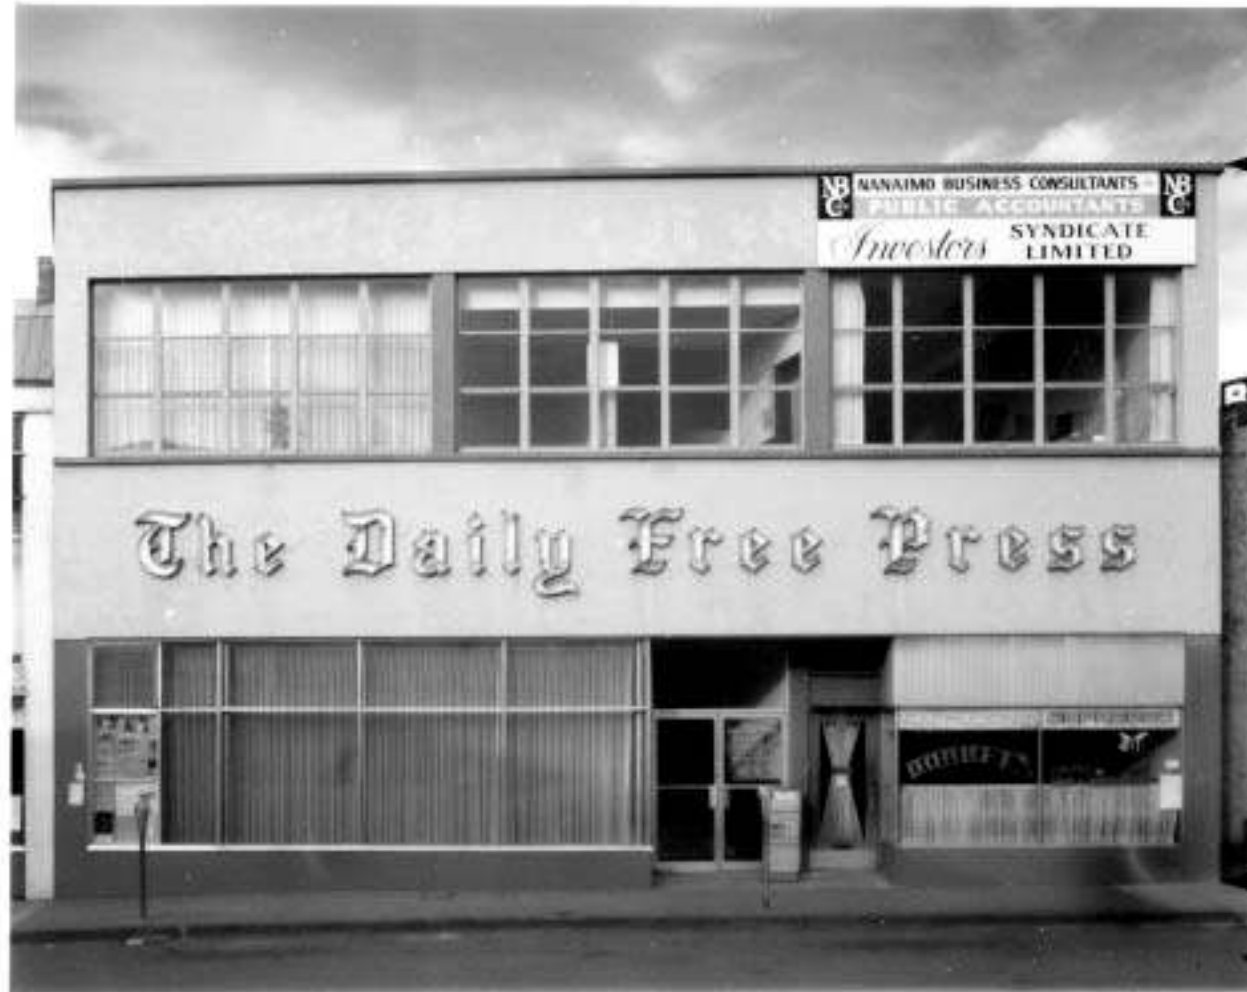
UNSUITABLE MODIFICATIONS

2. Entire facade has been rebuilt

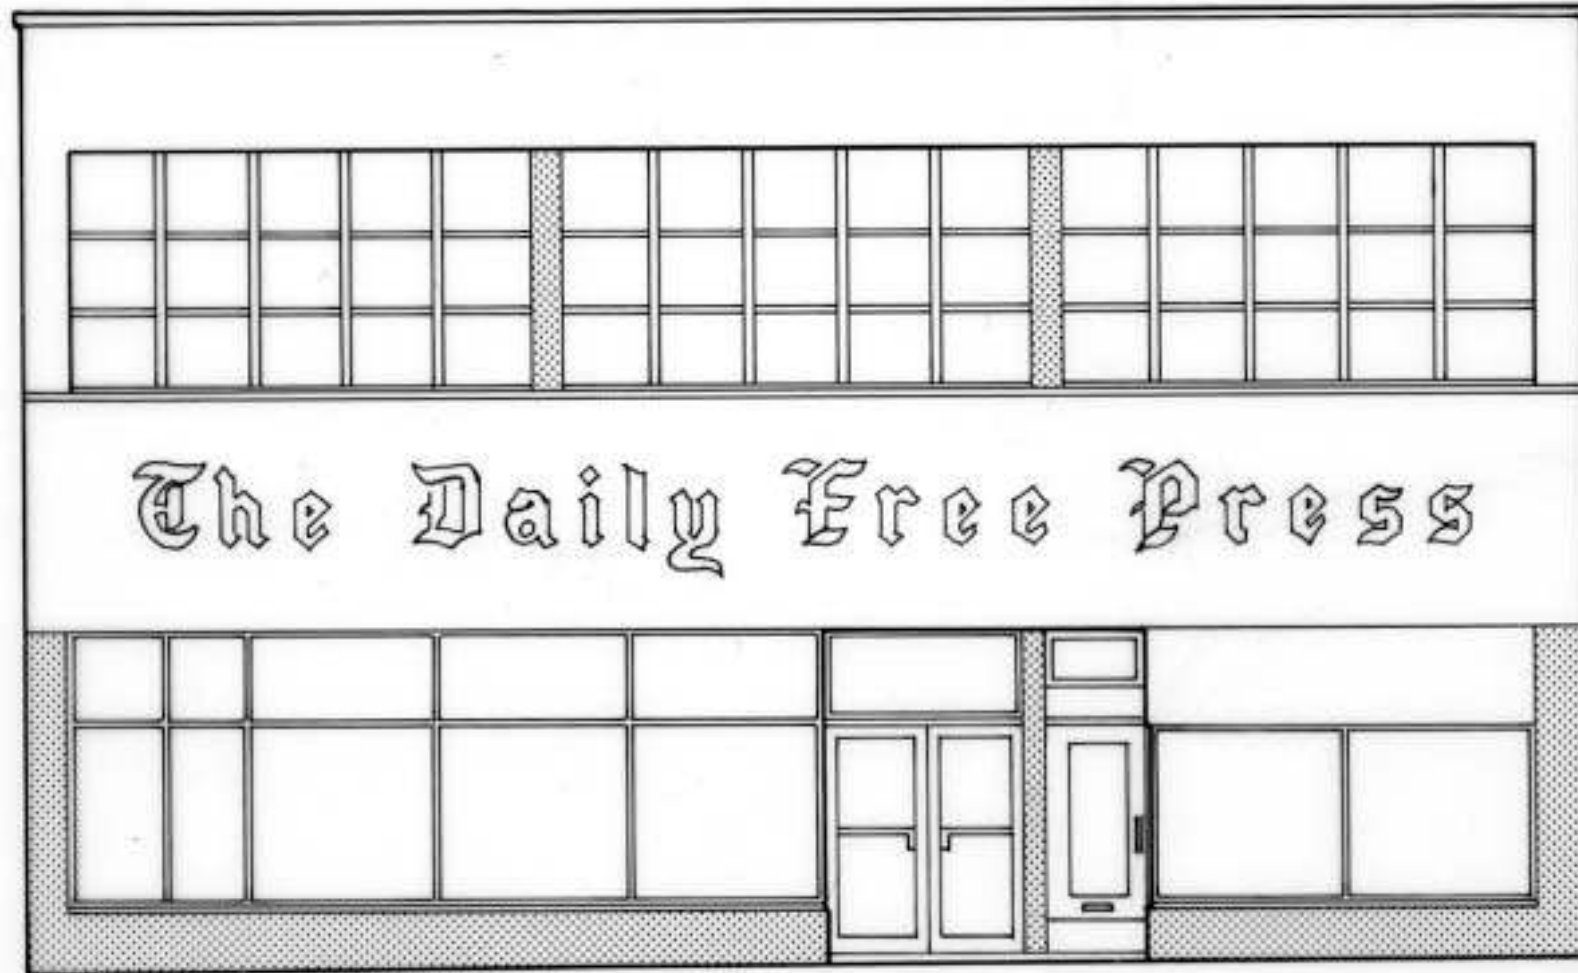
B. Recommended design

Short of an entire rebuilding, it is recommended that the facade be treated only with colour and canopies

It is recommended that the facade be painted in colours sympathetic to the area that will act as a backdrop to the surrounding historic buildings. A brick-coloured body tone is recommended. Canopies may then be in a lighter cream or beige tone. The building is of a rather severe nature, which could be considerably softened through these remedial measures. Interestingly, the Free Press Building forms a significant modern period grouping with the adjacent building, the Modern Café, which is an excellent period facade.

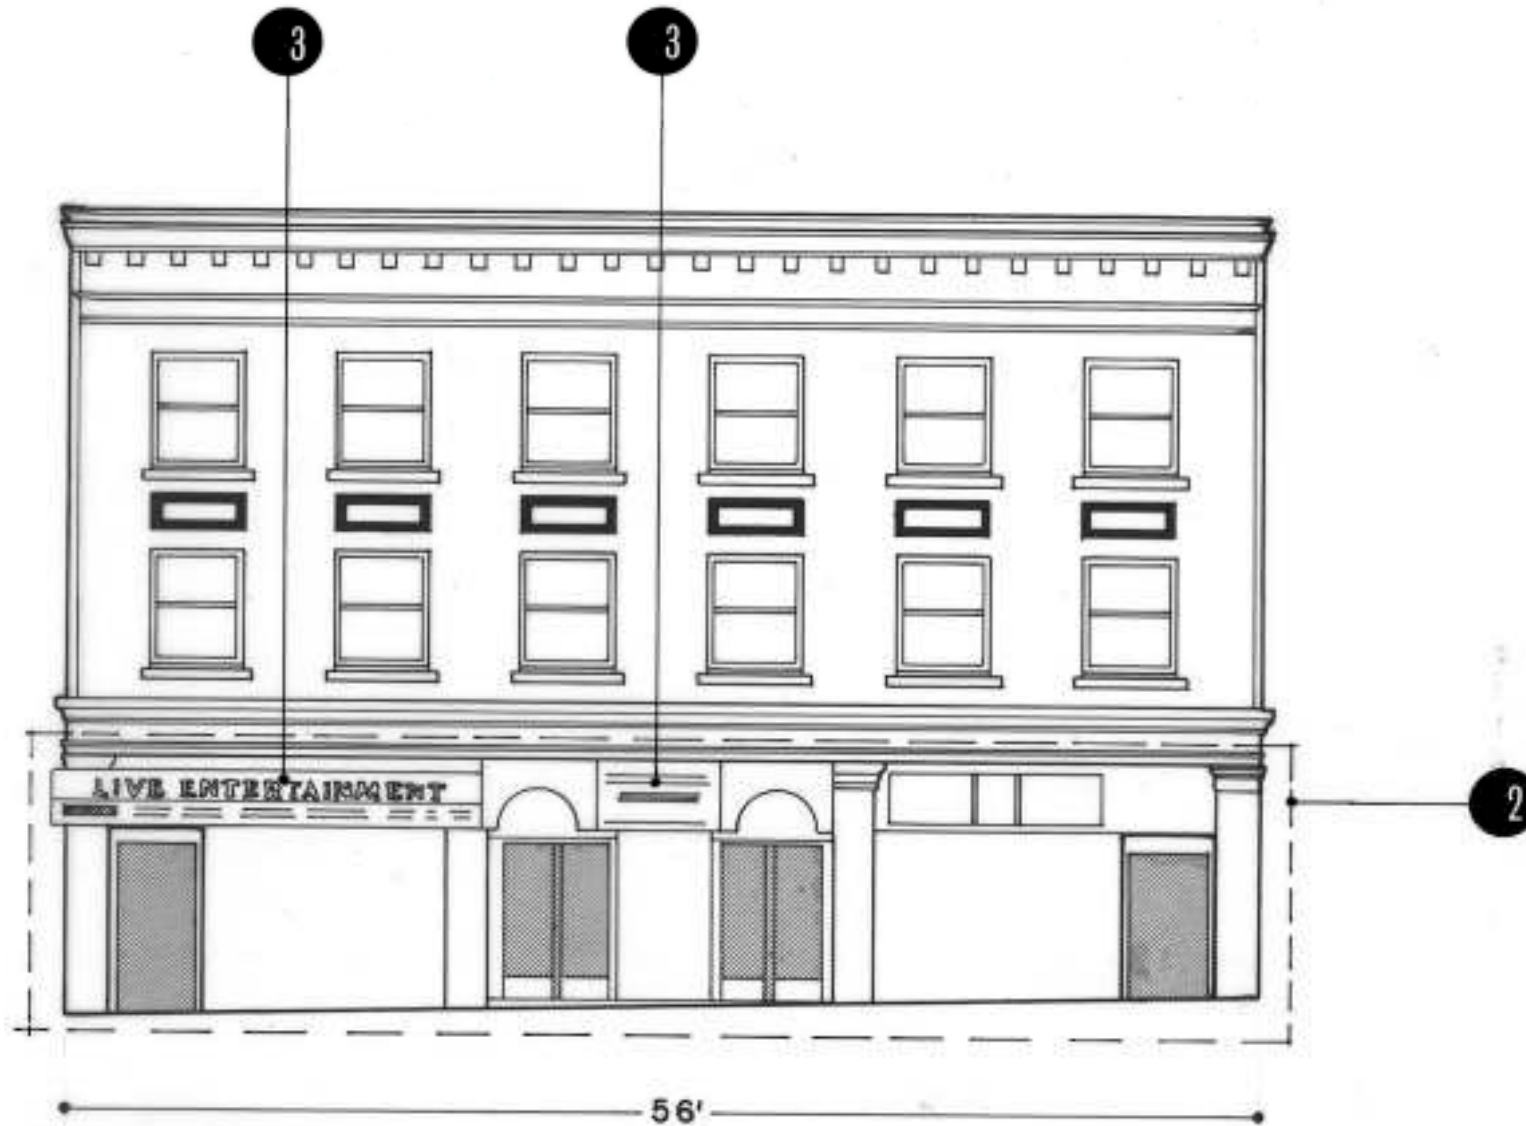
UNSUITABLE MODIFICATIONS

2. Ground floor has been unsympathetically altered
3. Inappropriate signage

This building is in good original condition above the ground floor. The street-level components, however, are inappropriate and should be rebuilt.

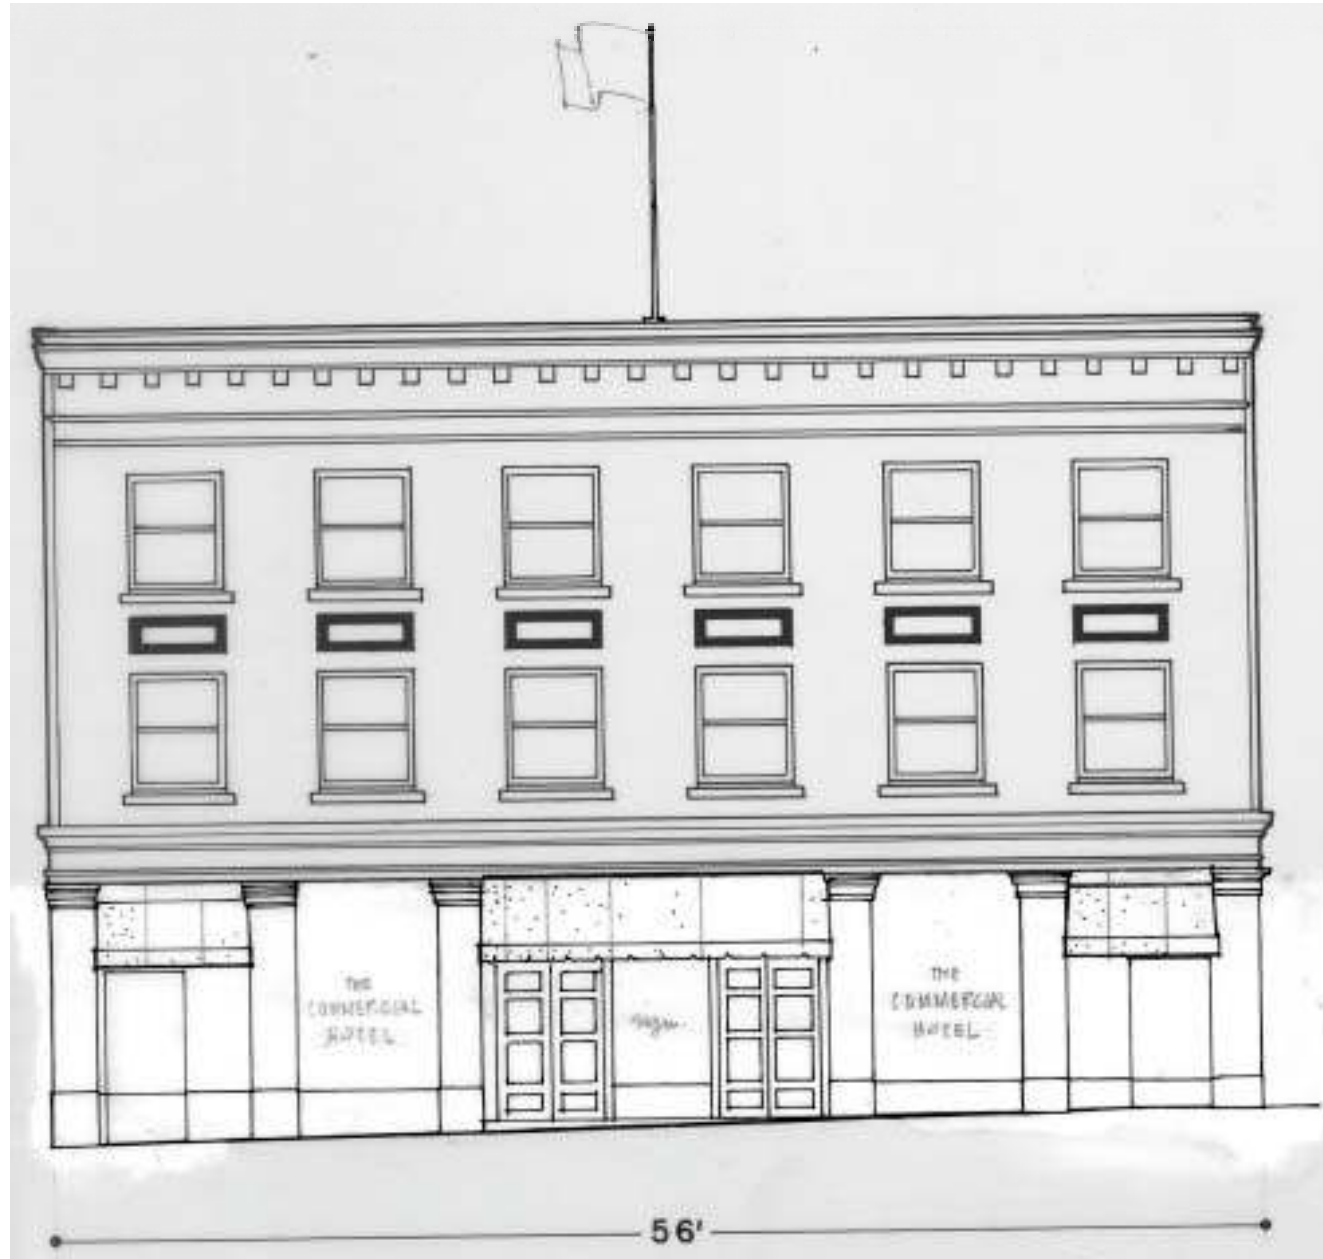
1. 3-point fabric canopies shaped to fit structural openings
2. Signage recommended along canopy valences, under canopies, horizontally projecting or neon tubing
3. Lighting recommended as part of canopy design

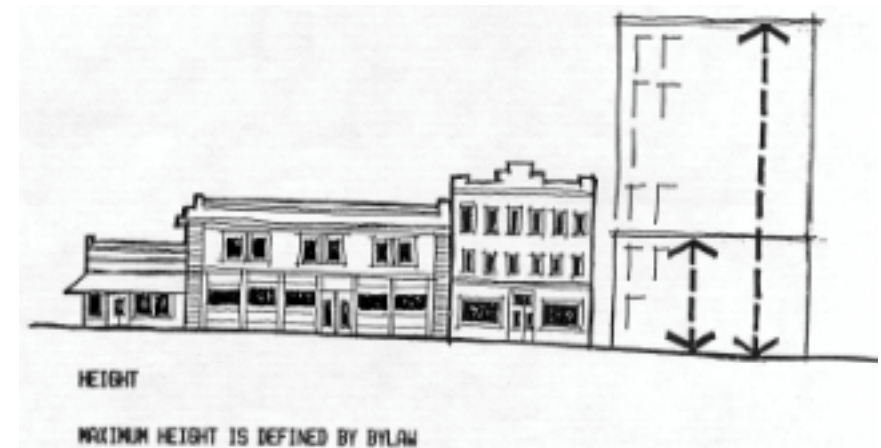
HEIGHT: Should conform to City Zoning Bylaw, Section 28.04 HEIGHT OF BUILDINGS. In addition, the cornice line of adjacent buildings should be respected so that there are no setbacks for the first one, two or three storeys, dependent on context and that storeys above this be set back to minimize their visual impact.
